Re: Review of Annual Maintenance  
977-ft Self-Support Tower  
San Francisco, California  
TCI Project Number 14.082.001

Tower Consultants Incorporated (TCI) performed a field evaluation of the structural repair and maintenance work performed on the 977-ft self-support tower located in San Francisco, California. Jeff Altmyer, P.E. and Yevgeny Kabatski performed the site observation from September 2014, through November 2014 as part of Sutro Tower's annual inspection.

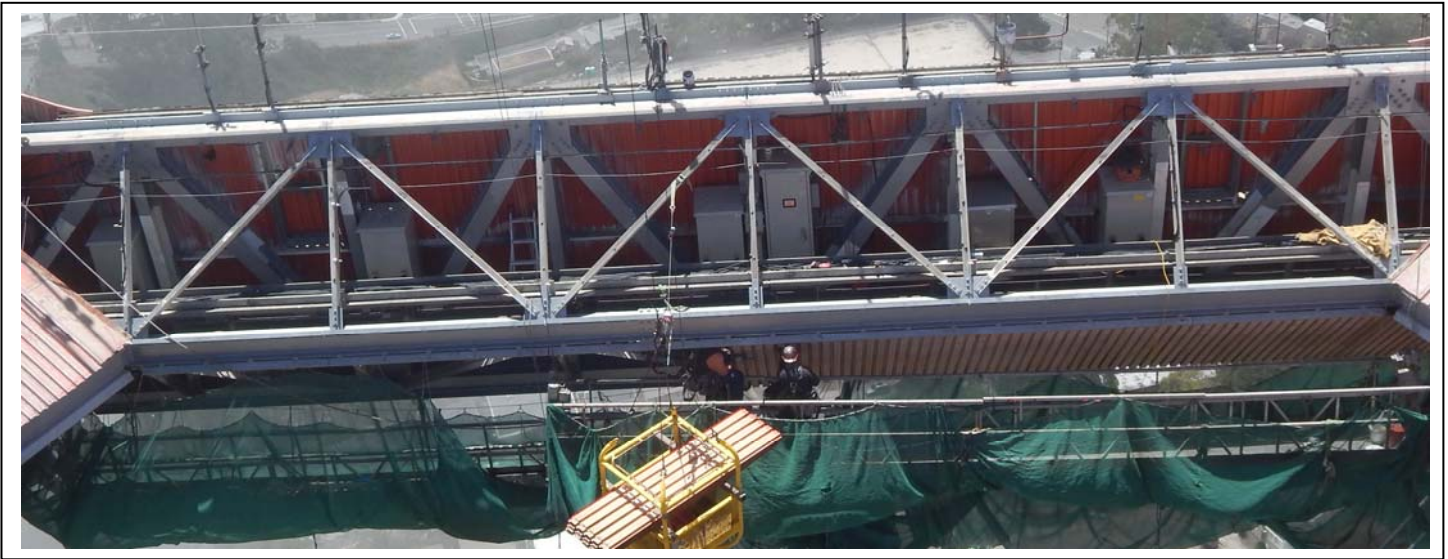
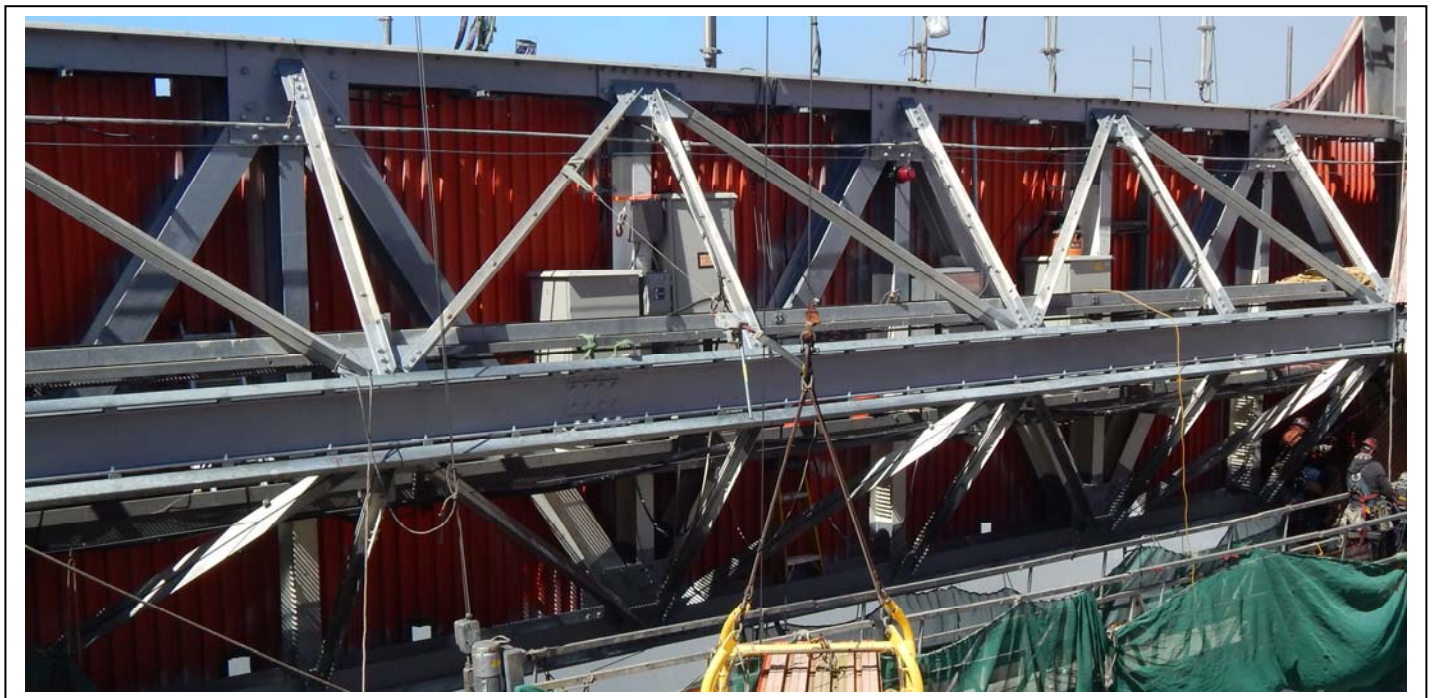
Photo Nos. 2 and 3 are views of freshly painted members on the south face at level 3.

1. Clean rust from tower members and bolts and repaint (Photo Nos. 2 – 16). This work was accomplished this year at levels 2, 3 and 6 and in leg B and at all 3 antenna stacks and all tower bases. PVC pipes were added to the beam drain holes to alleviate corrosion (Photo Nos. 31 – 33).

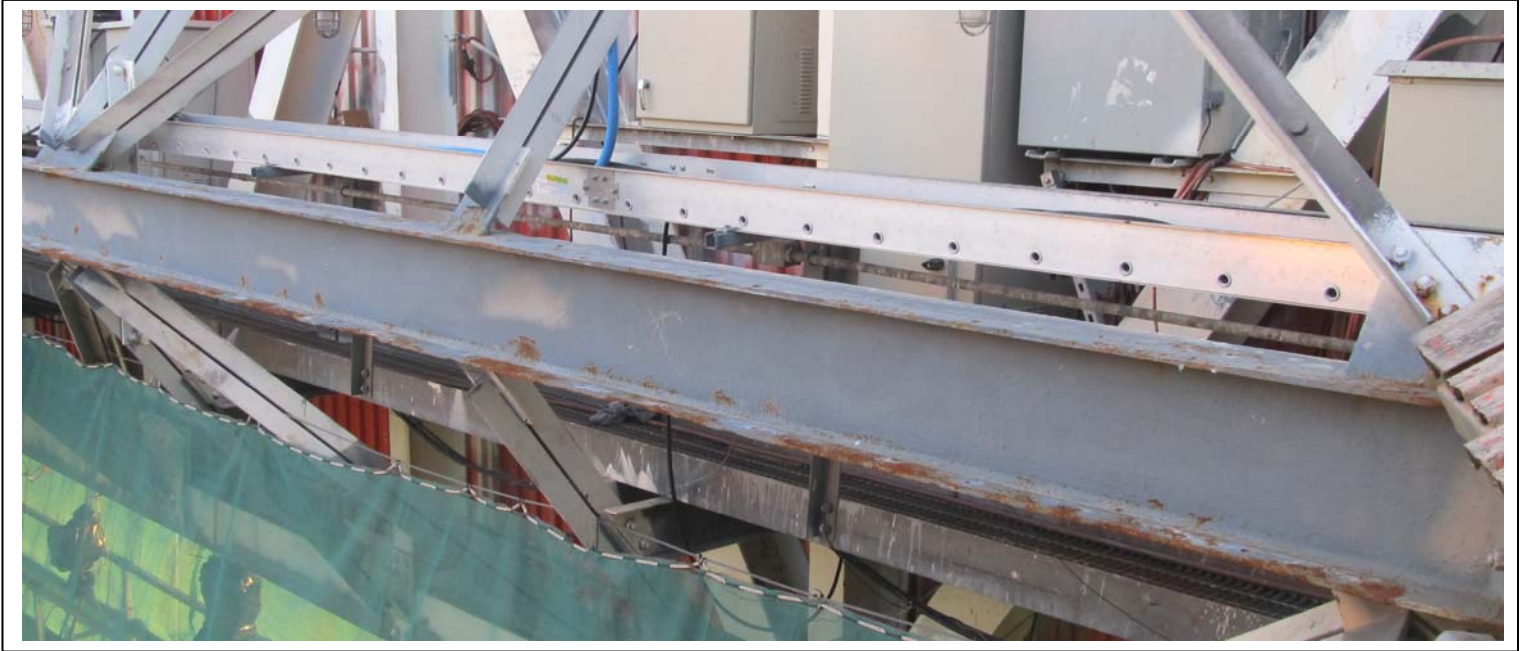
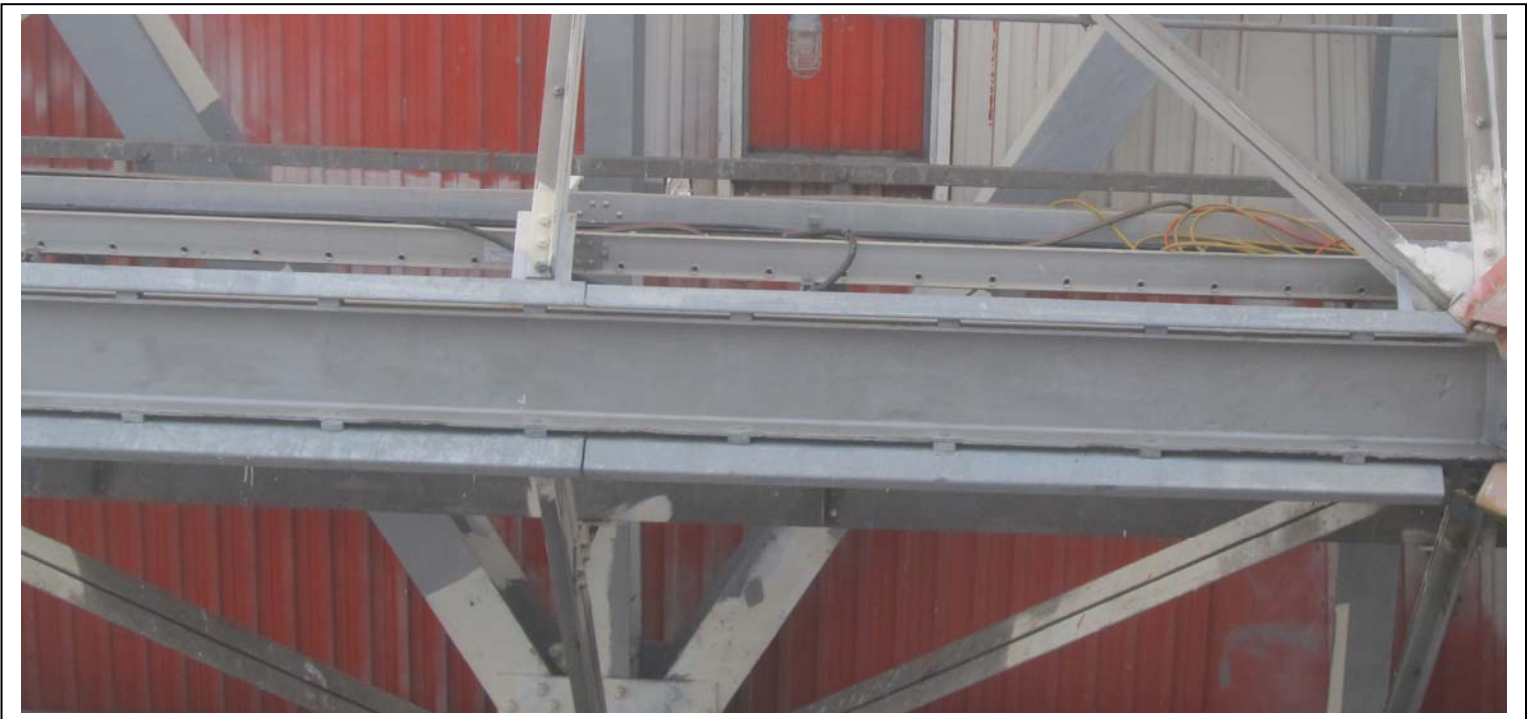
Photo Nos. 4 and 5 show a beam before and after rust treatment and painting.

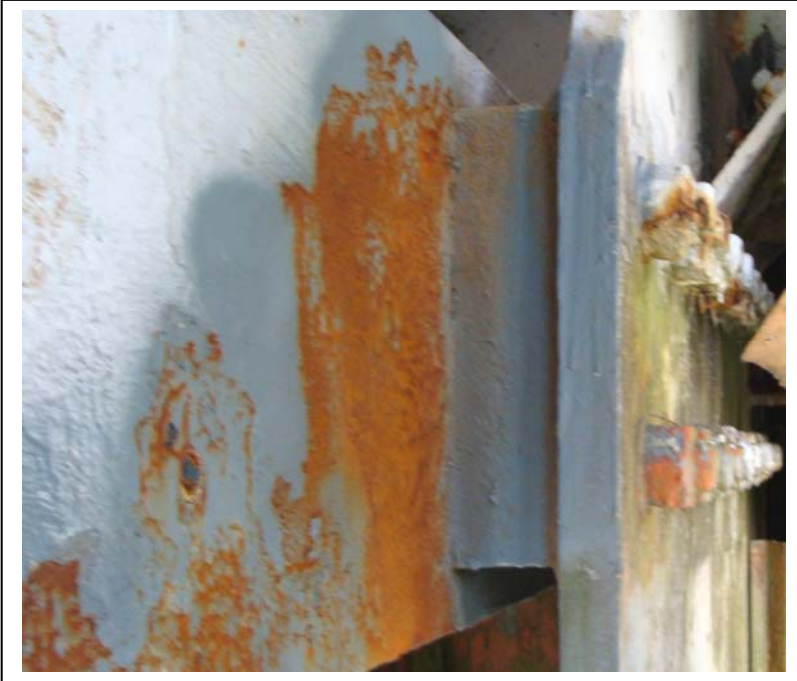
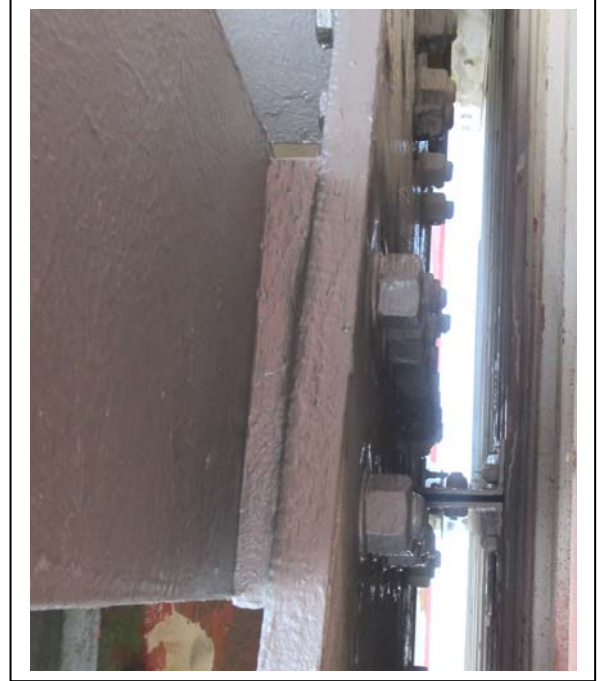
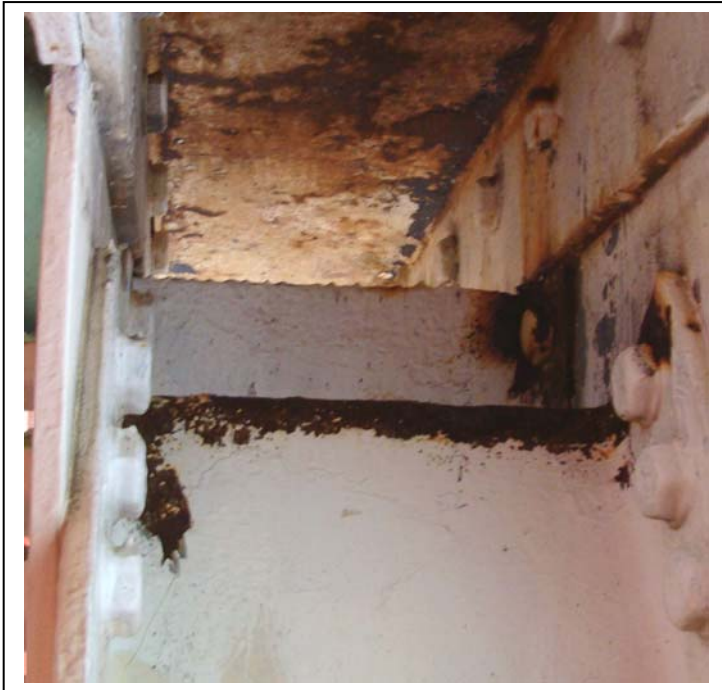
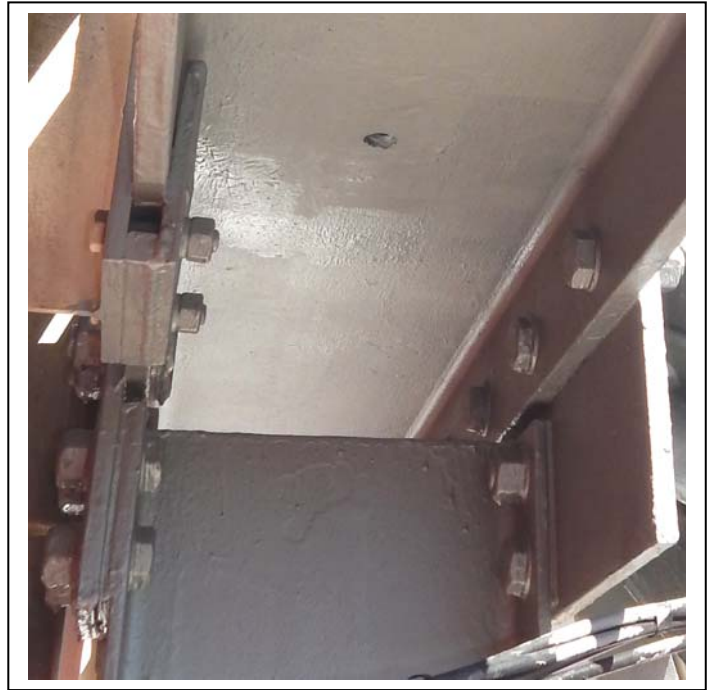
Photo Nos. 6 - 9 show beams before and after rust treatment and painting.

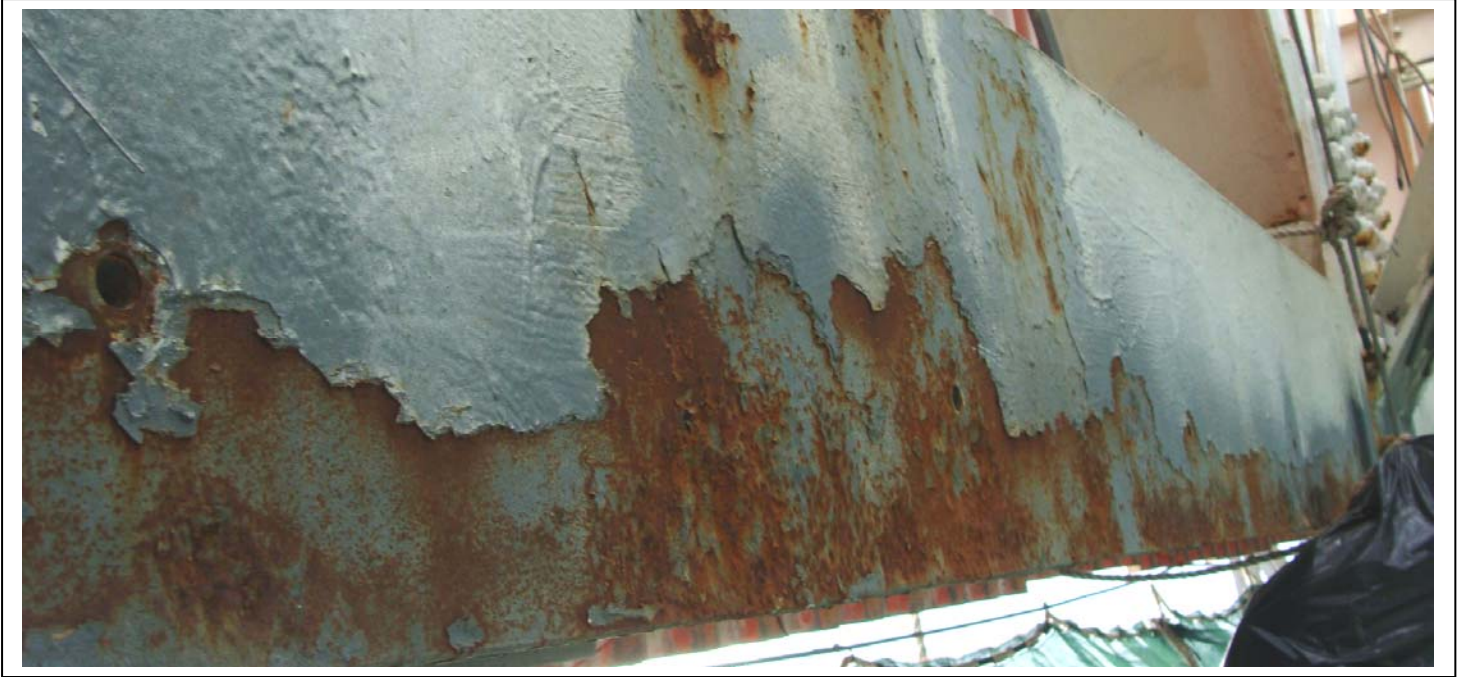
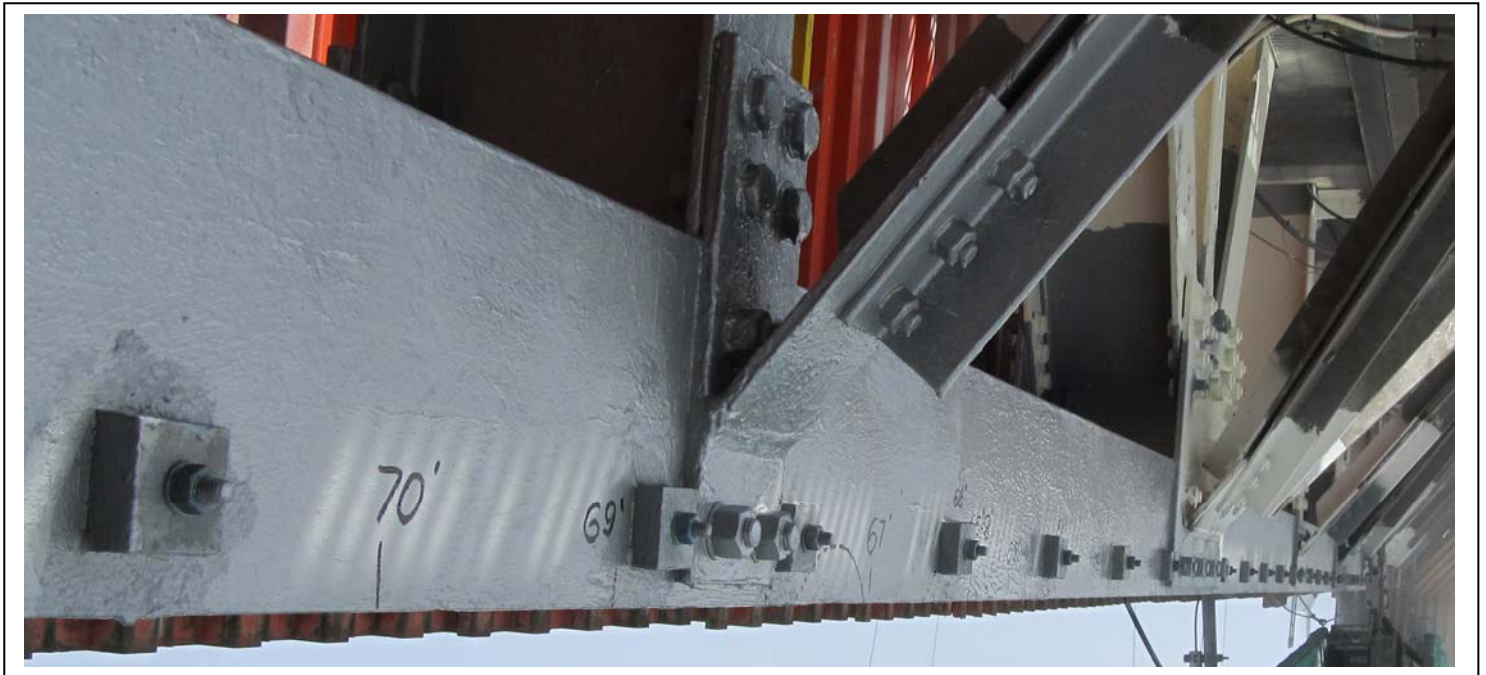
Photo Nos. 10 and 11 show beams before and after rust treatment and painting.

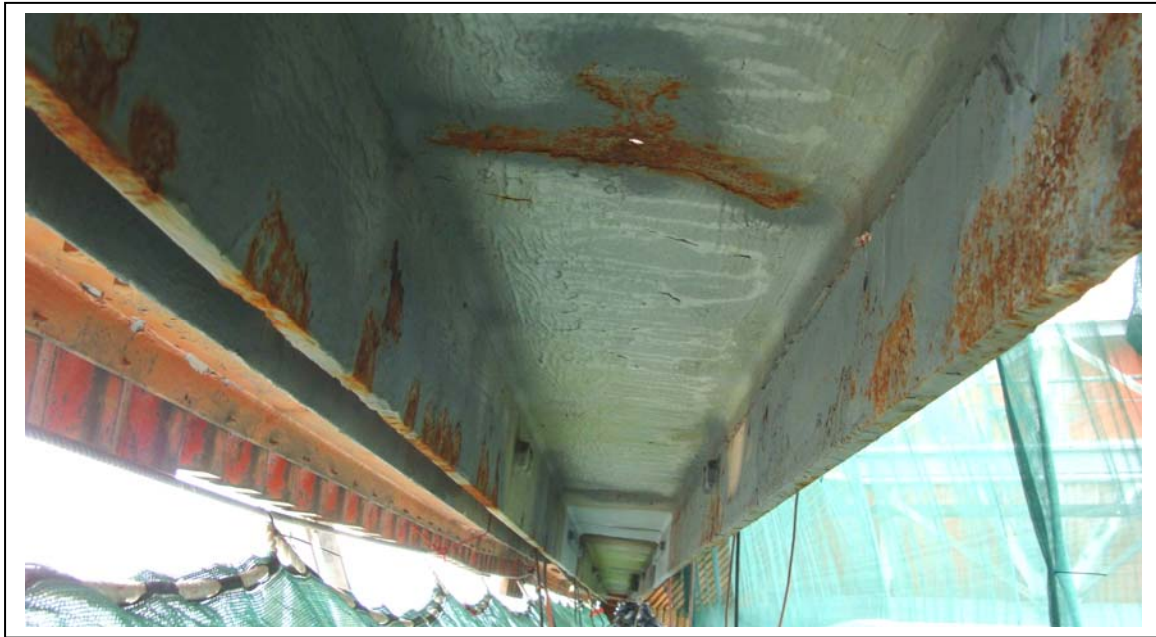
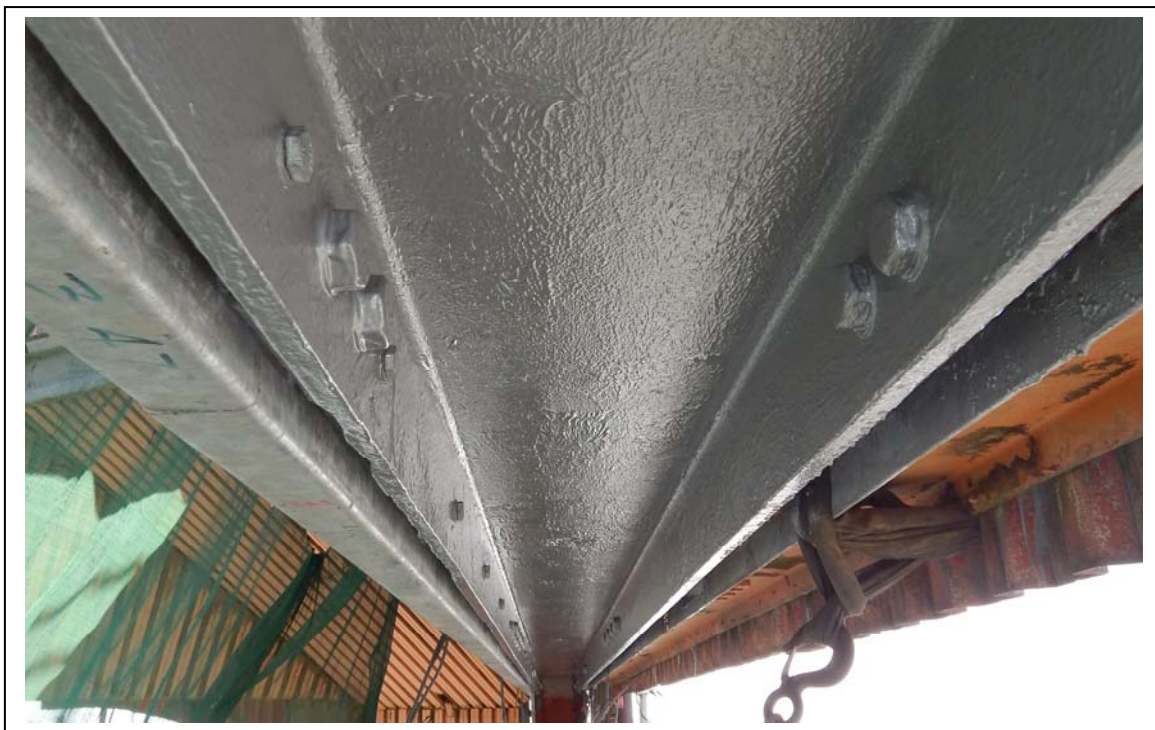
Photo Nos. 12 and 13 show beams before and after rust treatment and painting.

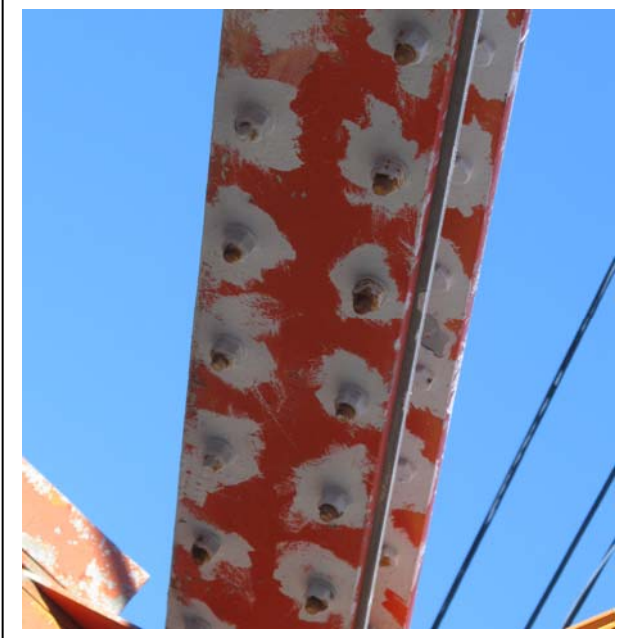
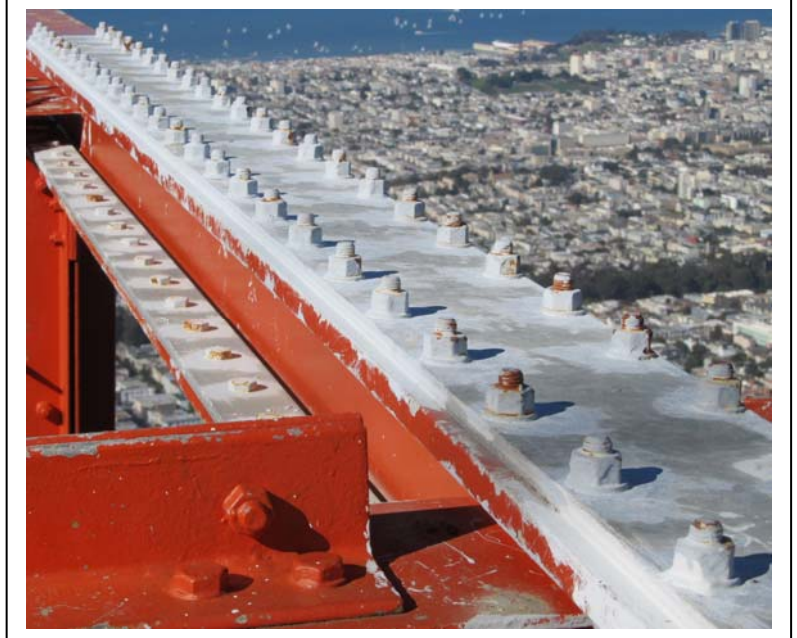
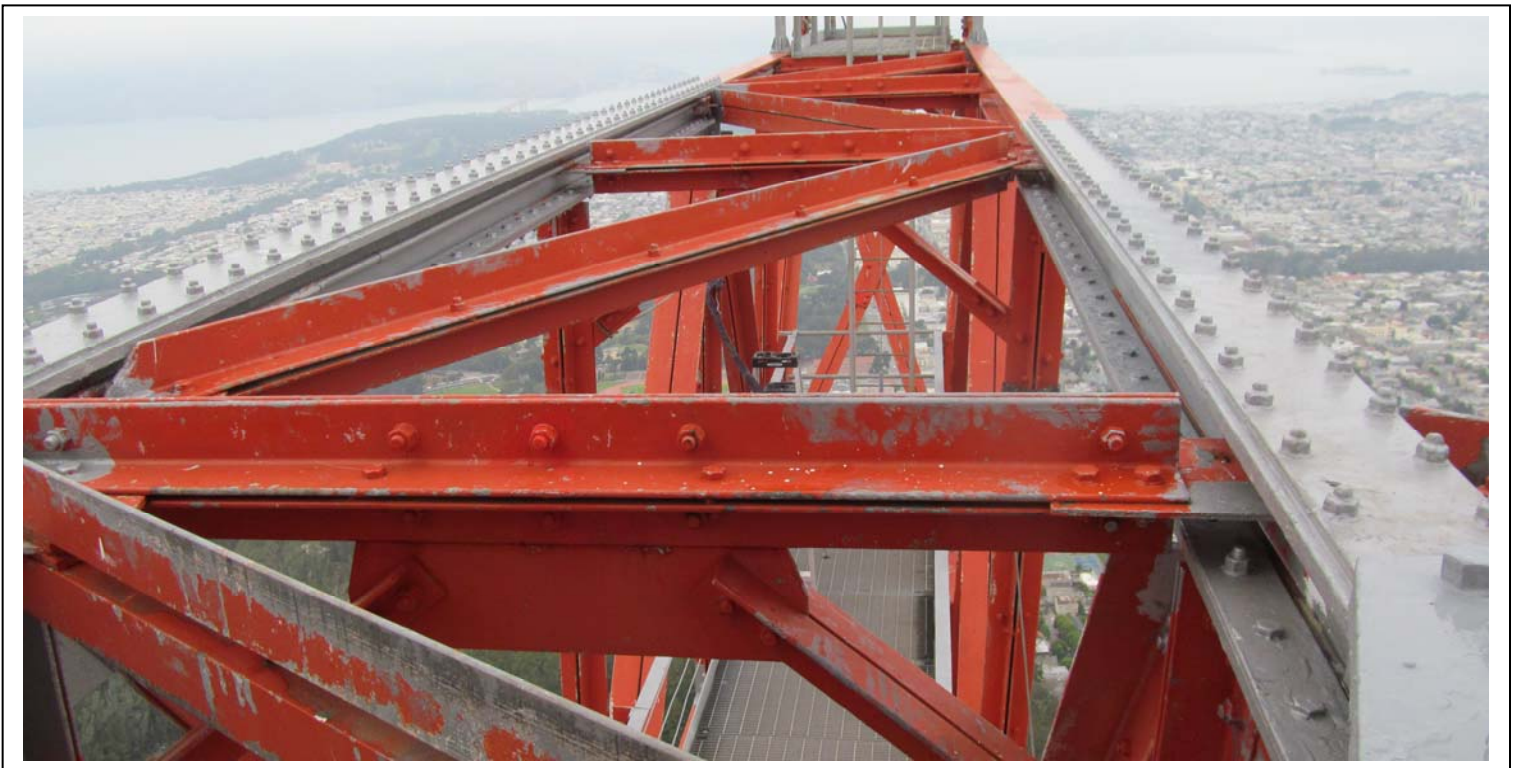
Photo Nos. 14 - 16 are views of the rust treated bolts at level 6.

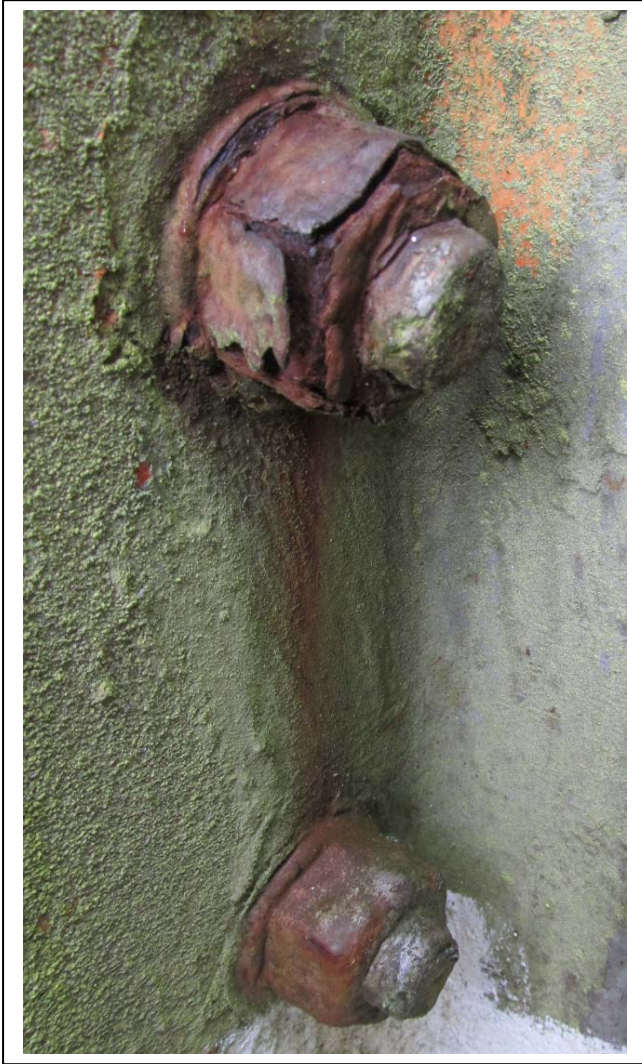
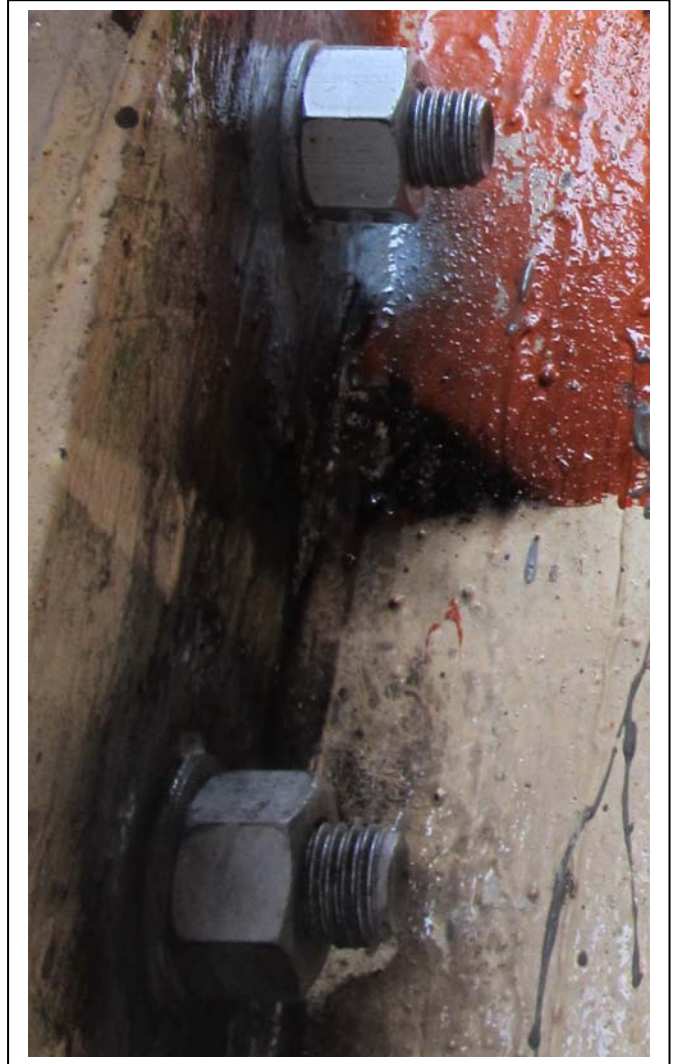
Photo Nos. 17 and 18 show leg bolts before and after they were replaced.

2. Rusted bolt replacement (Photo Nos. 17 – 24). This year bolts were replaced at levels 2, 3 and 6 and partially at level 4 and in the antenna stacks. In some cases mildly rusted bolts were replaced in lieu of painting due to limited accessibility for preparation. We estimate that 1,000 bolts have been replaced this year.

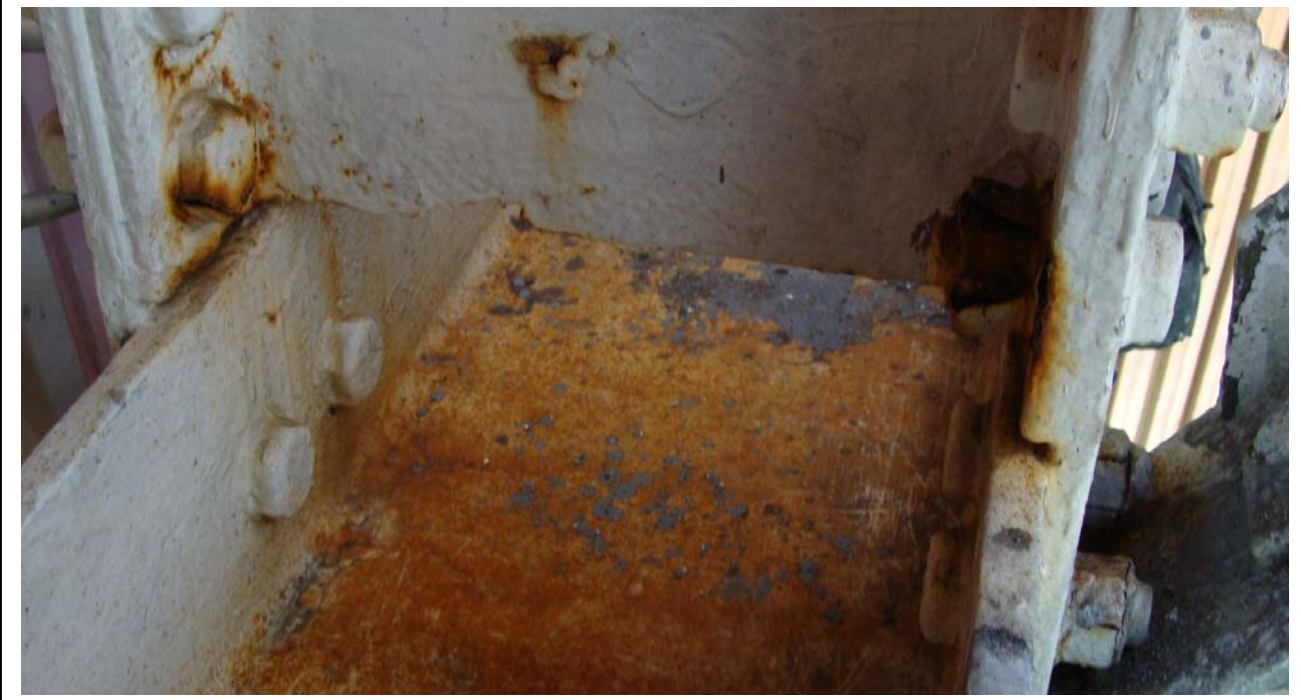
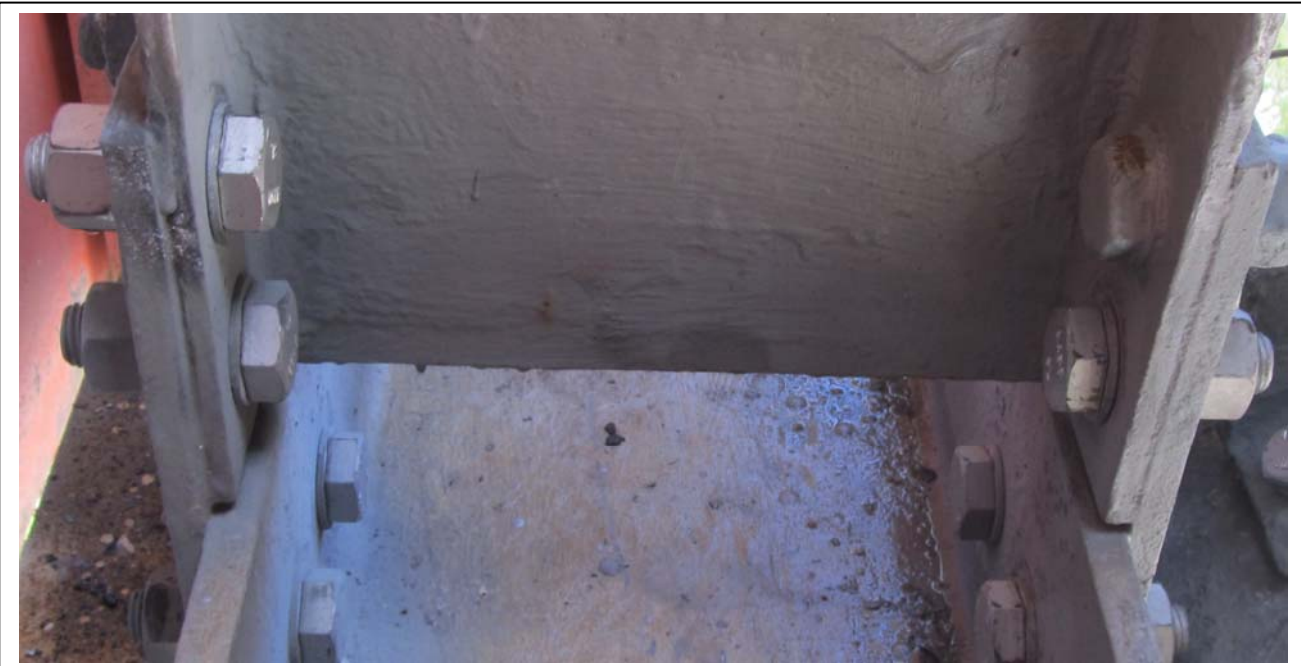
Photo Nos. 19 and 20 show vertical beam connection bolts before and after they were replaced.

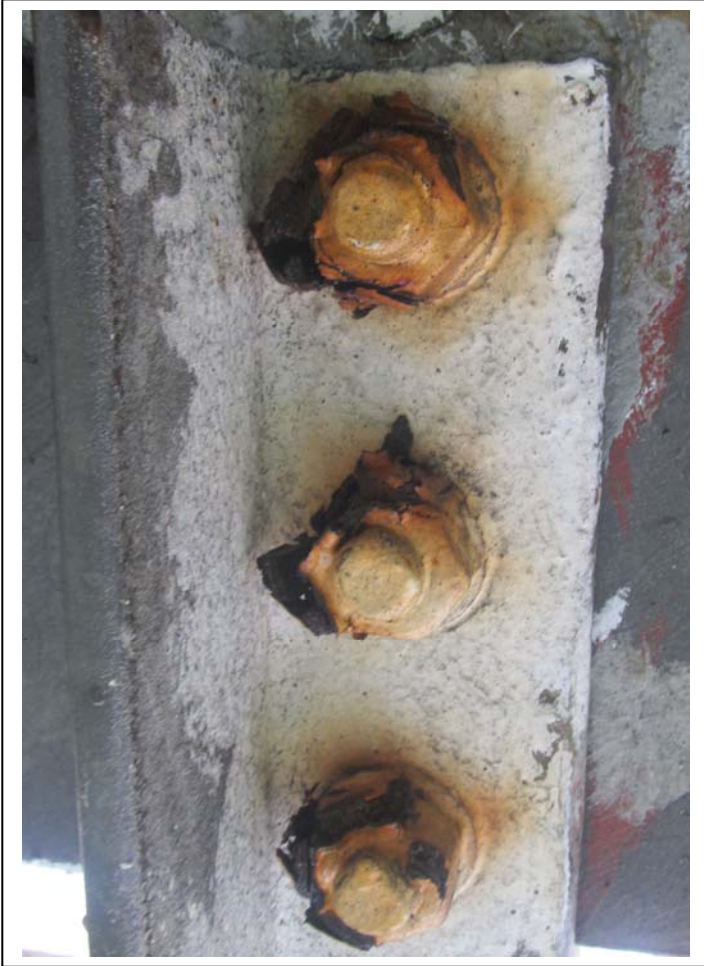
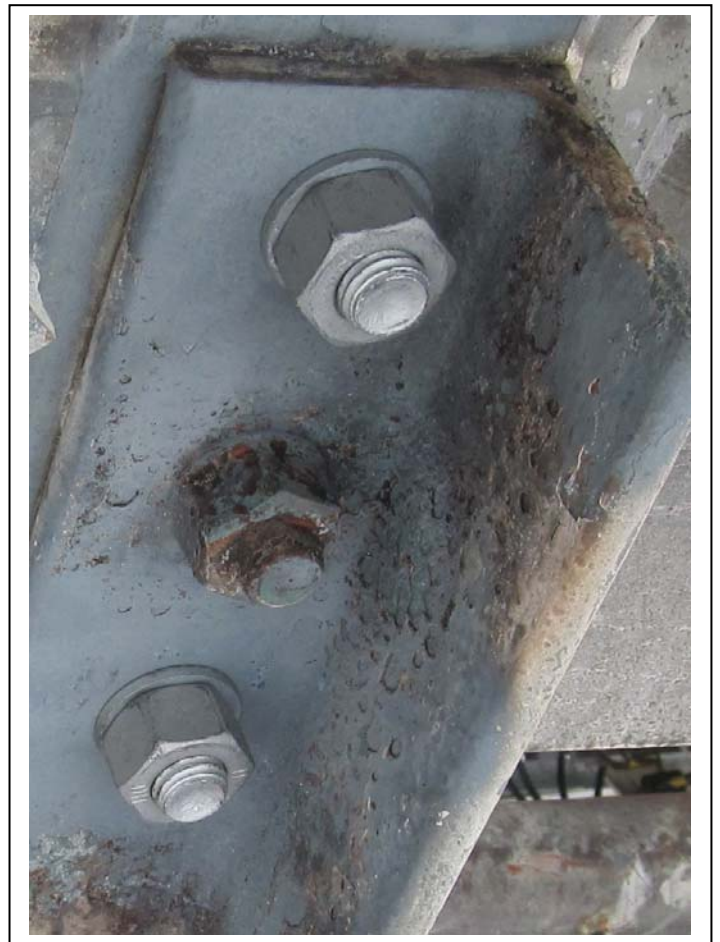
Photo Nos. 21 and 22 show connection bolts before and after they were replaced.

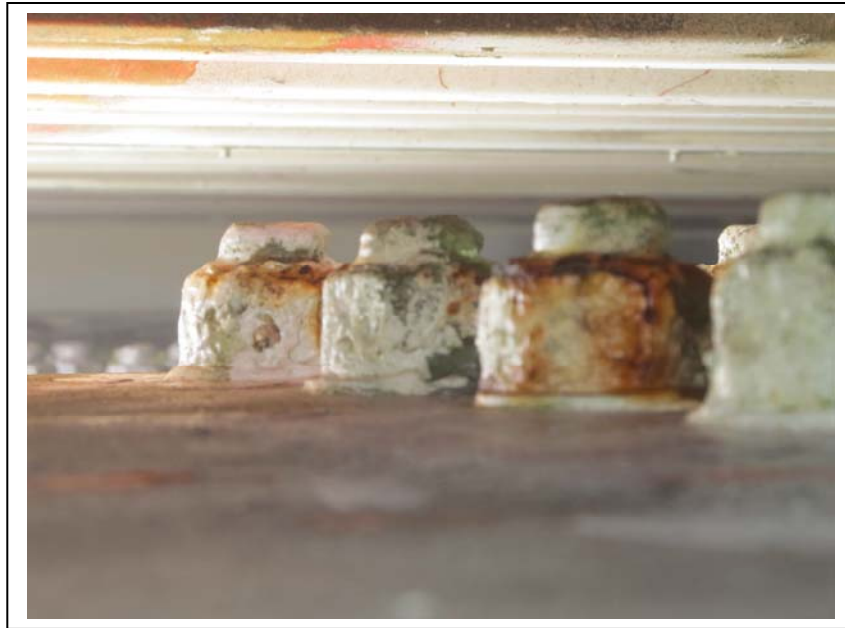
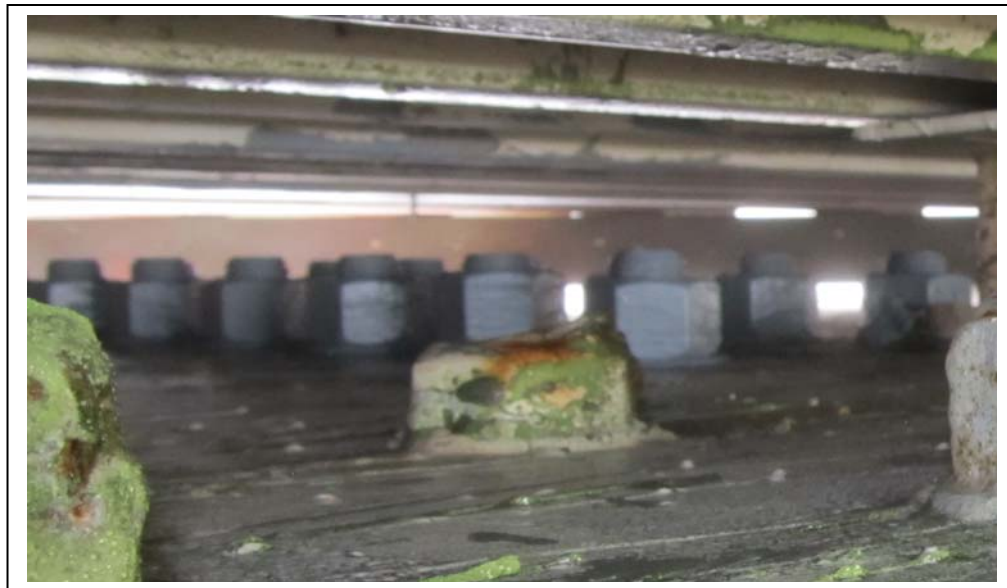
Photo Nos. 23 and 24 show leg bolts before and after they were replaced.

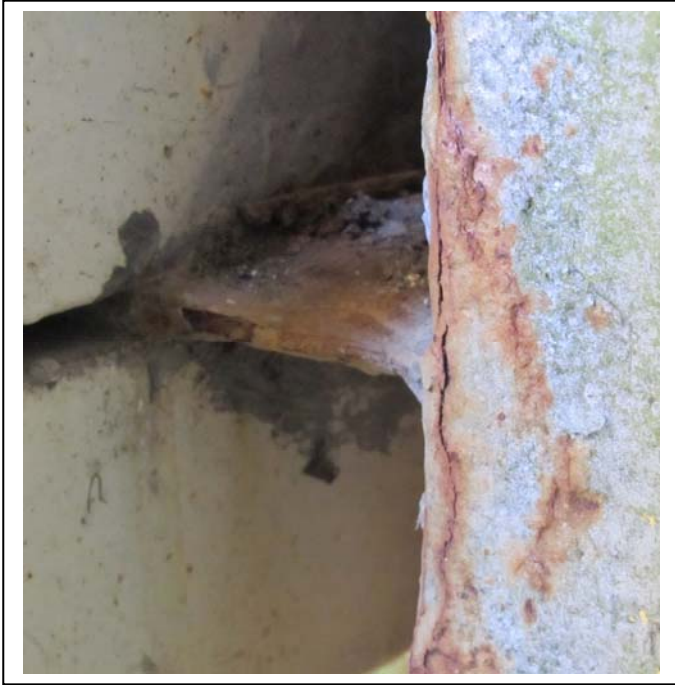
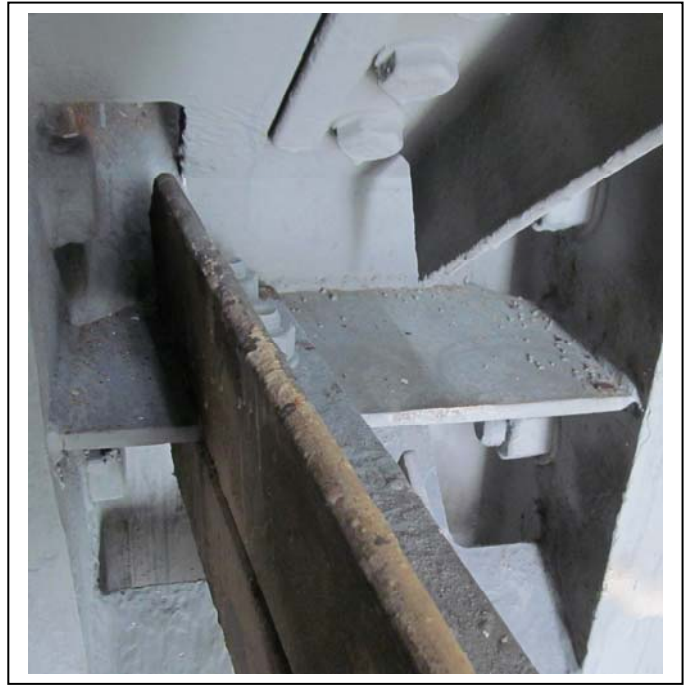
Photo Nos. 25 & 26 show the severely rusted gusset in leg B before and after the recent repair work.  
Photo Nos. 27 & 28 show an elevator anchorage before and after the recent repair work.

3. Gusset replacement on leg B just below level 2 (Photo Nos. 25 & 26).
4. Bent Member reinforcement at level 6 (Photo Nos. 29 & 30).
5. Elevator anchorage repair (Photo Nos. 27 & 28).

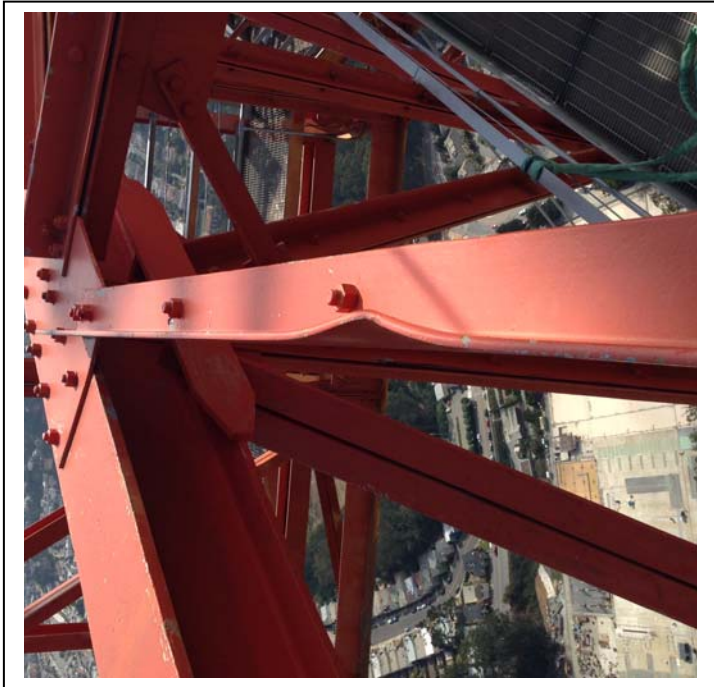
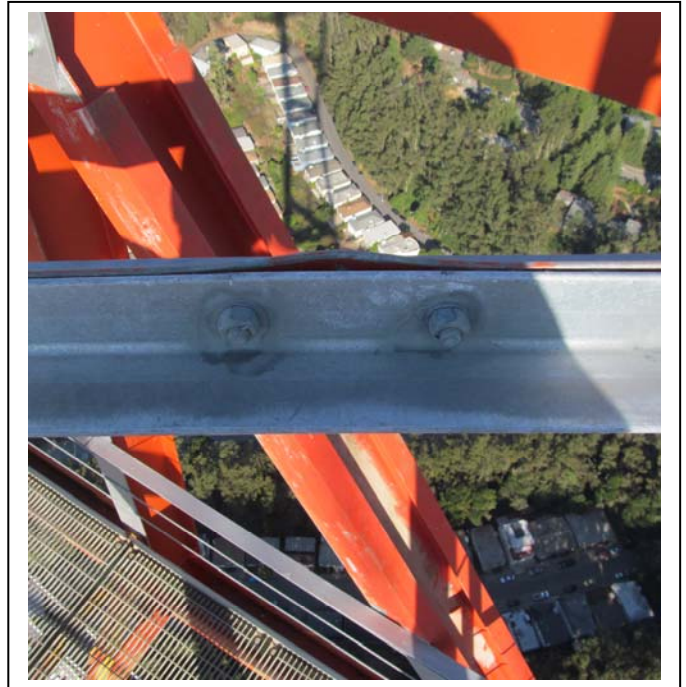
Photo Nos. 29 & 30 show the bent angle at level 6 before and after the recent repair work.

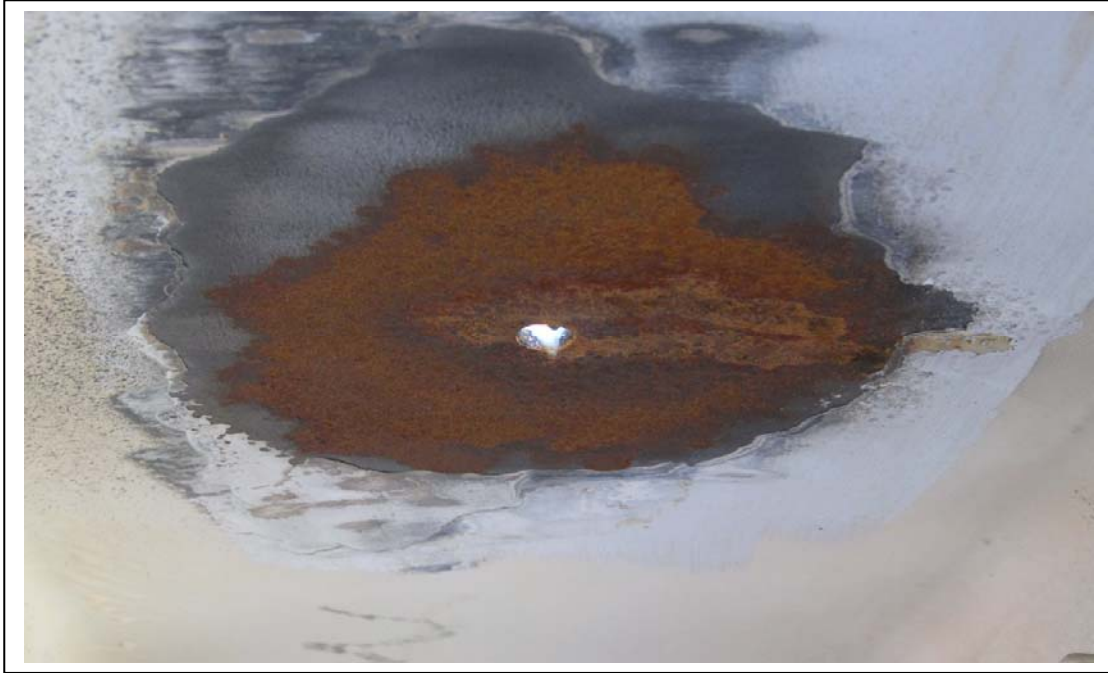
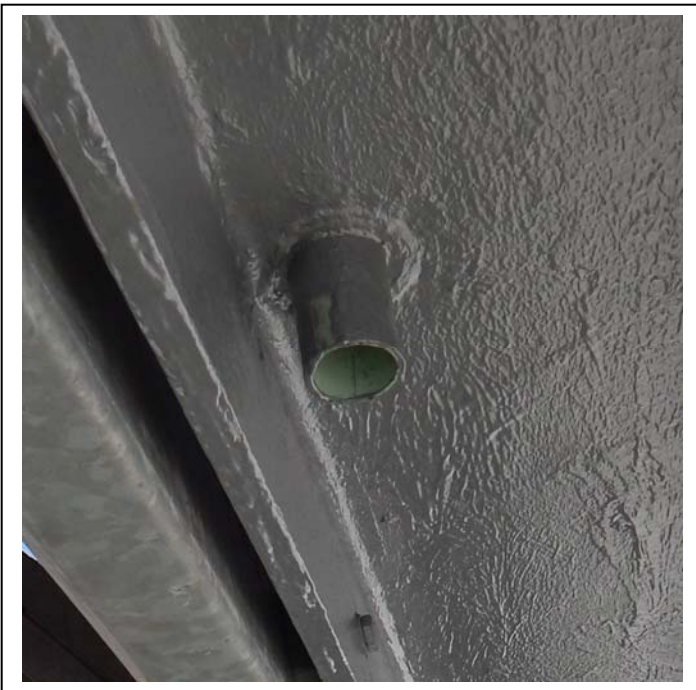
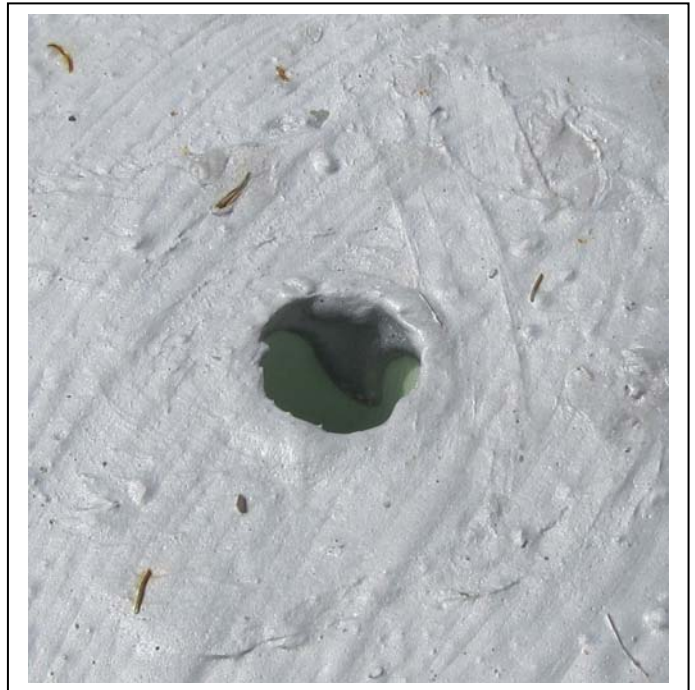
Photo No. 31 is a picture of a drain hole in a beam before the recent maintenance project.  
Photo Nos. 32 and 33 show a drain hole after the maintenance project was completed.

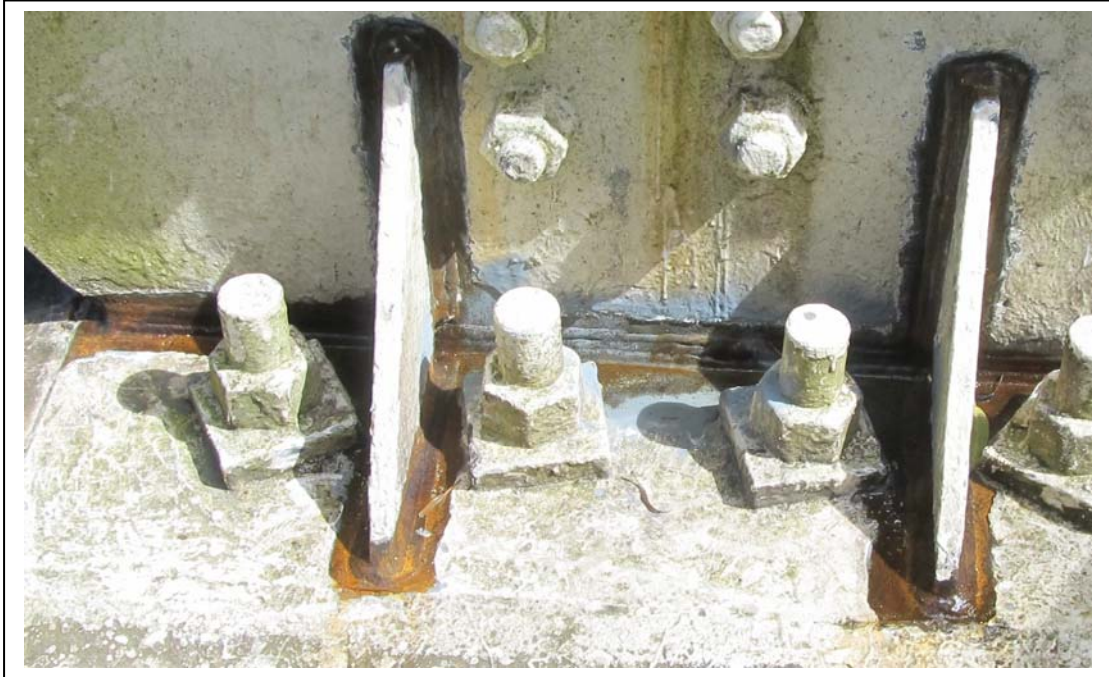
**Photo No. 34 (Before)**

Photo No. 34 is a picture of the weld for the tower leg column to the tower base plate before the recent maintenance project.

7. Repair of the cracked weld for the A tower leg column to the base plate (Photo Nos. 34 & 35).

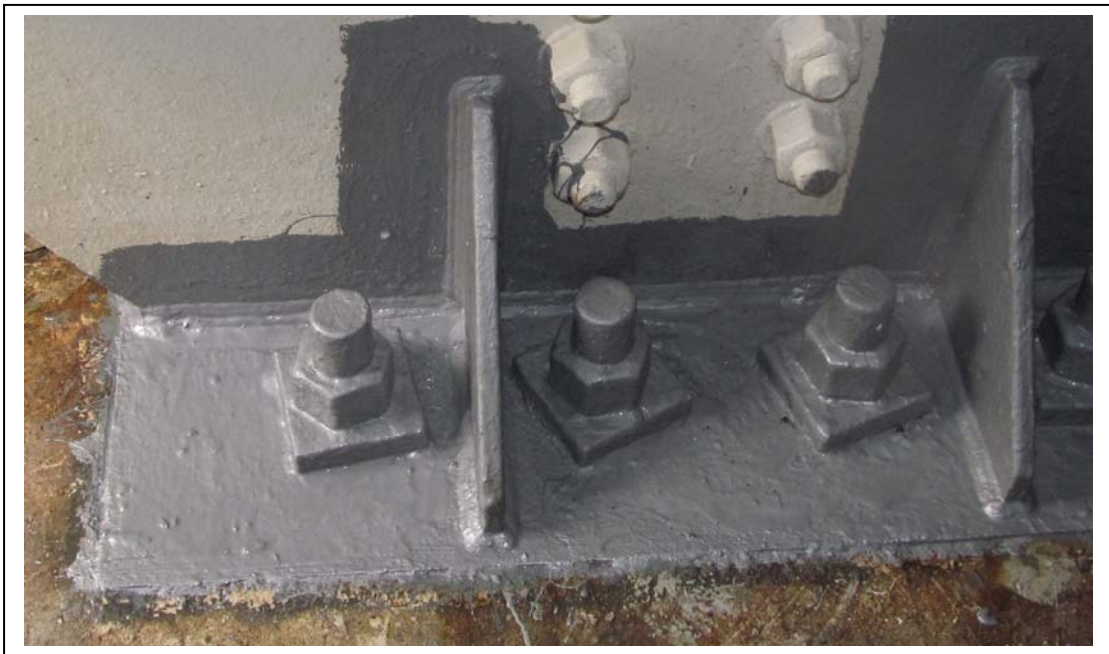
**Photo No. 35 (After)**

Photo No. 35 shows the base plate weld after the maintenance project was completed.
