Re: **Field Evaluation of Existing  
977-Foot Self-Support Tower  
San Francisco, California  
TCI Project Number 14.082.001**

Tower Consultants Incorporated was retained by Sutro Tower Company to conduct a field observation of the 977-foot self-support tower. The inspection work has been performed in accordance with the requirements of the ANSI/TIA-222-G standard.

The purpose of the field observation was to visually evaluate the condition and structural integrity of the tower. A routine inspection was performed of leg C, the south face trusses, the strands and the bases and stack C above the 6<sup>th</sup> level.

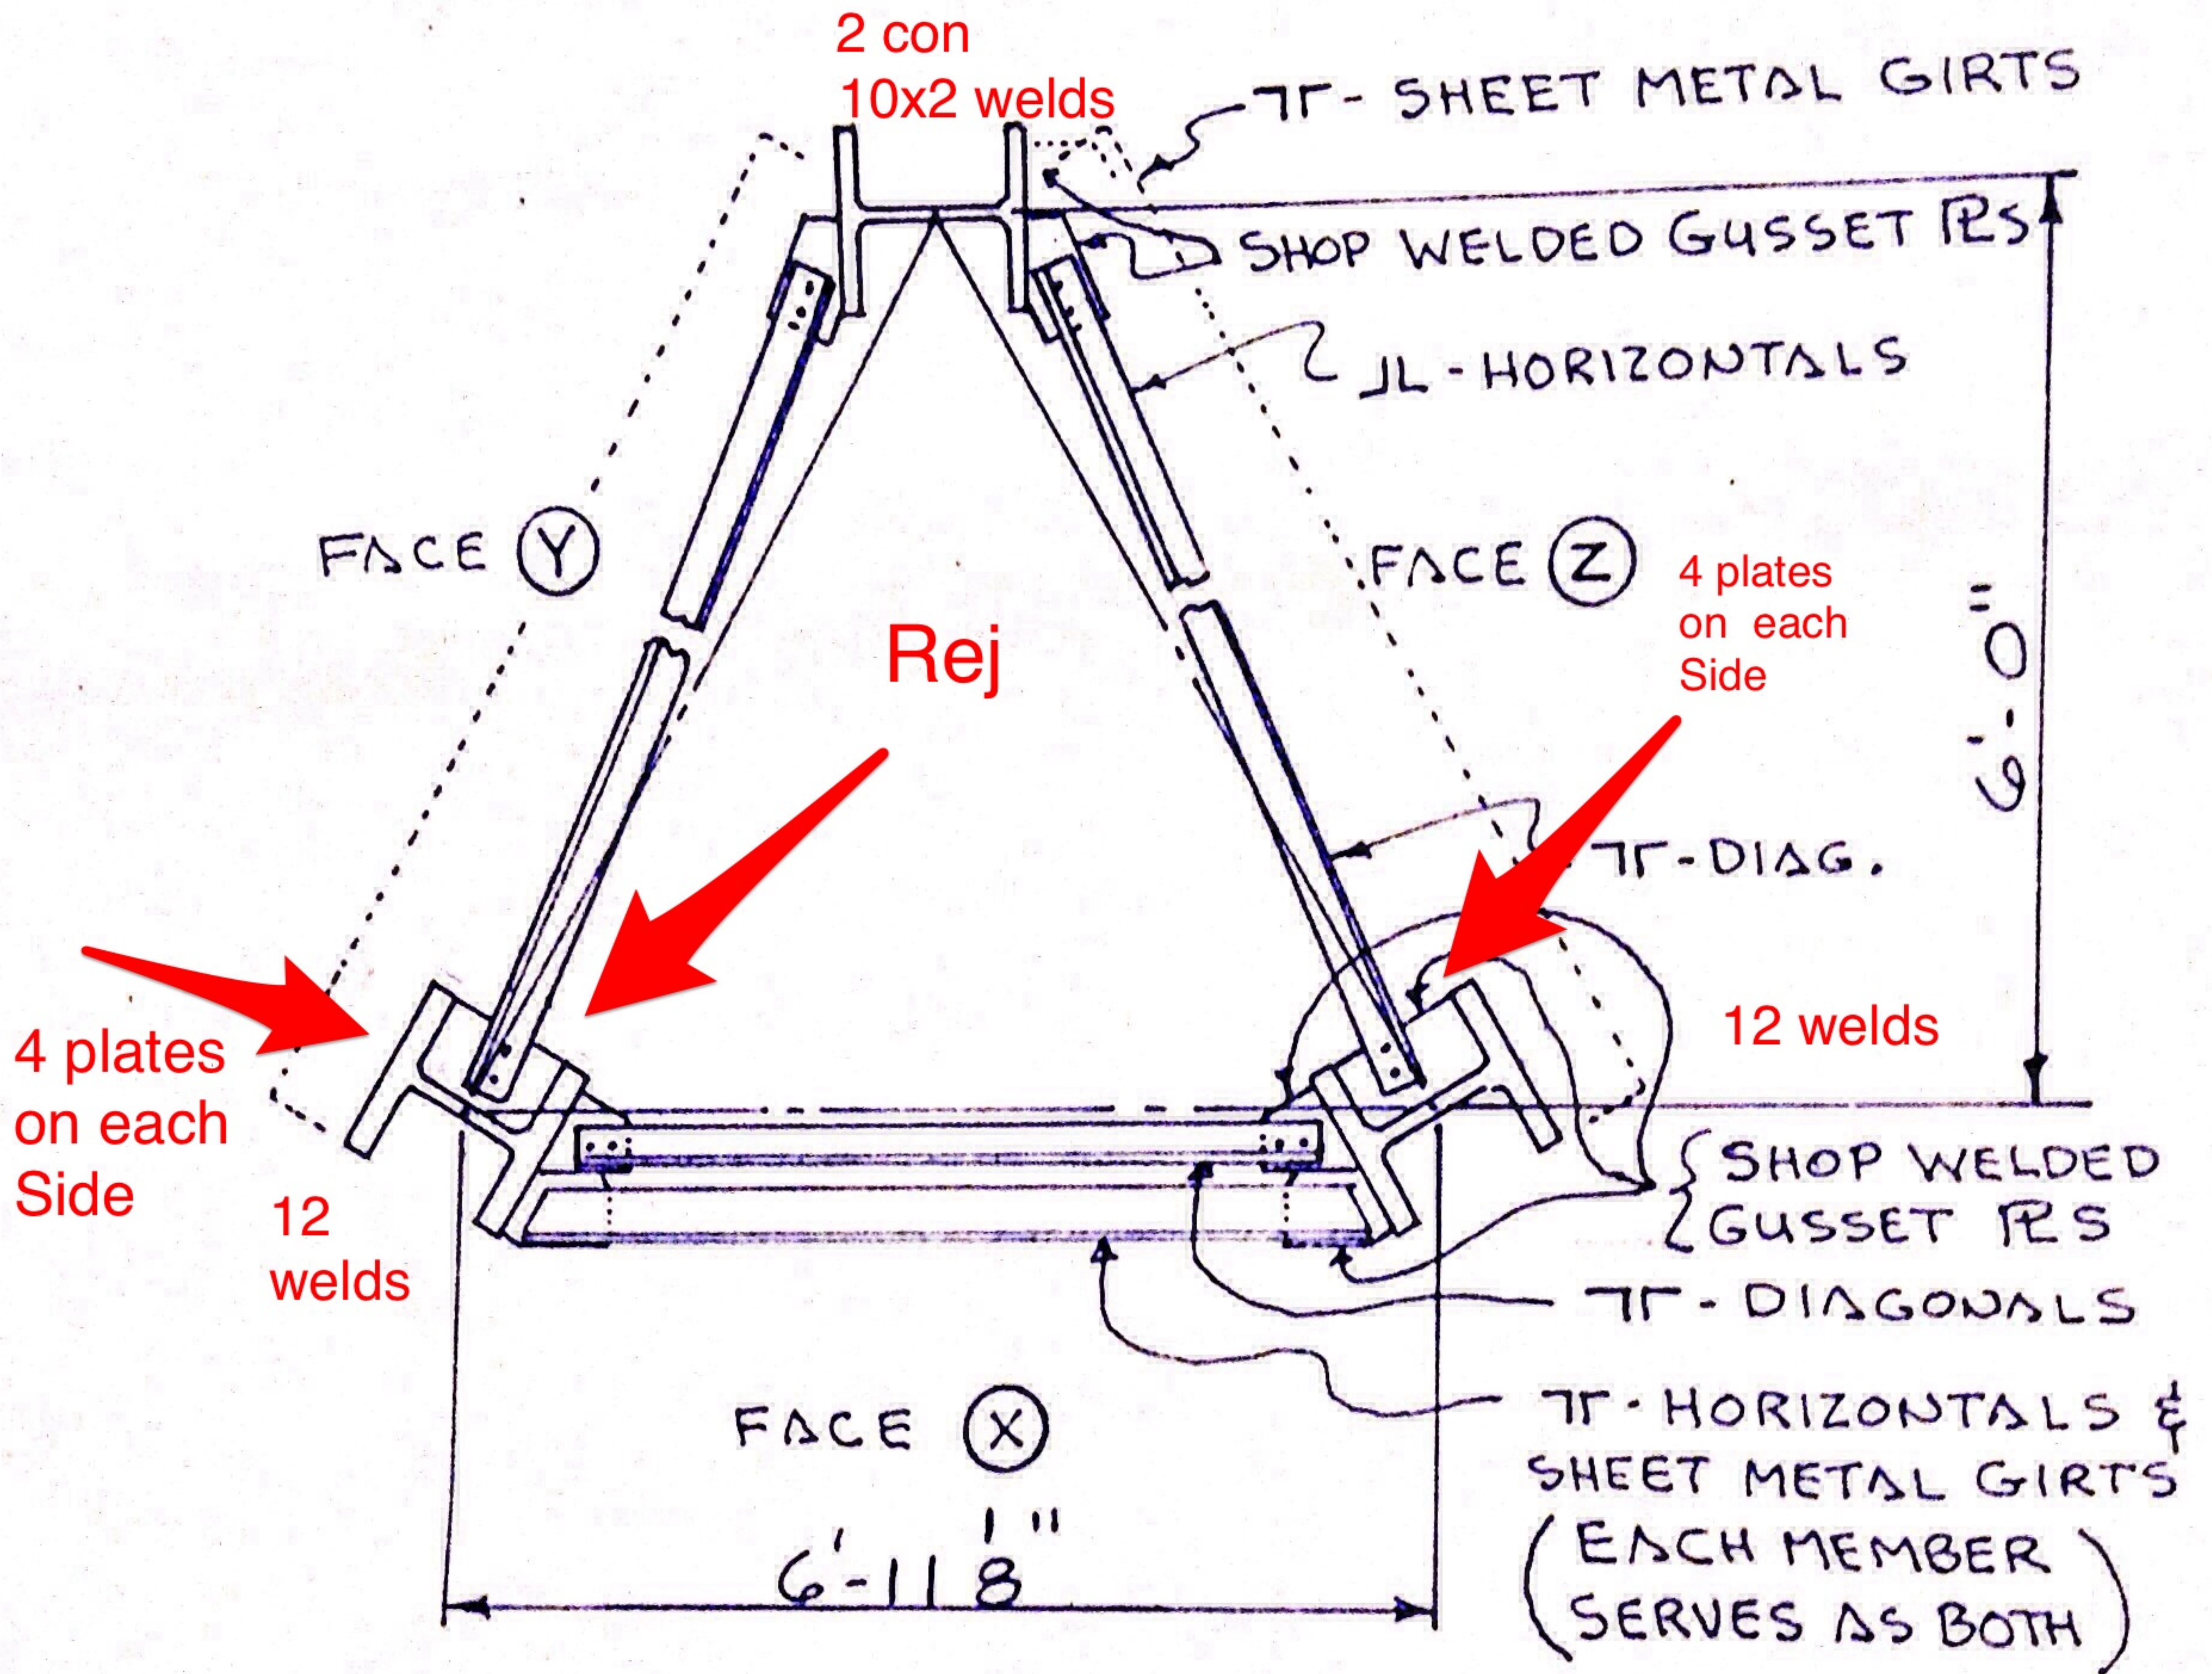
Leg A/ Col B

Piece No. / Locations	NDE Type	Acc/Rej	Repaired/ Reinspected	Status	Remarks
Leg A / Column B ( 1 of 3 )	MT	Accept	-----	Complete	C-BP & 4 gusset - 12 welds- 5 connection
Leg A/ Column B ( 2 of 3 )	MT	Reject		In Progress	Column Web only
Leg A/ Column B ( 3 of 3 )	MT	Accept	-----	Complete	2P-BP-20 welds - 4 and 4 connection
Leg A/ Column B (2 of 3 )	Mt	Accept		In Progress	C-BP & 4 gusset - 11 welds ACC/ 1 REJ 5 connection
