February 11, 2015

Re: **Field Evaluation of Existing  
977-Foot Self-Support Tower  
San Francisco, California  
TCI Project Number 14.082.001**

# Inspection Summary – Year 2015

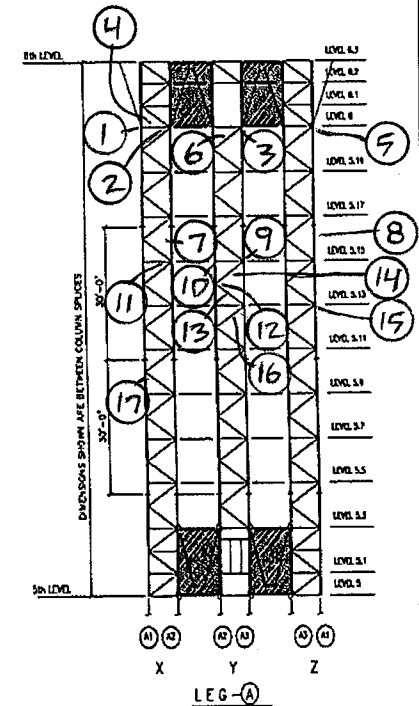
## Inspection Data Sheet: Leg A (Level 5 to Level 6)

Observ. No.	Location / Identification			Photo No.	Observation Comments
	Column	Elevation	Item <sup>1</sup>		
1	A1	6	C	1	RF(3), LEG BOLTS
2	A2	6	C	2	RF(2), LEG BOLTS
3	A3	6	C	3	RF(3), LEG BOLTS
4	X-FACE	6	O	4	JUNCTION BOX HAS ONE LOOSE BOLT
5	A1	6	C	5	MAIN GUSSET PLATE IS RUSTED
6	Y-FACE	6	C	6	RF(2), DIAGONAL BOLTS
7	X-FACE	5.16	C	7	MINOR RUST ON LEG SPLICE BOLTS
8	ALL FACES	5-6	O	8	DRAINAGE HOLES NEED TO BE CLEANED
9	ALL FACES	5.15	C	9	MINOR RUST ON DIAG. & HORIZ. CONN. BOLTS
10	CENTER	5.15	O	10	MAJOR RUST ON ELEVATOR CABLE KEEPERS
11	X-FACE	5.15	C	11	RF(1), HORIZONTAL BOLT
12	Y-FACE	5.14	C	12	RF(1), DIAGONAL BOLT
13	Y-FACE	5.14	O	13	(2) 1 5/8" CABLE SUPPORT U-BOLTS ARE RUSTED
14	Y-FACE	5.14	C	14	RF(1), DIAGONAL BOLT
15	Z-FACE	5.13	C	15	RF(2), HORIZONTAL BOLTS
16	Y-FACE	5.13	C	16	RF(1), DIAGONAL BOLT
17	A1	5.10	C	17	RF(1), LEG BOLT
<b>Sutro Tower</b>				Signature: _____	Page: <u>1</u> of <u>2</u>
<b>San Francisco, CA</b>				File: _____	Date: <u>1/9/15</u>

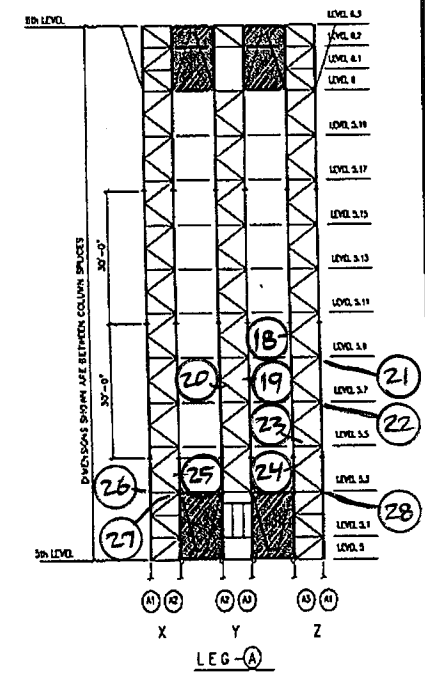
## Inspection Data Sheet: Leg A (Level 5 to Level 6)

Observ. No.	Location / Identification			Photo No.	Observation Comments
	Column	Elevation	Item <sup>1</sup>		
18	Z-FACE	5.10	O	18	RUSTED JUNCTION BOX
19	A3	5.8	C	19	RF(10), LEG BOLTS
20	Y-FACE	5.8	C	20	RF(1), DIAGONAL BOLT
21	Z-FACE	5.9	C	21	RF(2), DIAGONAL BOLT
22	Z-FACE	5.7	C	22	RF(3), DIAGONAL BOLT
23	Z-FACE	5.5	C	23	RF(2), DIAGONAL BOLT
24	Z-FACE	5.4	C	24	RF(6), LEG BOLTS
25	A2	5.4	C	25	RF(2), LEG BOLTS
26	A1	5.3	C	26	RF(5), LEG BOLTS
27	A2	5.3	C	27	RF(3), LEG BOLTS
28	A1	5.3	C	28	GUSSET PLATE IS RUSTED
<b>Sutro Tower</b>				Signature:	Page: <u>2</u> of <u>2</u>
<b>San Francisco, CA</b>				File:	Date: <u>11/9/15</u>

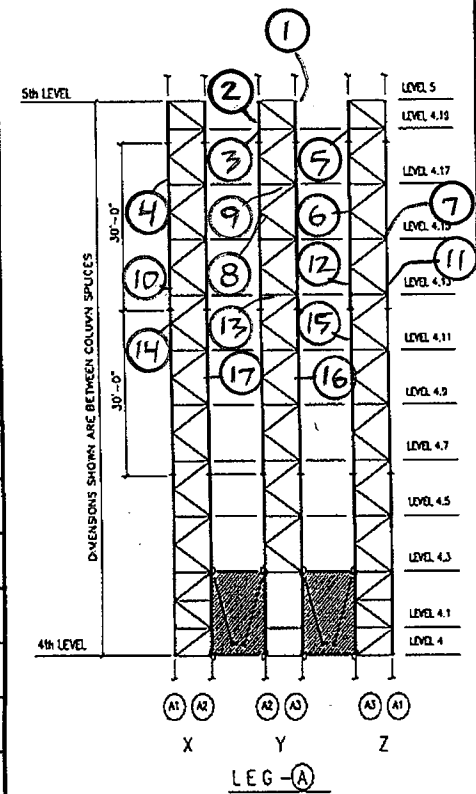
## Inspection Data Sheet: Leg A (Level 4 to Level 5)

Observ. No.	Location / Identification			Photo No.	Observation Comments
	Column	Elevation	Item <sup>1</sup>		
1	A3	5	C	1	MANY BOLTS FOR LEG UPGRADE ARE RUSTED
2	Y-FACE	4.19	C	2	RF(2), DIAGONAL BOLTS
3	Y-FACE	4.19	C	3	RF(2), HORIZONTAL BOLTS
4	X-FACE	4.17	C	4	RF(9), LEG BOLTS
5	Z-FACE	4.19	C	5	RF(3), DIAGONAL BOLTS
6	Z-FACE	4.16	C	6	RF(2), DIAGONAL BOLTS
7	Z-FACE	4.15	C	7	RF(1), DIAGONAL BOLTS
8	Y-FACE	4.16	C	8	RF(2), DIAGONAL BOLTS
9	Y-FACE	4.17	C	9	RF(3), DIAGONAL BOLTS
10	X-FACE	4.13	C	10	RF(2), HORIZONTAL BOLTS
11	Z-FACE	4.13	C	11	RF(1), DIAGONAL BOLT
12	Z-FACE	4.13	C	12	RF(2), HORIZONTAL BOLTS
13	Y-FACE	4.13	C	13	RF(2), SKIN SUPPORT ANGLE BOLTS
14	X-FACE	4.12	C	14	RF(1), DIAGONAL BOLT
15	Z-FACE	4.11	C	15	RF(2), HORIZONTAL BOLTS
16	A3	4.10	C	16	RF(7), LEG BOLTS
17	AZ	4.10	C	17	RF(2), LEG BOLTS
<b>Sutro Tower</b>				Signature: _____	Page: <u>1</u> of <u>2</u>
<b>San Francisco, CA</b>				File: _____	Date: <u>11/9/15</u>

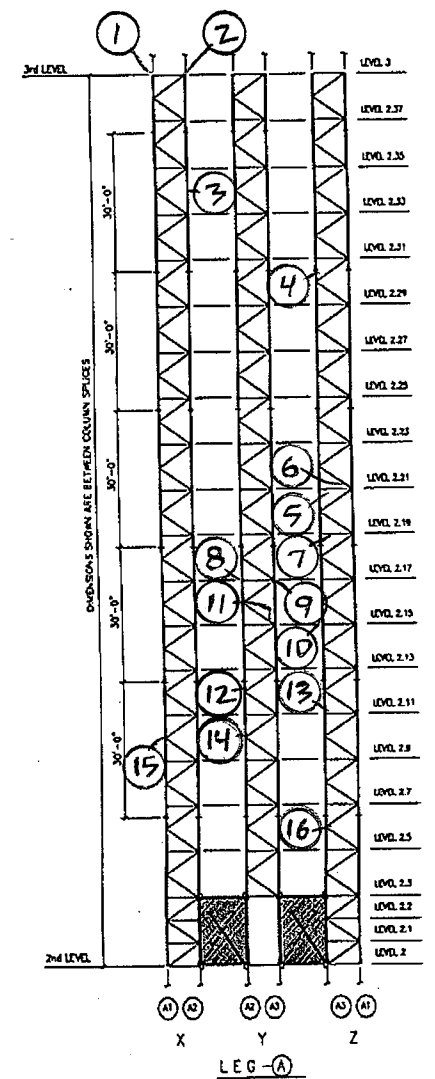
## Inspection Data Sheet: Leg A (Level 2 to Level 3)

Observ. No.	Location / Identification			Photo No.	Observation Comments	
	Column	Elevation	Item <sup>1</sup>			
1	A1	3	O	1	(2) RUSTED JUNCTION BOXES	
2	A2	3	C	2	RF(2), LEG GUSSET	
3	A2	2.34	C	3	RF(1), LEG BOLT	
4	Z-FACE	2.30	C	4	RF(2), DIAGONAL BOLTS	
5	Z-FACE	2.21	O	5	RUSTED JUNCTION BOX	
6	Z-FACE	2.21	H	6	RUST ON GUSSET PLATE	
7	Z-FACE	2.19	O	7	BROKEN JUNCTION BOX CONNECTOR	
8	Y-FACE	2.17	C	8	RF(2), DIAGONAL BOLTS	
9	A3	2.17	C	9	RF(1), LEG BOLT	
10	Z-FACE	2.16	C	10	RF(1), DIAGONAL BOLT	
11	Y-FACE	2.15	C	11	RF(2), DIAGONAL BOLTS	
12	Y-FACE	2.12	C	12	RF(1), DIAGONAL BOLT	
13	Z-FACE	2.11	C	13	RF(1), HORIZONTAL BOLT	
14	A2	2.10	C	14	RF(1), LEG BOLT	
15	A1	2.10	C	15	RF(1), LEG BOLT	
16	Z-FACE	2.6	C	16	RF(1), DIAGONAL BOLT	
<b>Sutro Tower</b>					Signature: _____	Page: <u>1</u> of <u>1</u>
<b>San Francisco, CA</b>					File: _____	Date: <u>1/9/15</u>

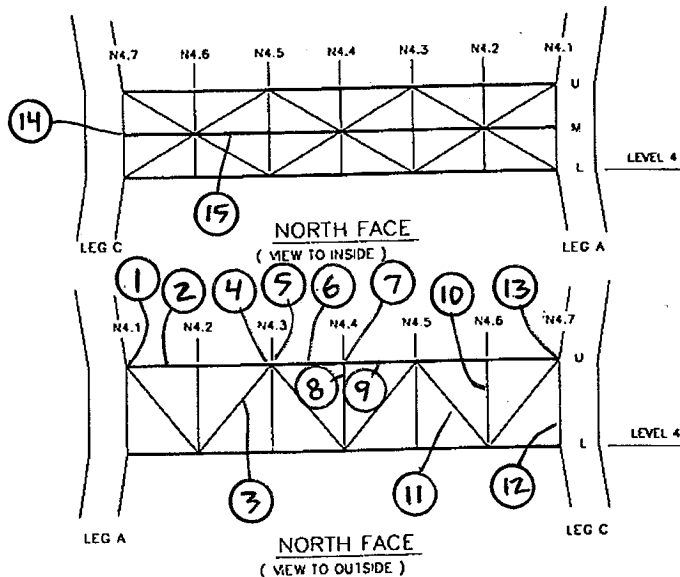
# Inspection Data Sheet: North Truss (Level 4)

Observ. No.	Location / Identification			Photo No.	Inspection Comments
	Chord <sup>1</sup>	Horiz. Location	Item <sup>2</sup>		
1	U	4.1	C	1	RF(5)
2	U	4.15	H	2	RUST ON BEAM
3	D	4.25	D	3	RUST ON BEAM
4	U	4.3	H	4	RUST ON BEAM
5	U	4.3	C	5	RF(3)
6	U	4.35	H	6	RUST ON BEAM
7	U	4.4	C	7	RF(1)
8	V	4.4	V	8	RUST ON BEAM
9	U	4.45	H	9	RUST ON BEAM
10	V	4.6	V	10	RUST ON BEAM
11	D	4.55	D	11	RUST ON BEAM
12	V	4.7	V	12	RUST ON BEAM
13	U	4.7	C	13	RF(7)
14	M	4.7	H	14	RUST ON BEAM
15	M	4.55	H	15	RUST ON BEAM

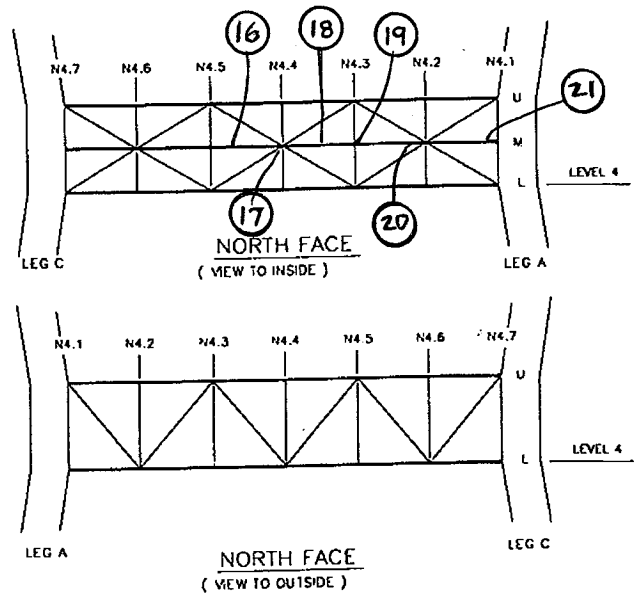
# Inspection Data Sheet: North Truss (Level 4)

Observ. No.	Location / Identification			Photo No.	Inspection Comments
	Chord <sup>1</sup>	Horiz. Location	Item <sup>2</sup>		
16	M	4.45	H	16	RUST ON BEAM
17	M	4.4	H	17	RUST ON BEAM
18	M	4.35	H	18	RUST ON BEAM
19	M	4.3	H	19	RUST ON BEAM
20	M	4.2	H	20	RUST ON BEAM
21	M	4.1	21	RF(3) AND RUST ON BEAM	
<b>Sutro Tower</b>				Signature: _____	Page: <u>2</u> of <u>2</u>
<b>San Francisco, CA</b>				File: _____	Date: <u>1/9/15</u>
