SUTRO TOWER REPORT
ROUTINE INSPECTION OF LEG A AND NORTH FACE
SAN FRANCISCO, CA
FOR
SUTRO TOWER, INC

Project No. D50541

SUBJ: Sutro Tower – Routine Inspection of Leg A and North Face – November, 2009
San Francisco, CA

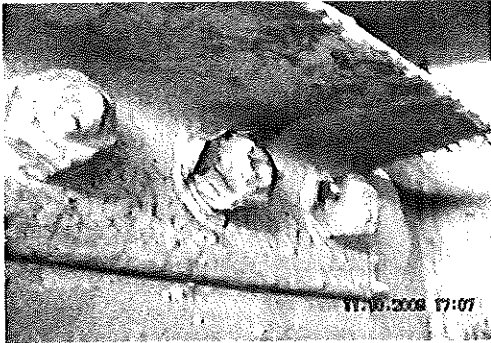
DSCN3513
11/10/2009

Observ. No.	Location / Identification			Photo No.	Inspection Comments
	Chord ¹	Horiz. Location	Item ²		
1	U	2.1	H	1	RF(3), Peeling Paint/Rust on Chord
2	U	2.9	C	2	RF
3	U	2.5-2.8	H	3	Rust on Beam Flange
4	U	2.10	C	4	RF(3)
5	L	2.12	C	5	RF(3)
6	U	2.13	C	6	RF
Sutro Tower				Signature: _____	Page: _____ of _____
San Francisco, CA				File: _____	Date: _____

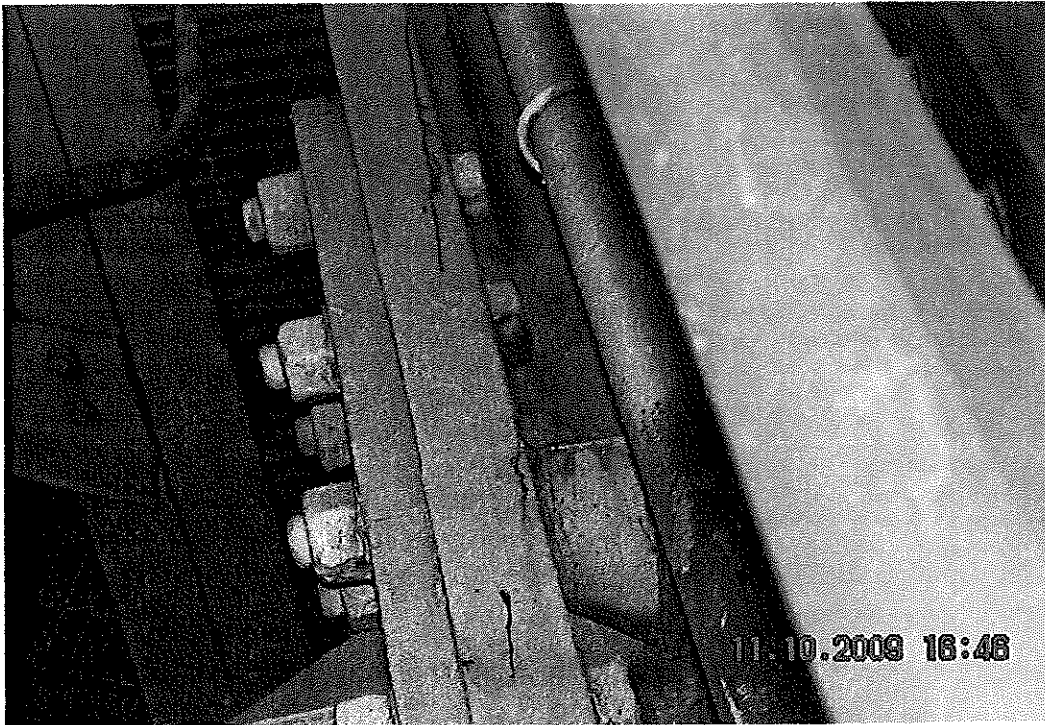
DSCN3510
11/10/2009

Observ. No.	Location / Identification		Photo No.	Observation Comments
	Column	Elevation		
1	A3	3	1	RF
2	A3	2.37		RF (no picture available)
3	A3	2.2	2	RF(3), Rust on Connection Plates
Signature: _____				Page: _____ of _____
File: _____				Date: _____
Sutro Tower				LECA
San Francisco, CA				2nd LEVEL

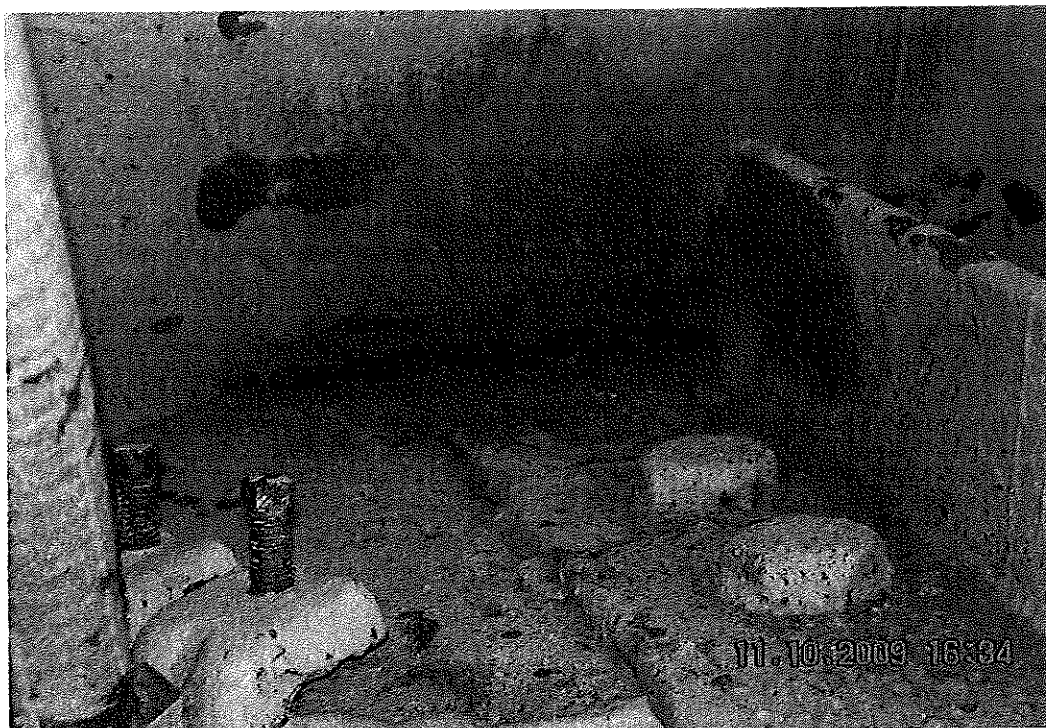
DSCN3503
11/10/2009

Observ. No.	Location / Identification		Photo No.	Observation Comments
	Column	Elevation		
1	A2	4.17	1	Rusty Weld
