26 January 2017

Project 067199.11 – Condition Assessment of Sutro Tower, 2017 Inspections
2016 Maintenance and Inspection Program

Photo Log

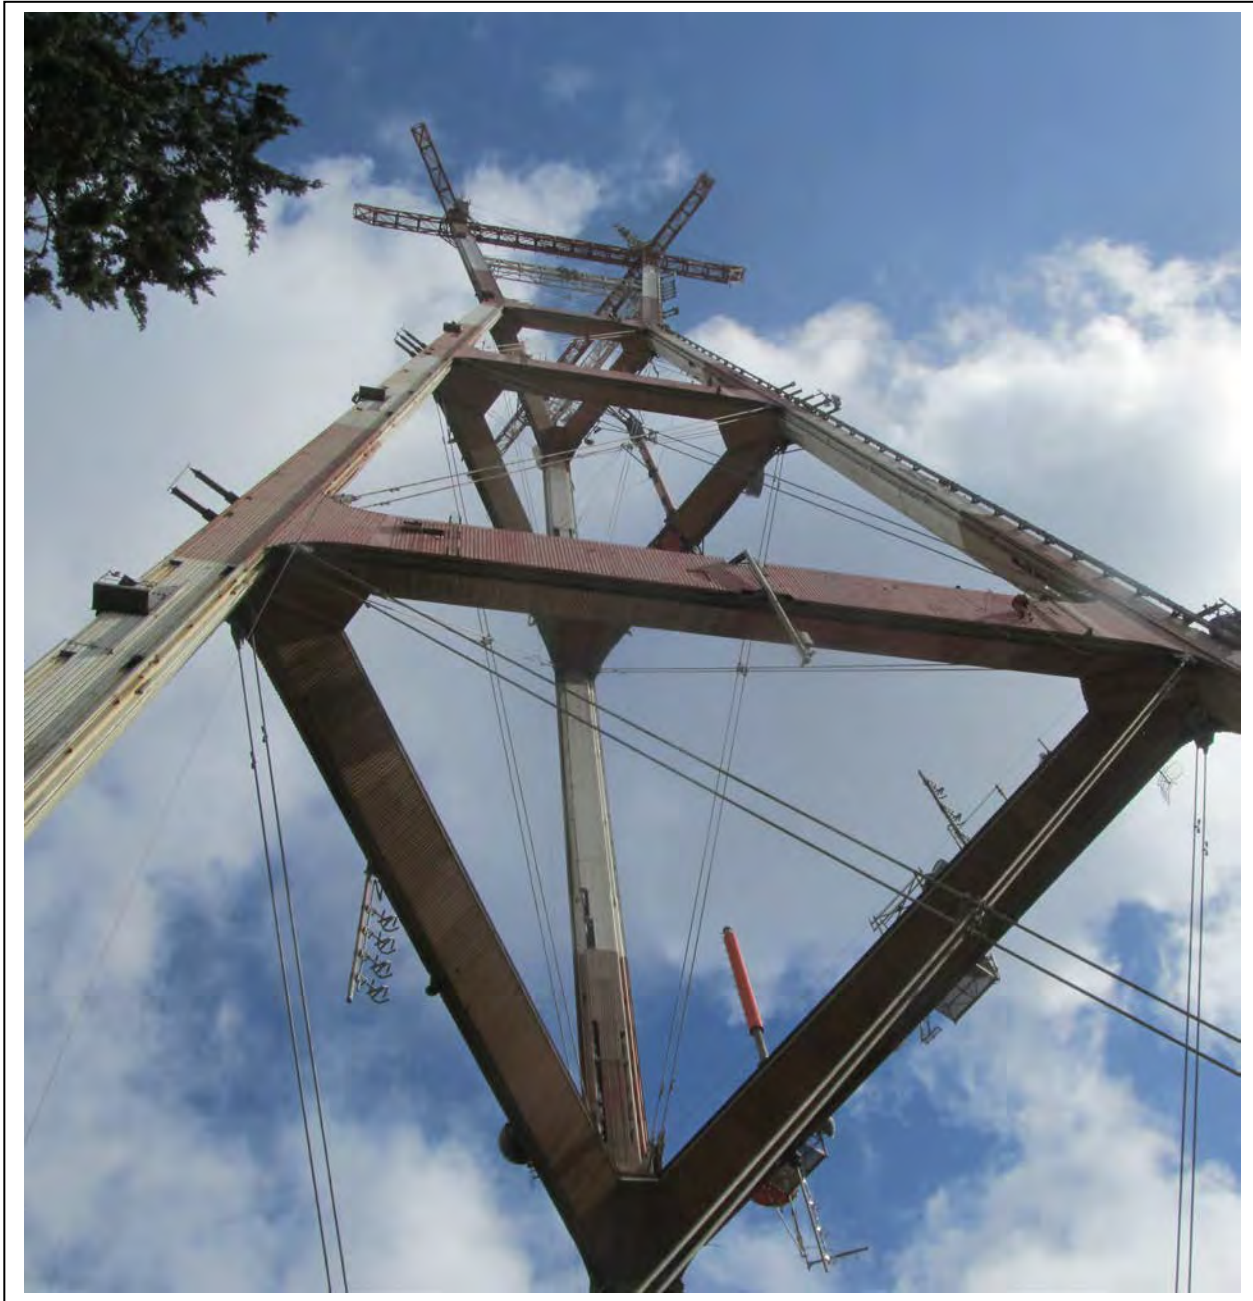
Photo No. 1 is an overall view of the 977-ft self-supporting tower.

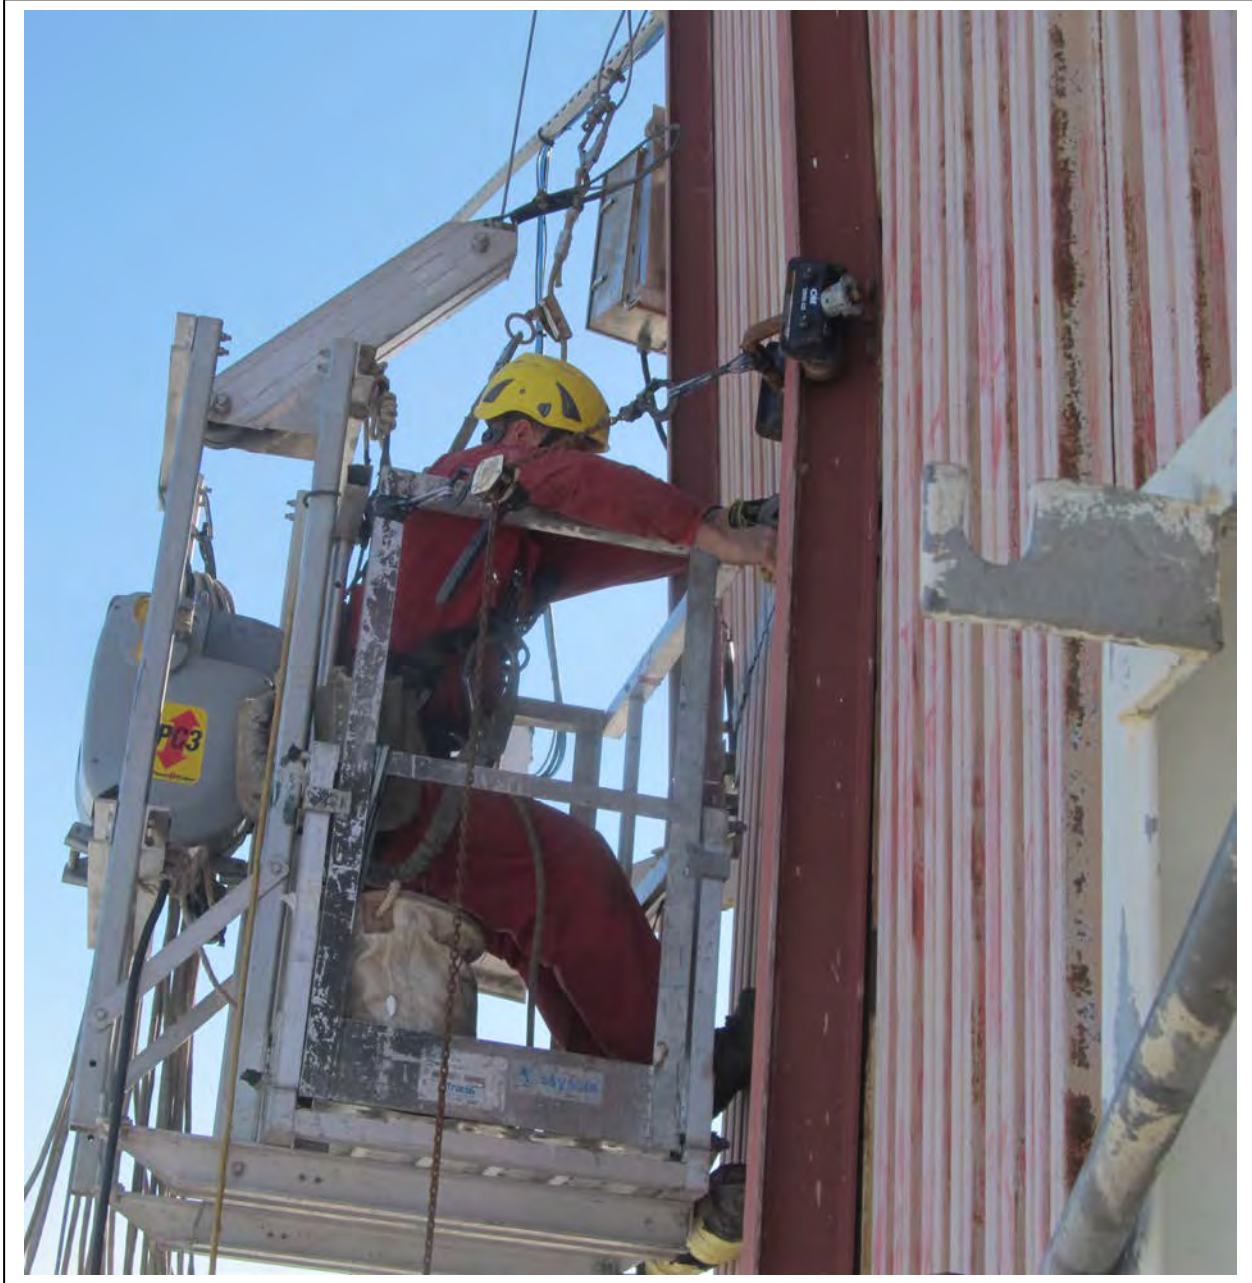
Photo No. 2 shows maintenance work performed on leg C.

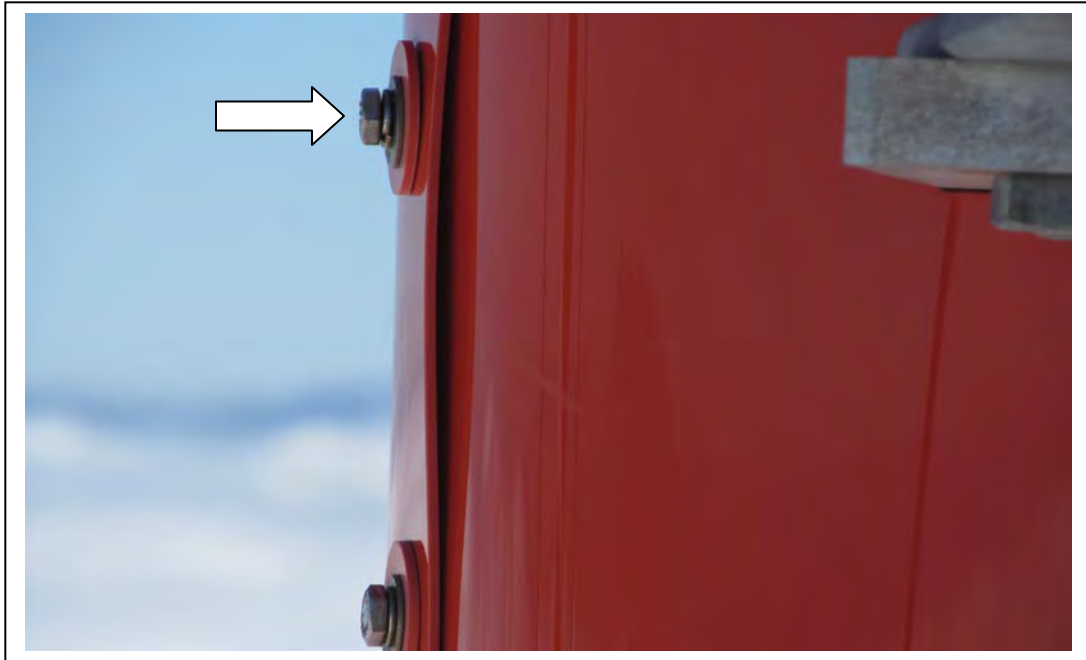
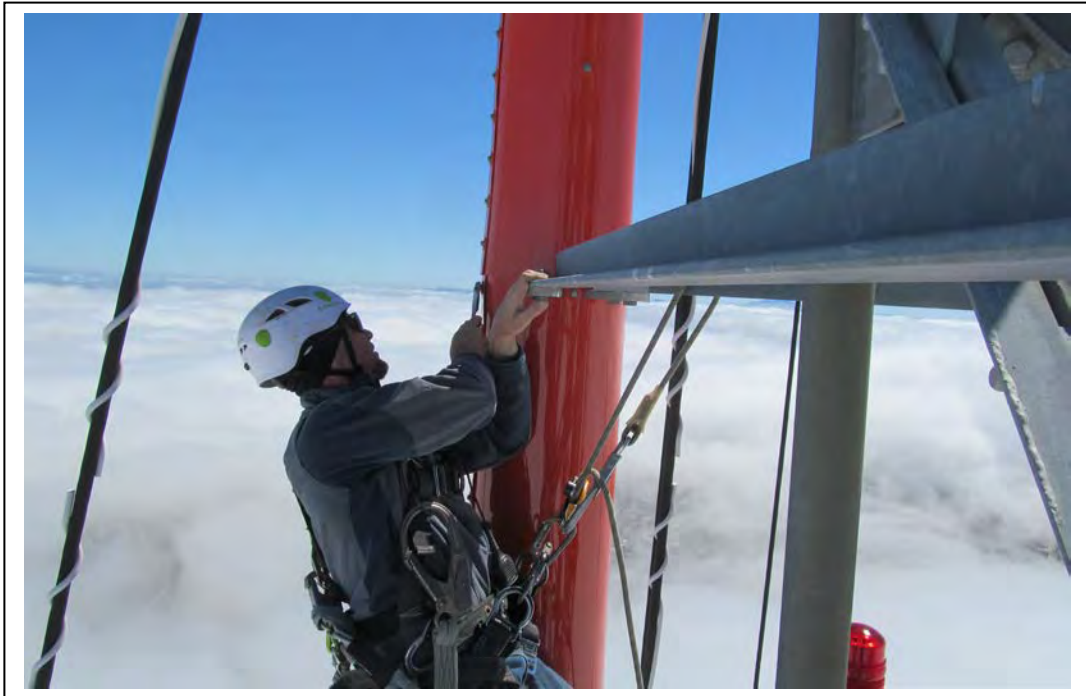
Photo Nos. 3 and 4 show the side mounted TV antenna on stack C before and after radome bolt tightening.

1. Address all issues found during the 2016 annual inspection at level 6 and stack C. All loose radome bolts for the side mounted TV antenna on stack C were properly tightened (Photo Nos. 3 and 4). A top skin support horizontal member on leg A was replaced with new stronger member (Photo Nos. 5 and 6).

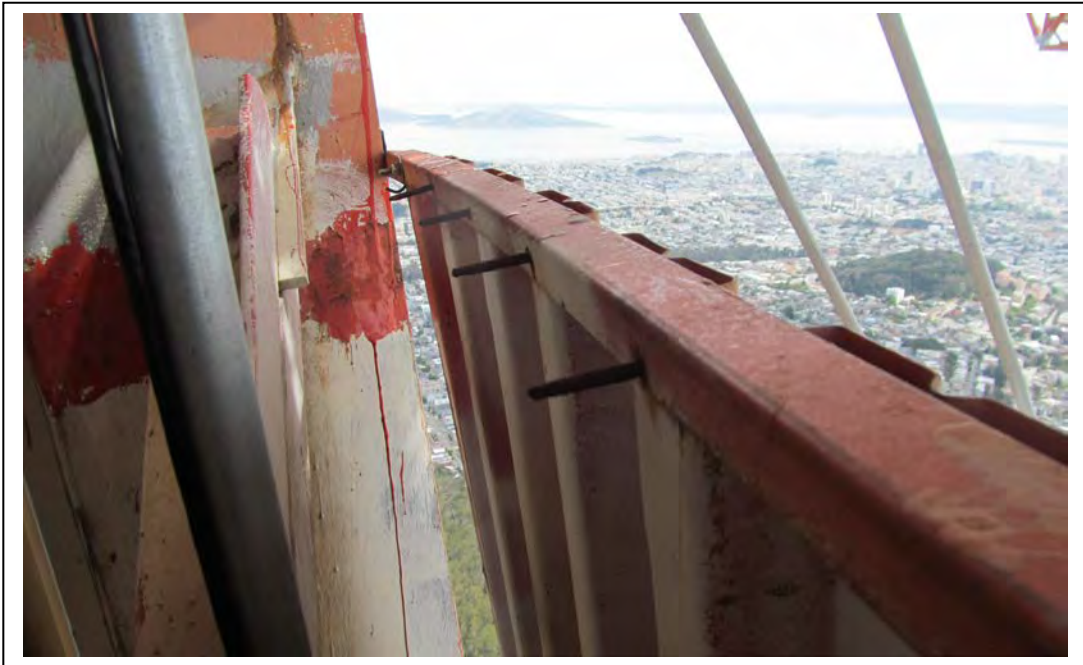
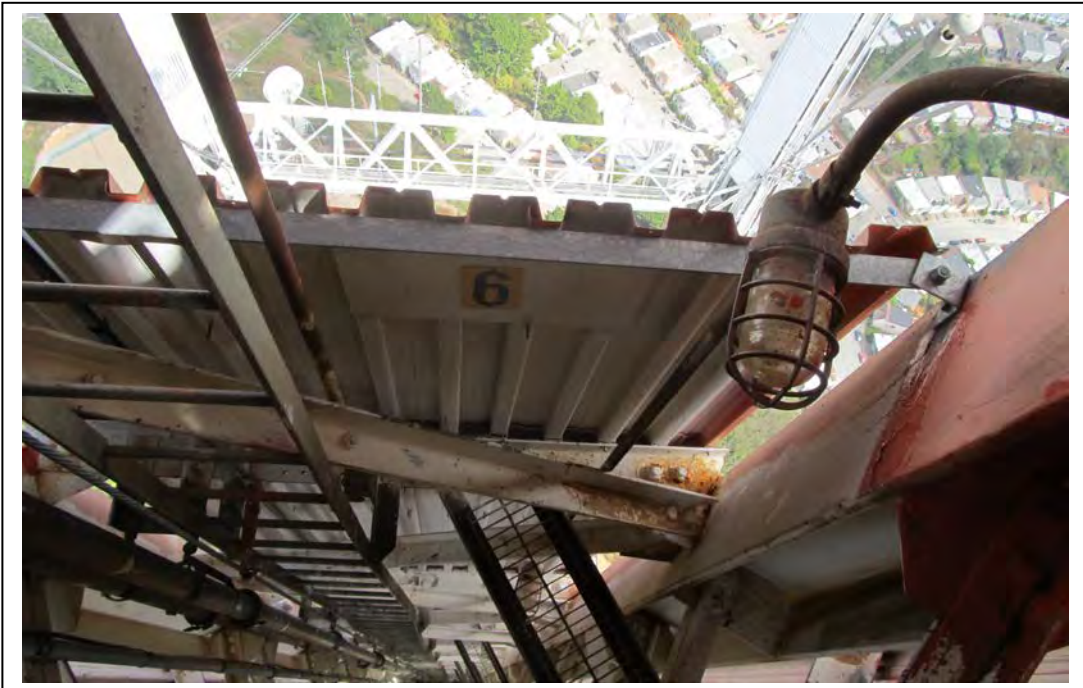
Photo Nos. 5 and 6 show the new skin support horizontal just below level 6 on leg A before and after angle replacement.

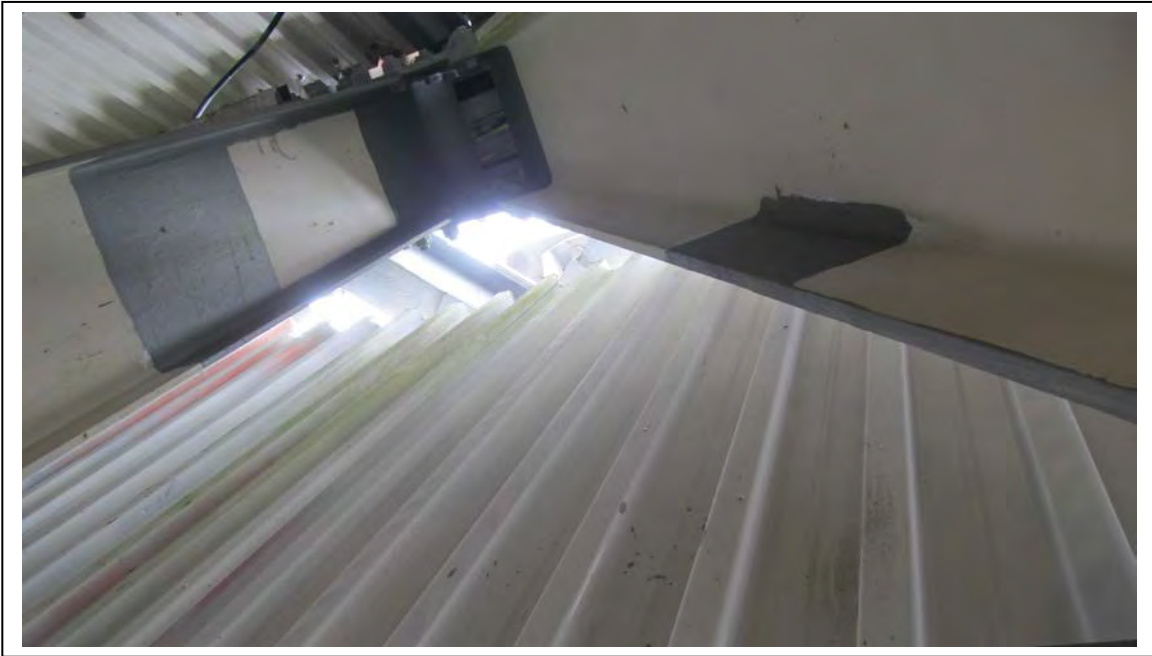
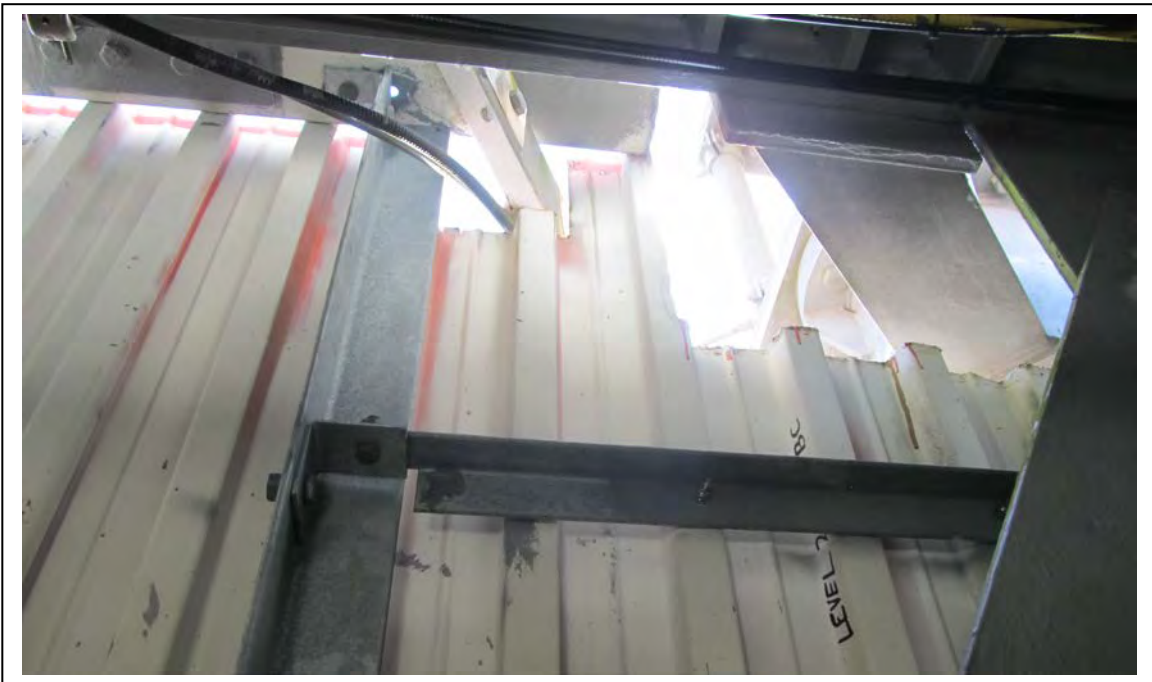
Photo Nos. 7 and 8 show the skin panel reinforcing at level 2 before and after frame installation.

2. Properly secure all loose skin panels to the tower members throughout the tower height. More than one thousand new connection bolts and self-tapping screws were installed on the tower at various locations to secure the existing skin panels to the tower legs and tower faces during the maintenance project (Photo Nos. 11 - 17). A typical panel was secured to the tower by placing bolts or screws at each corrugation on the top and bottom sides and by adding screws or bolts on the sides of the panel at 30" intervals.

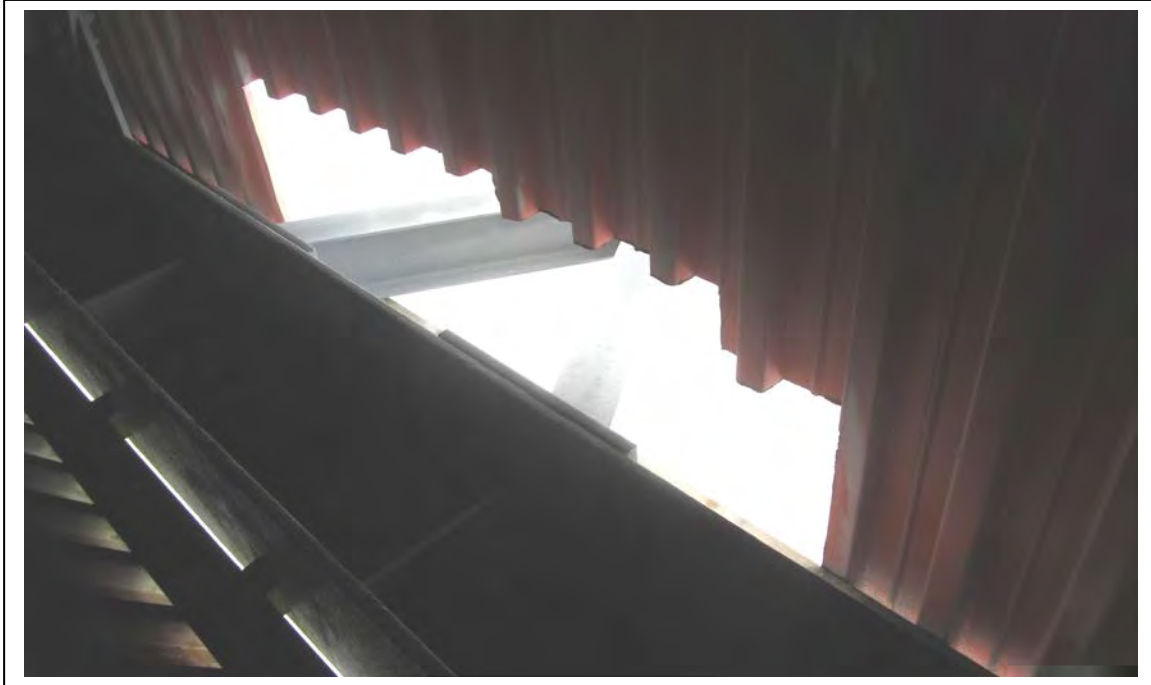
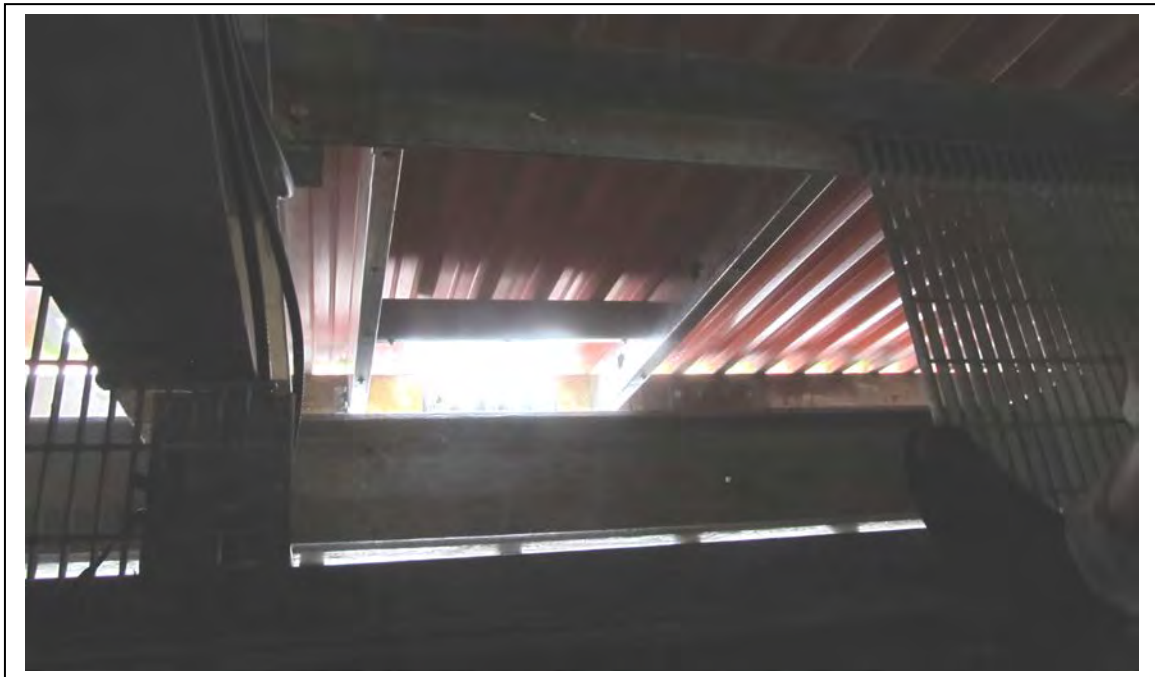
Photo Nos. 9 and 10 show skin panel reinforcing at level 3 before and after frame installation.

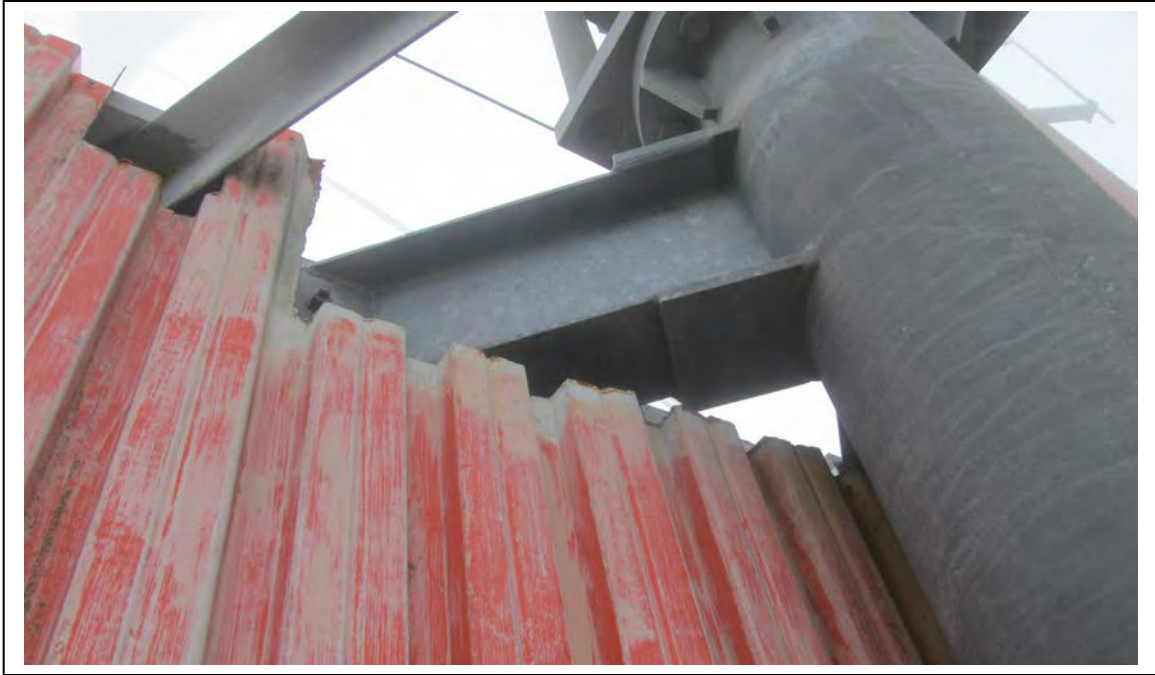
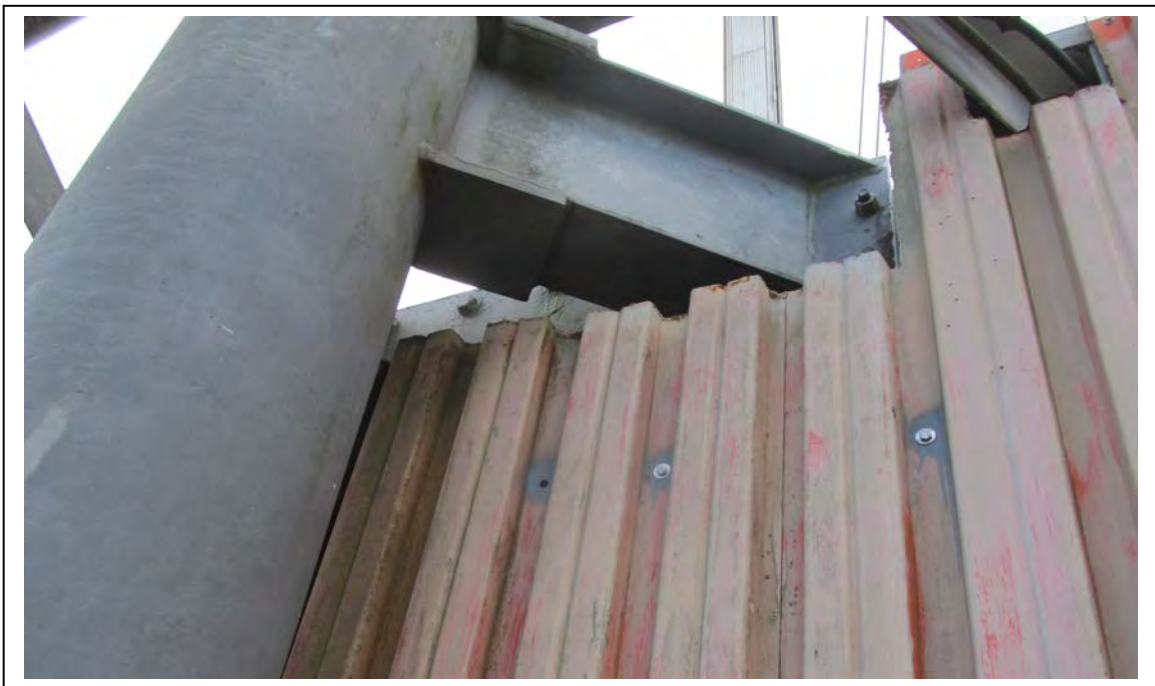
Photo Nos. 11 and 12 show the skin panel on face BC at level 2 before and after panel reinforcing.

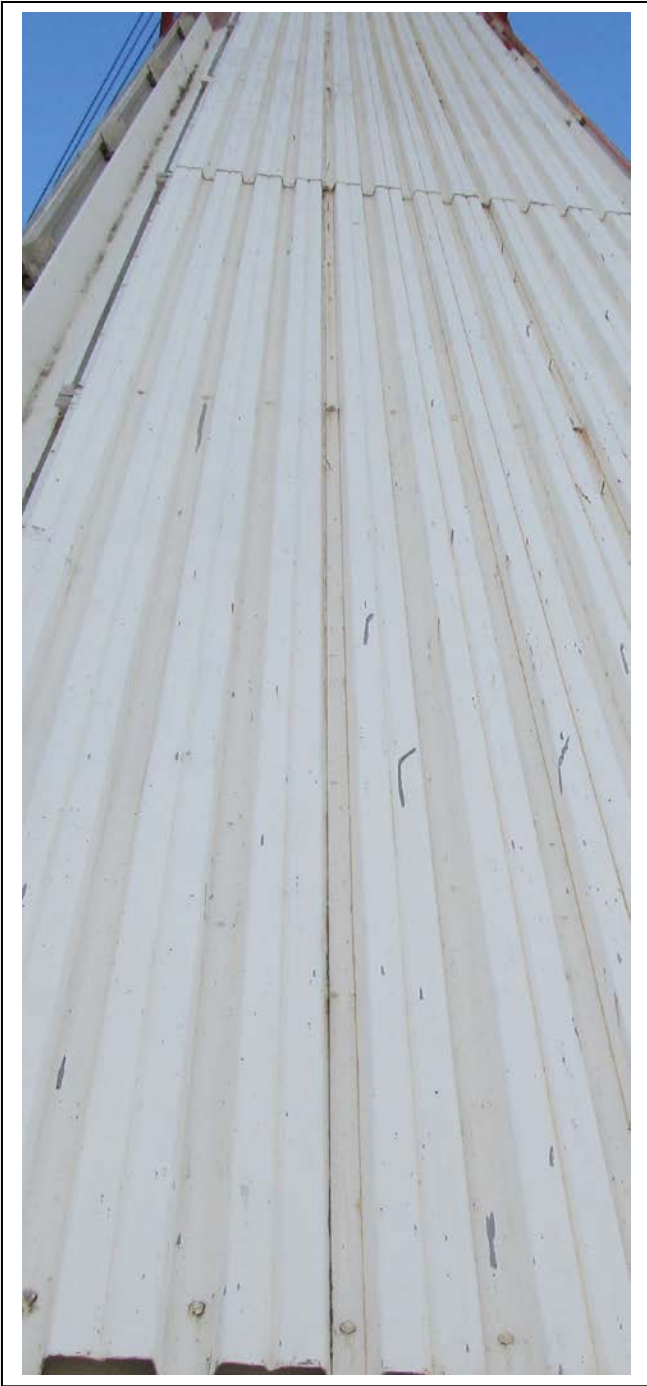
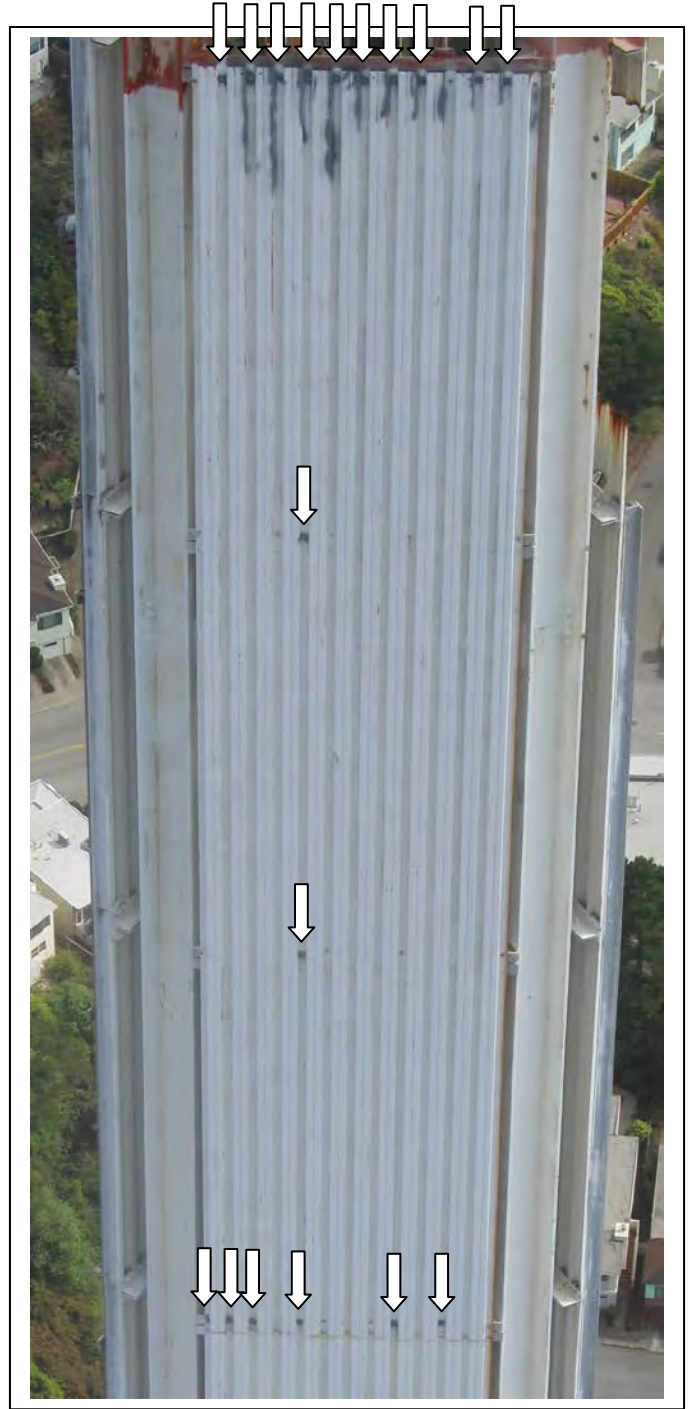
Photo Nos. 13 and 14 show the skin panels before and after panel reinforcing by adding more connection bolts. The arrows show the locations of the new connection bolts.

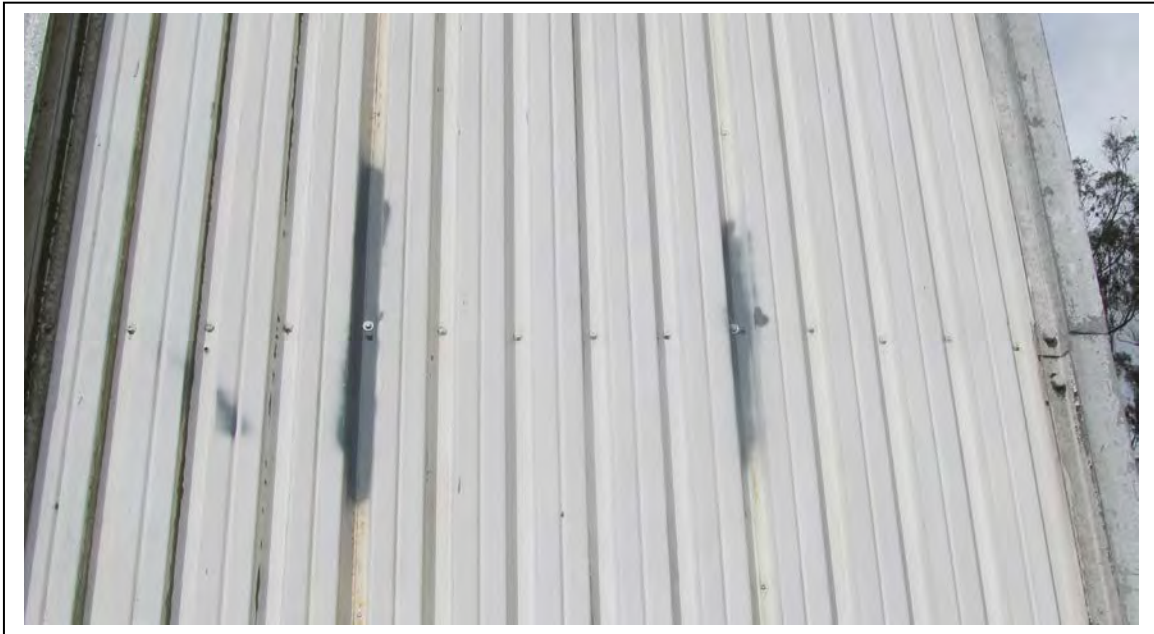
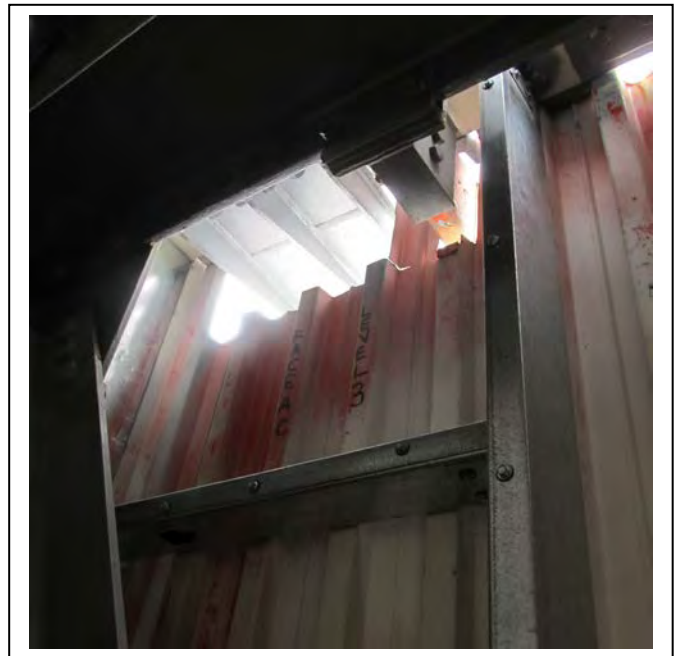
Photo Nos. 15 - 17 show the skin panel reinforcing at various levels after the recent repair work.
