Project 067199.11 – Condition Assessment of Sutro Tower, 2018 Inspections
2017 Maintenance and Inspection Program

FIELD INSPECTION REPORT

WEST LEG A & NORTH TRUSS LEVEL 2-5

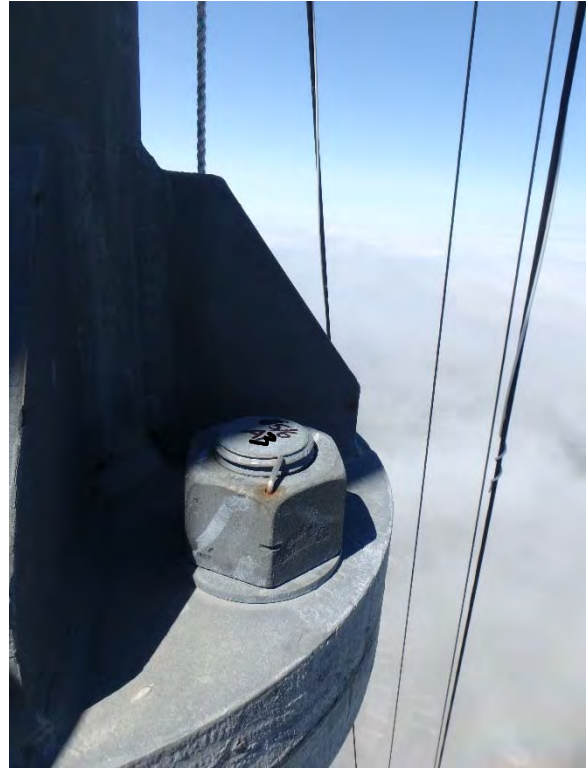
Picture 8: OBSERVATION 8

8	A3	6.32	C	8	SB (X1), ANCO Pin Not Fully Engaged, Leg Bolt	Replace with longer bolts, or remove flat washer to allow full engagement of ANCO locking pin
9	X-FACE	6.30	C	9	MRB (X2), Horiz Bolts	Surface prepare and treat
10	Y-FACE	6.30	C	10	MRB (X1), Diag Bolt	Surface prepare and treat
11	A1	6.24	C	11	SB (X2), ANCO Pin Not Fully Engaged, Leg Bolt	Replace with longer bolts, or remove flat washer to allow full engagement of ANCO locking pin
12	Y-FACE	6.22	C	12	MRB (X1), Diag Bolt	Surface prepare and treat
13	Y-FACE	6.20	C	13	MRB (X1), Diag Bolt	Surface prepare and treat
14	(Inside)	6.20	O	14	Minor Rust On J-Box Plugs (X2)	Replace plugs in near future
15	X-FACE	6.20	C	15-16	HDG Coating Damaged (X2), Gusset Plate	Surface prepare and treat
16	A2	6.16	C	17	SB (X2), ANCO Pin Not Fully Engaged, Leg Bolt	Replace with longer bolts, or remove flat washer to allow full engagement of ANCO locking pin
17	Y-FACE	6.16	O	18	Missing Rigid Line Spring Hanger (X1)	Corrected By Sutro Staff ~ Hanger installed 8/22/17

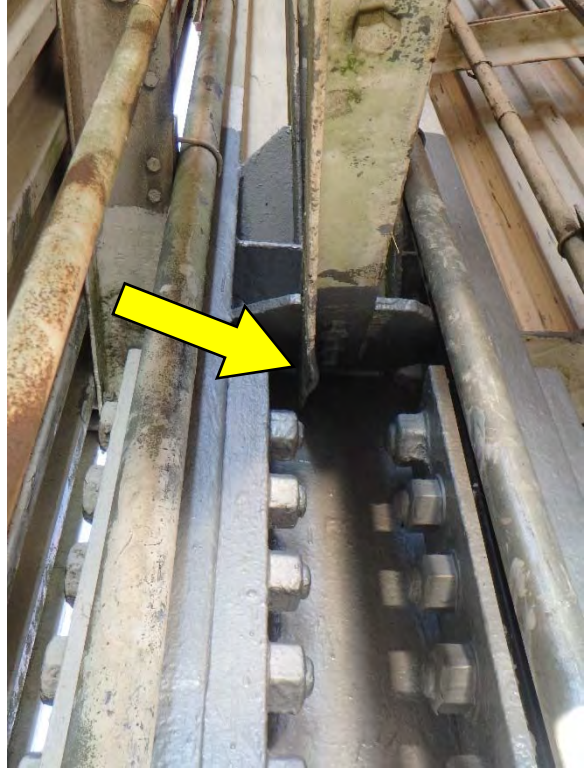
Picture 54: OBSERVATION 47

- **ON 14:** Damaged/bent flange on I-beam horizontal at elevation 5.10 on the X-Face inside the West Leg "A" (photo no. 17)
- **ON 47:** Damaged/bent angle leg on diagonal between elevations 1.29 and 1.31 on the Z-Face inside the West Leg "A" (photo no. 54-55)

46	Z-Face	2.0-1	C	53	Missing stitch bolt; Diagonal	Install new Ø3/4"x2-1/2" HDG A325 bolt with ANCO lock nut
47	Z-Face	1.29-31	D	54-55	Damaged/bent angle leg on diagonal	Field-straighten, or contact EOR to determine if any CA is warranted
48	X-Face	1.27-29	O	56	Severe rust on Ø1.9" conduit	Replace conduit
49	Z-Face	1.27	O	57	Lighting fixture junction box cover is severely corroded/disconnected and moderate rust present on conduit	Replace junction box cover, and surface prepare and treat conduit, or replace
50	OB Level	1.27-29	O	58	Moderate rust on red light conduit feed	Surface prepare and treat
51	X-Face	1.19-21	O	59-60	Rusted plugs on junction box (x4)	Replace junction box plugs
52	Z-Face	1.19-21	O	61	Severe rust on Ø2.375" conduit	Replace conduit
53	Z-Face	1.17	O	62	Severe rust on Ø2.375" conduit	Replace conduit
54	Y-Face	1.15	O	63	Severe rust on Ø1.9" conduit	Replace conduit
55	Y-Face	1.13	O	64	Severe rust on Ø1.9" conduit	Replace conduit

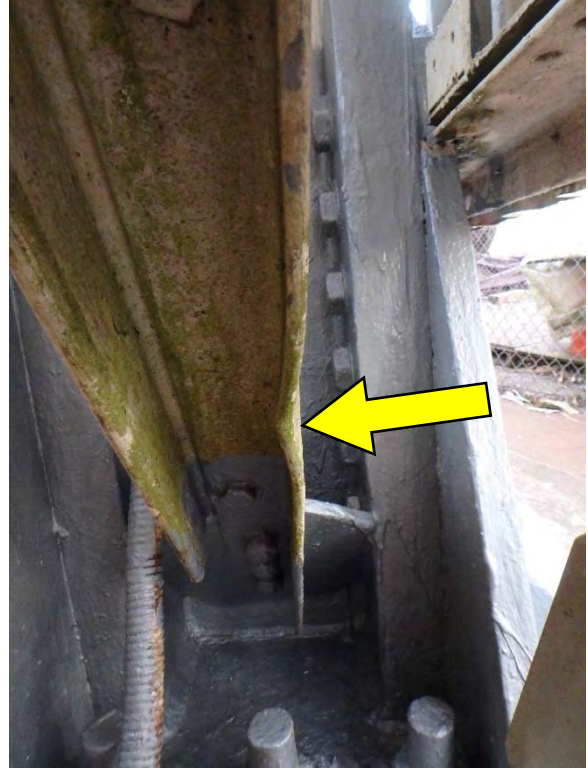
Picture 70: OBSERVATION 60

and the results of our further review. Observation 60 in the 24 June 2018 report can be repaired using details like those previously used for this purpose. We will provide details for this location and recommend you make repairs this season. Observation 140 in the same report is not a safety issue but should be addressed to improve comfort of individuals using the stair. We will provide details for this condition as well.

- **ON 60:** Damaged/bent angle leg on diagonal between elevations 1.0 and 1.1 on the Y-Face inside the West Leg "A" (photo no. 69-70)
- **ON 61:** Damaged/bent angle leg on cladding support horizontal at elevation 1.0 on the Y-Face inside the West Leg "A" (photo no. 71-72)

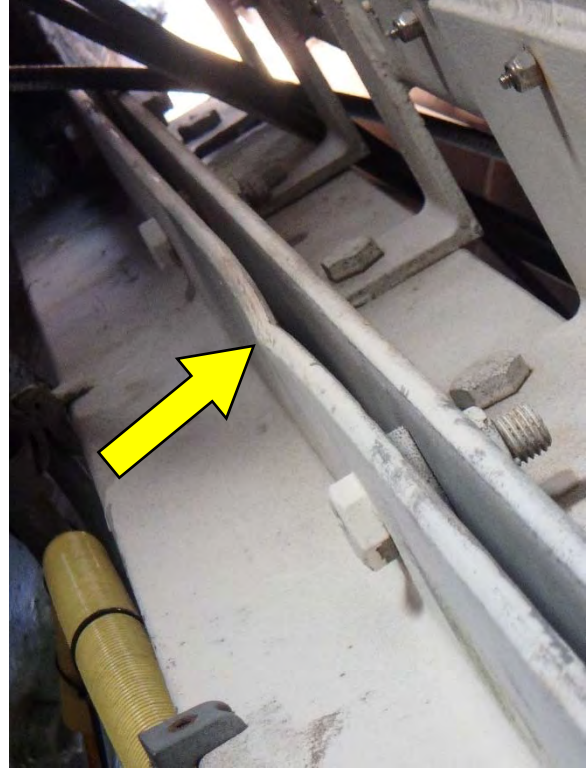
Picture 82: OBSERVATION 70

- **ON 70:** Damaged/bent angle leg on diagonal between truss verticals 4.6 and 4.7 in the North Truss Level 4 (photo no. 81-82)
- **ON 79:** Damaged/bent flange on I-beam vertical at truss vertical 3.3 in the North Truss Level 3 (photo no. 94-95)

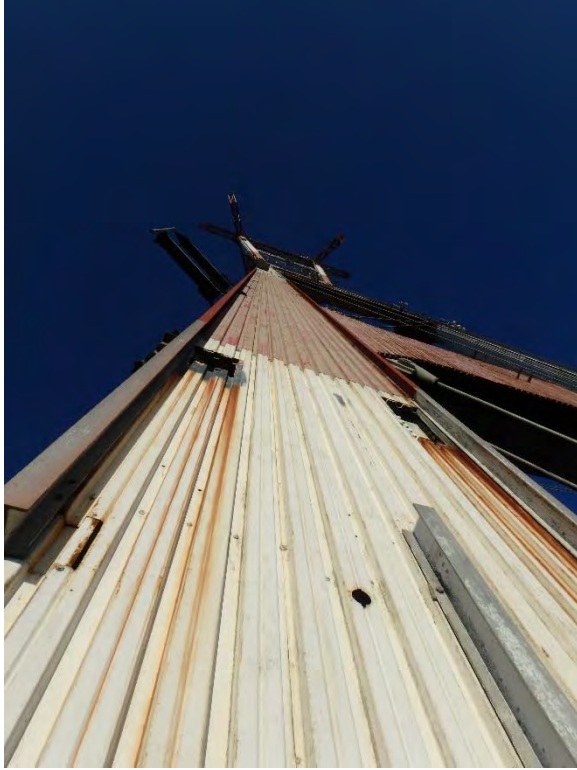
Picture 161: OBSERVATION 138

- **ON 138:** The existing cladding is considered in fair condition due to numerous cut-outs, minor surface rust, and inconsistent attachment means (photo no. 161-164)

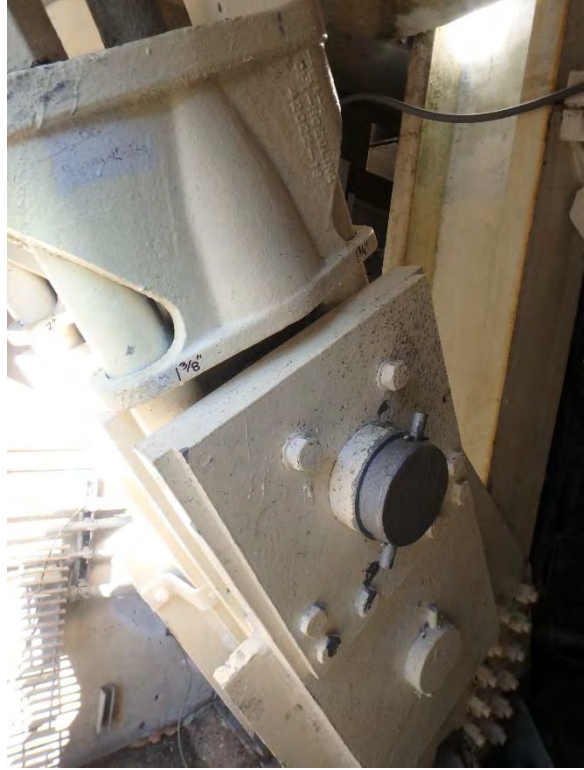
Picture 174: OBSERVATION 145

Note Unraveled Strands
