FIELD INSPECTION REPORT

NE STACK C, NE LEG C & SOUTH TRUSS LEVELS 2-6

SEPTEMBER 1, 2021

ERI PROJECT 38470/38471
977 FT SELF-SUPPORT TOWER
SAN FRANCISCO, CA
ASRN 1001289

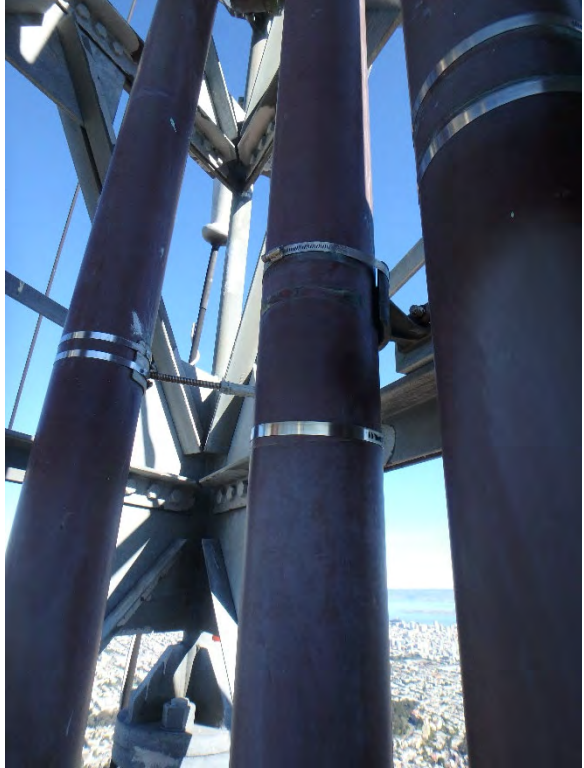
OBSERVATION 1:	LOCATION:

NE Stack C, Level 6.38
	CONCERN:
	Loose hose clamps on 6-1/8" rigid line fixed hanger
	RECOMMENDED ACTION:
Secure loose hose clamps	ADDITIONAL COMMENTS:
N/A	
OBSERVATION 2:	LOCATION:

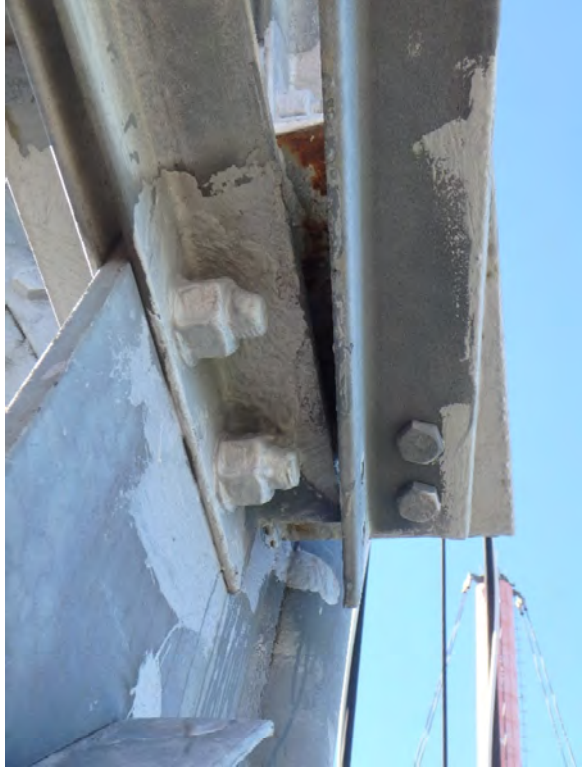
NE Stack C, Level 6.32
	CONCERN:
	Moderate rust on side-mount bracket assembly
	RECOMMENDED ACTION:
Surface prepare and treat IAW STI-SOP-0001	ADDITIONAL COMMENTS:
N/A

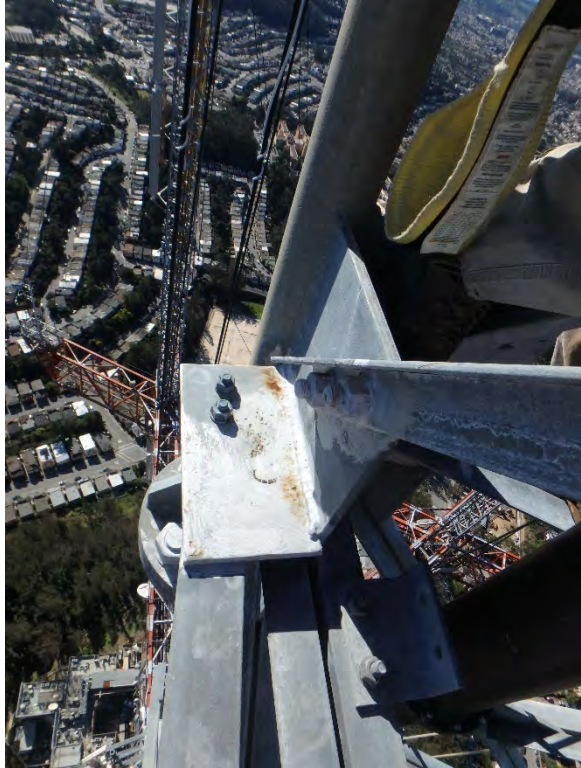
<p>OBSERVATION 3:</p>

<p>LOCATION: NE Stack C, Level 6.32</p> <p>CONCERN: Moderate rust on side-mount bracket assembly</p> <p>RECOMMENDED ACTION: Surface prepare and treat IAW STI-SOP-0001</p> <p>ADDITIONAL COMMENTS: N/A</p>
<p>OBSERVATION 4:</p>

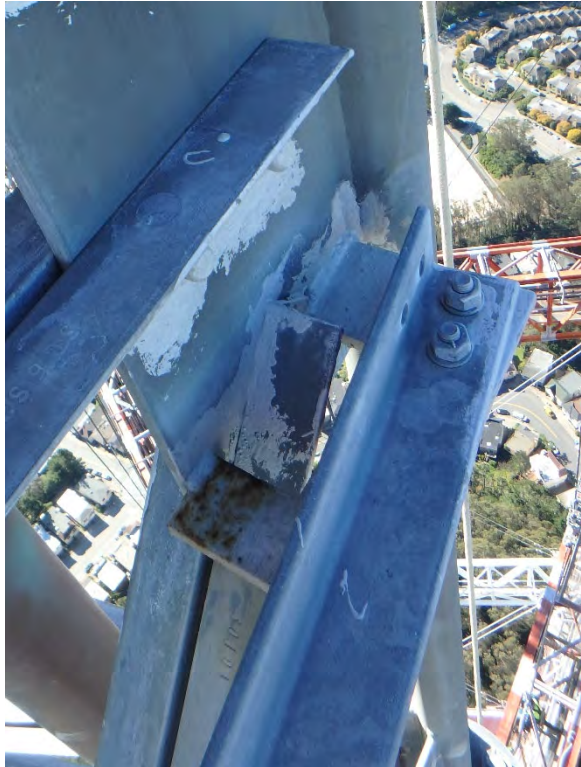
<p>LOCATION: NE Stack C, Level 6.26</p> <p>CONCERN: Moderate rust on side-mount bracket assembly</p> <p>RECOMMENDED ACTION: Surface prepare and treat IAW STI-SOP-0001</p> <p>ADDITIONAL COMMENTS: N/A</p>

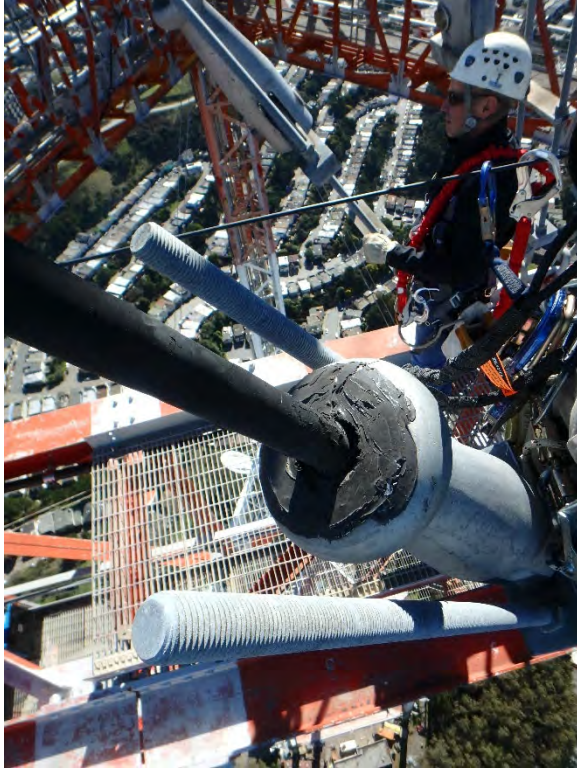
OBSERVATION 7:

NE Stack C Guying, Level 1 Wires

Three locations including 1 on N Truss and 2 at NE Outrigger; Silicone sealant at socketed corona ends has split and separated from the cable and socket at anchor attachment ~ No damage noted to polyurethane jackets or poured resin

Remove loose silicone and debris and inject fresh pure black silicone ~ High quality pure black silicone from a local paint distributor may be used

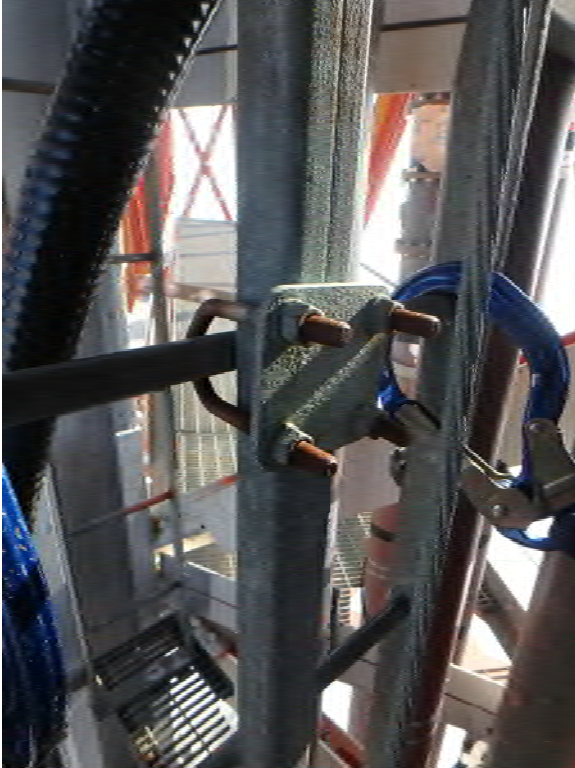
OBSERVATION 8:

NE Leg C, Level 6.1, X-Face

Moderate rust on safety climb top anchorage v-bolts

Replace v-bolts (x3)

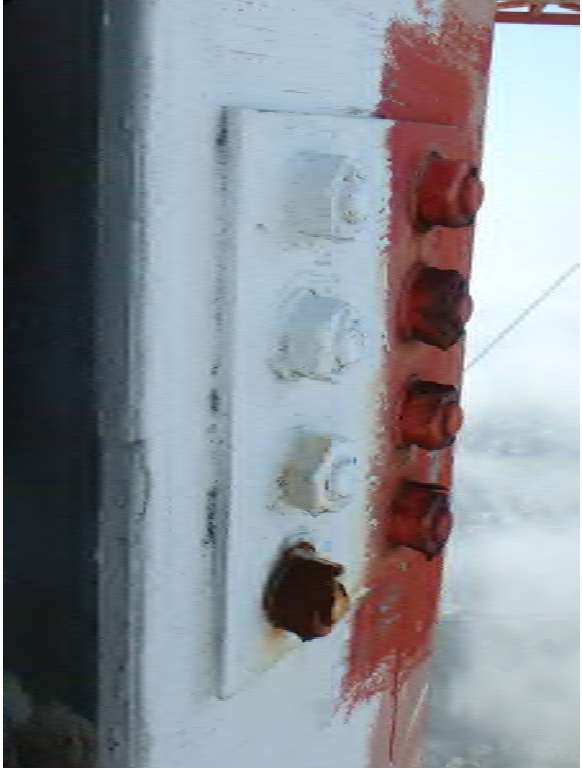
<p>OBSERVATION 9:</p>

<p>LOCATION: NE Leg C, Level 5.16-5.17, Ca</p> <p>CONCERN: Moderate/severe rust on column bolts</p> <p>RECOMMENDED ACTION: Surface prepare bolts and replace if material loss exceeds limits set in the 2014 Bolt Replacement Criteria, Tables 5 & 6. If material loss is within acceptable tolerances, repair and coat IAW STI-SOP-0001.</p> <p>ADDITIONAL COMMENTS: N/A</p>
<p>OBSERVATION 10:</p>

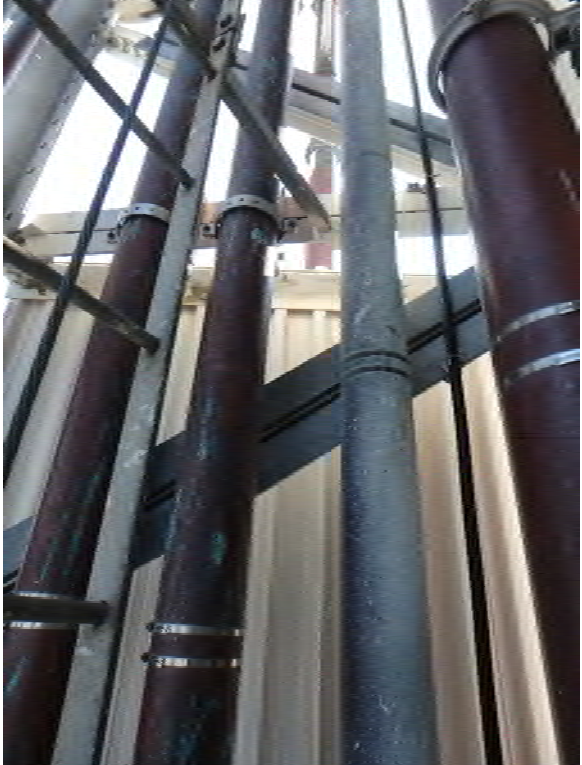
<p>LOCATION: NE Leg C, Level 5.9</p> <p>CONCERN: Missing spring hanger on 6-1/8" rigid line</p> <p>RECOMMENDED ACTION: Install spring hanger</p> <p>ADDITIONAL COMMENTS: N/A</p>

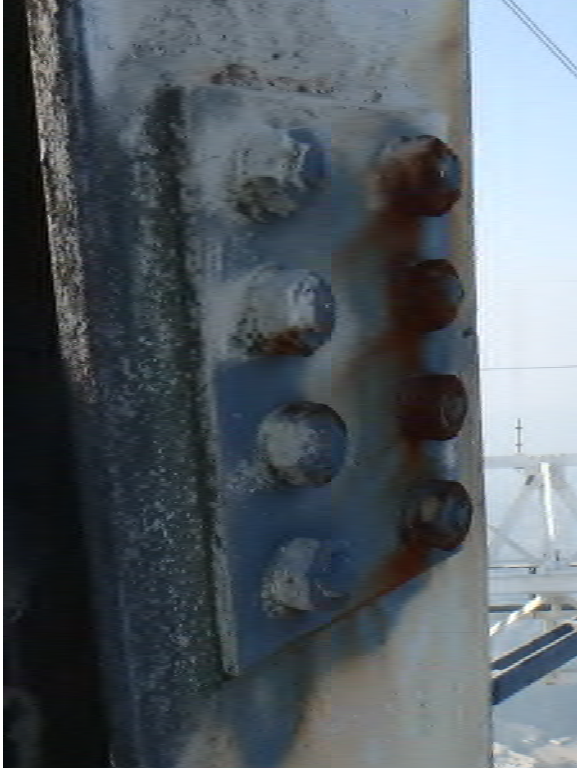
OBSERVATION 11:	LOCATION:

NE Leg C, Level 5.4-5.5, Ca
	CONCERN:
	Moderate/severe rust on column bolts
	RECOMMENDED ACTION:
	Surface prepare bolts and replace if material loss exceeds limits set in the 2014 Bolt Replacement Criteria, Tables 5 & 6. If material loss is within acceptable tolerances, repair and coat IAW STI-SOP-0001.
	ADDITIONAL COMMENTS:
	N/A
OBSERVATION 12:	LOCATION:

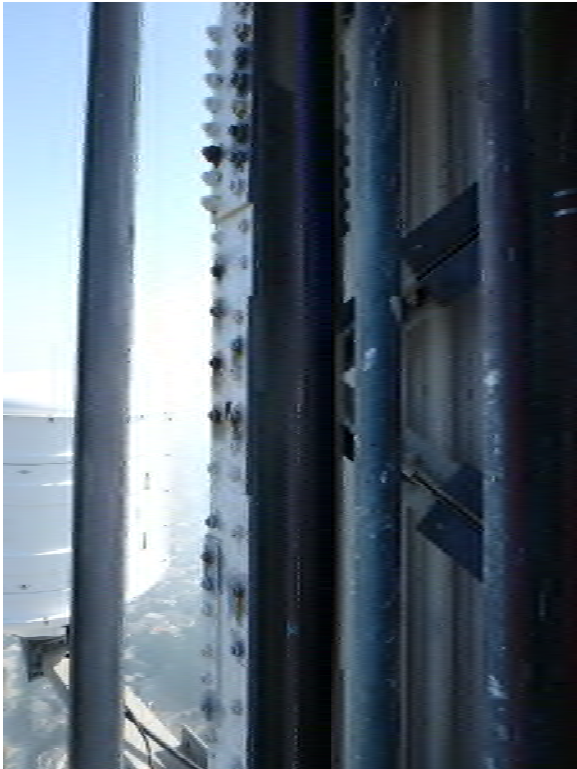
NE Leg C, Level 5.4-5.5, Cc
	CONCERN:
	Moderate/severe rust on column bolts
	RECOMMENDED ACTION:
	Surface prepare bolts and replace if material loss exceeds limits set in the 2014 Bolt Replacement Criteria, Tables 5 & 6. If material loss is within acceptable tolerances, repair and coat IAW STI-SOP-0001.
	ADDITIONAL COMMENTS:
	N/A

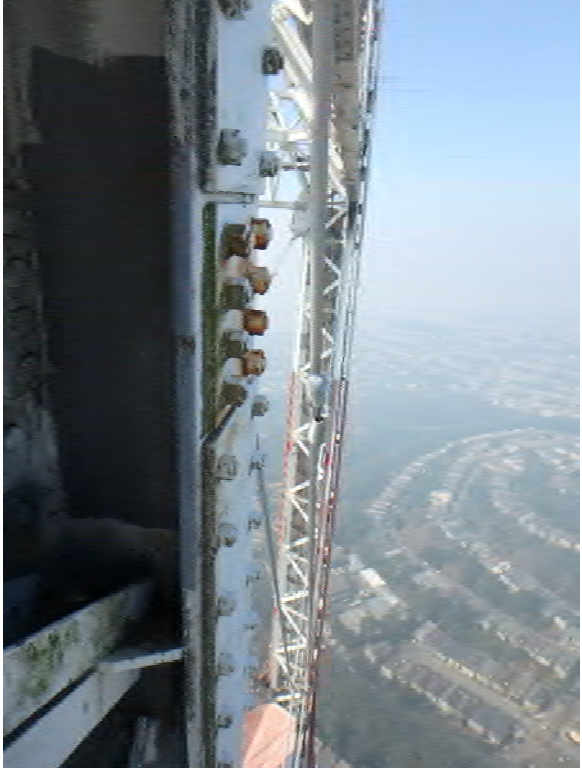
<p>OBSERVATION 13:</p>	<p>LOCATION:</p>

<p>NE Leg C, Level 4.18-4.19, Ca</p>
	<p>CONCERN:</p>
	<p>Moderate/severe rust on column bolts</p>
	<p>RECOMMENDED ACTION:</p> <p>Surface prepare bolts and replace if material loss exceeds limits set in the 2014 Bolt Replacement Criteria, Tables 5 & 6. If material loss is within acceptable tolerances, repair and coat IAW STI-SOP-0001.</p>
<p>ADDITIONAL COMMENTS:</p>	<p>N/A</p>
<p>OBSERVATION 14:</p>	<p>LOCATION:</p>

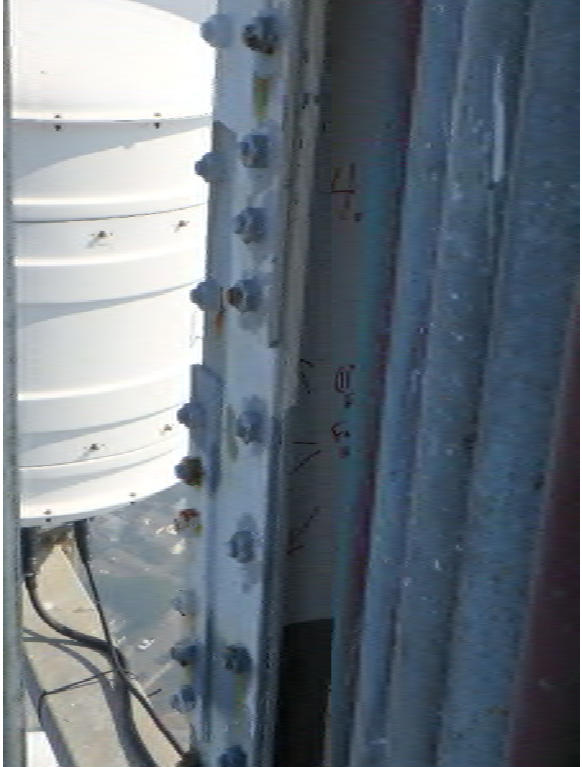
<p>NE Leg C, Level 4.18, Cc</p>
	<p>CONCERN:</p>
	<p>Moderate/severe rust on column bolts</p>
	<p>RECOMMENDED ACTION:</p> <p>Surface prepare bolts and replace if material loss exceeds limits set in the 2014 Bolt Replacement Criteria, Tables 5 & 6. If material loss is within acceptable tolerances, repair and coat IAW STI-SOP-0001.</p>
<p>ADDITIONAL COMMENTS:</p>	<p>N/A</p>

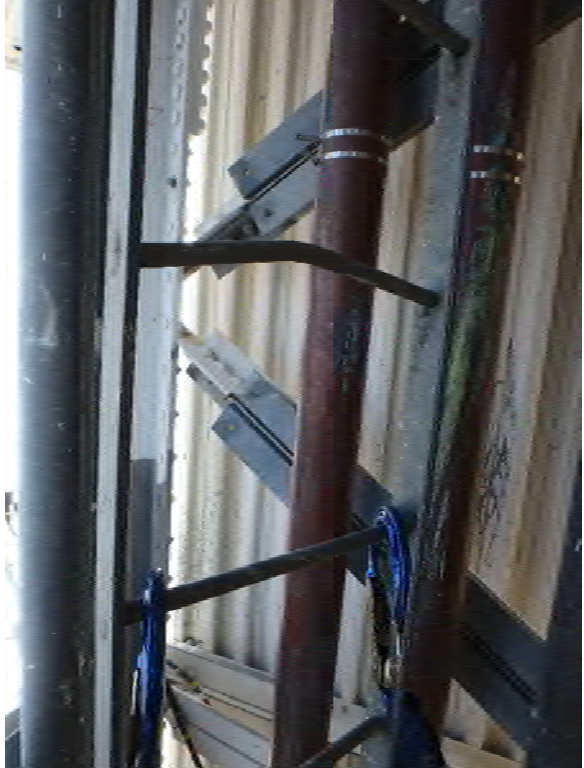
<p>OBSERVATION 15:</p>

<p>LOCATION: NE Leg C, Level 4.18, X-Face</p> <p>CONCERN: Bent climbing ladder rungs</p> <p>RECOMMENDED ACTION: Field-straighten bent rung (x2)</p> <p>ADDITIONAL COMMENTS: N/A</p>
<p>OBSERVATION 16:</p>

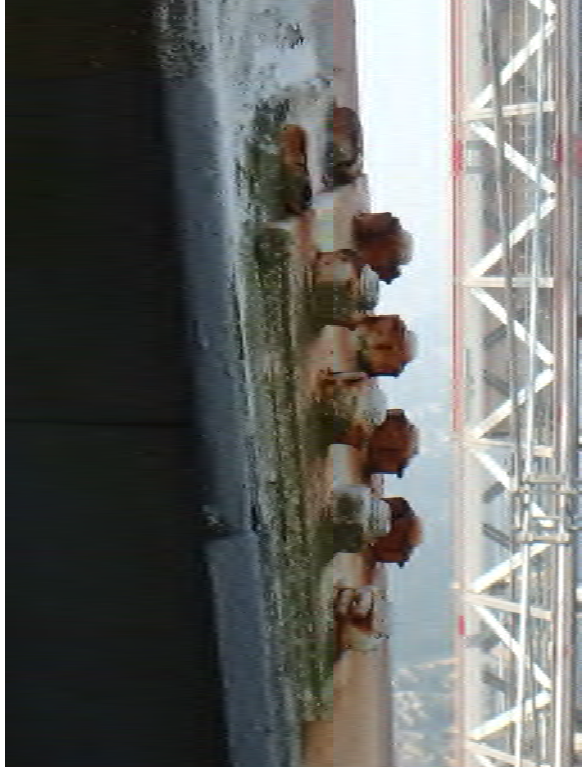
<p>LOCATION: NE Leg C, Level 4.12-4.13, Ca</p> <p>CONCERN: Moderate/severe rust on column bolts</p> <p>RECOMMENDED ACTION: Surface prepare bolts and replace if material loss exceeds limits set in the 2014 Bolt Replacement Criteria, Tables 5 & 6. If material loss is within acceptable tolerances, repair and coat IAW STI-SOP-0001.</p> <p>ADDITIONAL COMMENTS: N/A</p>

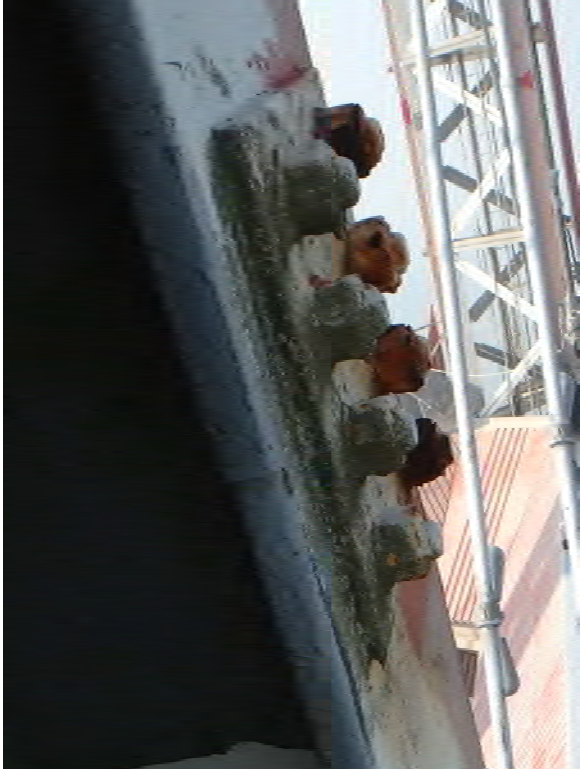
OBSERVATION 17:	LOCATION:

NE Leg C, Level 4.6-4.7, Ca
	CONCERN:
	Moderate/severe rust on column bolts
	RECOMMENDED ACTION:
	Surface prepare bolts and replace if material loss exceeds limits set in the 2014 Bolt Replacement Criteria, Tables 5 & 6. If material loss is within acceptable tolerances, repair and coat IAW STI-SOP-0001.
	ADDITIONAL COMMENTS:
	N/A
OBSERVATION 18:	LOCATION:

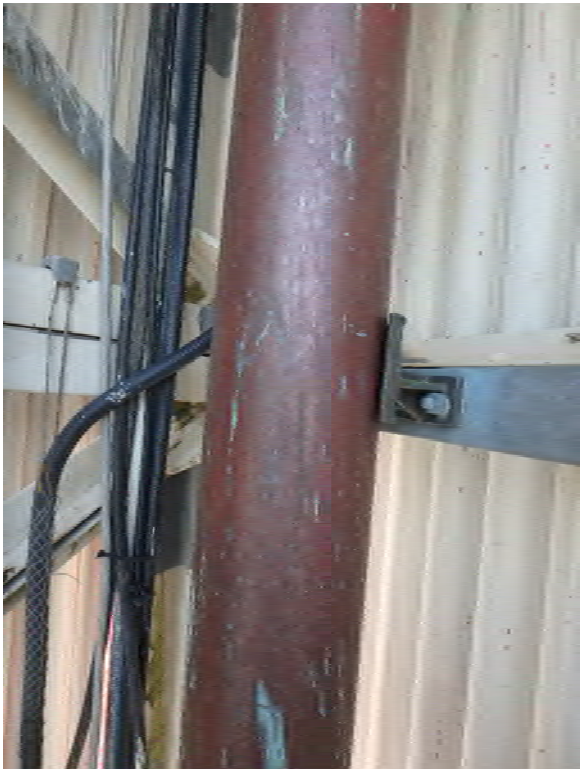
NE Leg C, Level 3.34
	CONCERN:
	Missing hose clamps on 8-3/16" rigid line fixed hanger
	RECOMMENDED ACTION:
	Install hose clamps (x2)
	ADDITIONAL COMMENTS:
	N/A

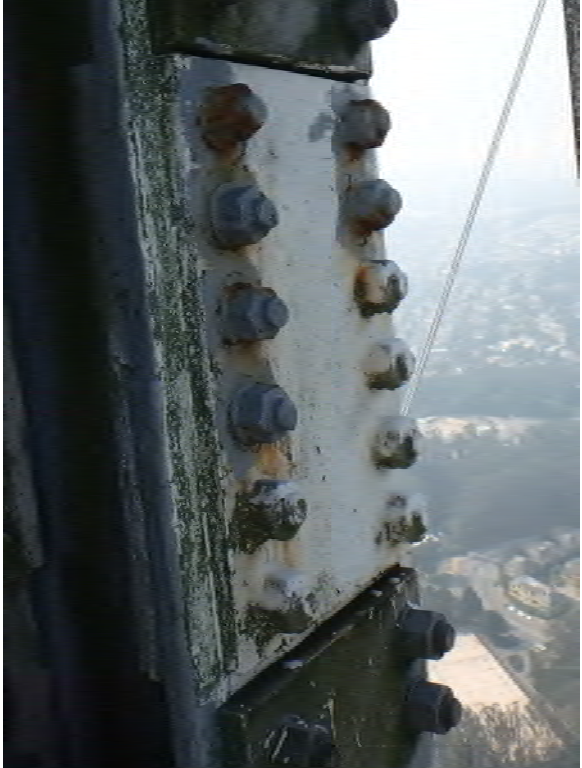
OBSERVATION 19:	LOCATION:

NE Leg C, Level 3.29-3.30, Ca
	CONCERN:
	Moderate/severe rust on column bolts
	RECOMMENDED ACTION:
	Surface prepare bolts and replace if material loss exceeds limits set in the 2014 Bolt Replacement Criteria, Tables 5 & 6. If material loss is within acceptable tolerances, repair and coat IAW STI-SOP-0001.
	ADDITIONAL COMMENTS:
	N/A
OBSERVATION 20:	LOCATION:

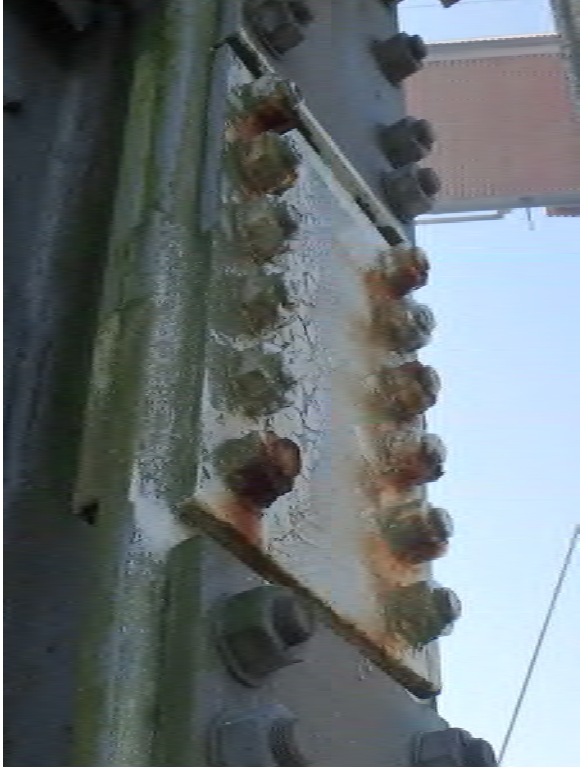
NE Leg C, Level 3.23-3.24, Ca
	CONCERN:
	Moderate/severe rust on column bolts
	RECOMMENDED ACTION:
	Surface prepare bolts and replace if material loss exceeds limits set in the 2014 Bolt Replacement Criteria, Tables 5 & 6. If material loss is within acceptable tolerances, repair and coat IAW STI-SOP-0001.
	ADDITIONAL COMMENTS:
	N/A

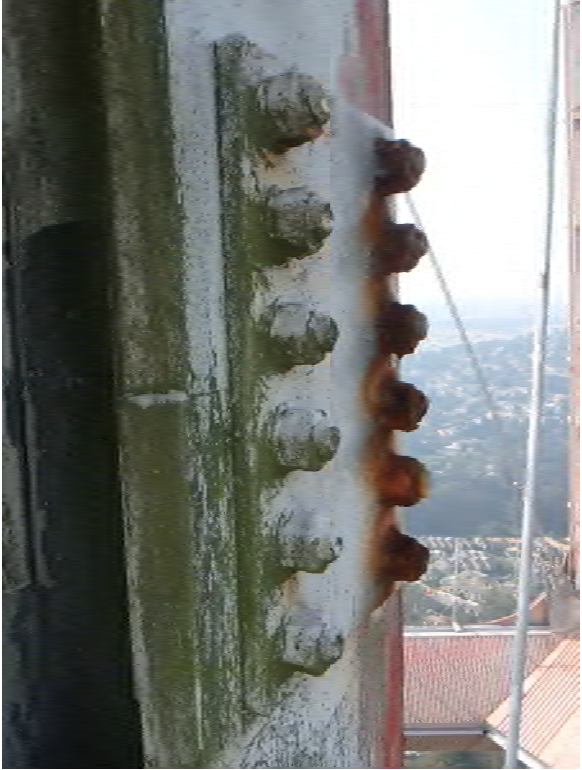
OBSERVATION 23:	LOCATION:

23	Ca	3.11-3.12	C	Moderate/severe rust on column bolts	Surface prepare bolts and replace if material loss exceeds limits set in the 2014 Bolt Replacement Criteria, Tables 5 & 6. If material loss is within acceptable tolerances, repair and coat IAW STI-SOP-0001.

NE Leg C, Level 3.11-3.12, Ca
	CONCERN:
	Moderate/severe rust on column bolts
	RECOMMENDED ACTION:
	Surface prepare bolts and replace if material loss exceeds limits set in the 2014 Bolt Replacement Criteria, Tables 5 & 6. If material loss is within acceptable tolerances, repair and coat IAW STI-SOP-0001.
ADDITIONAL COMMENTS:	N/A
OBSERVATION 24:	LOCATION:

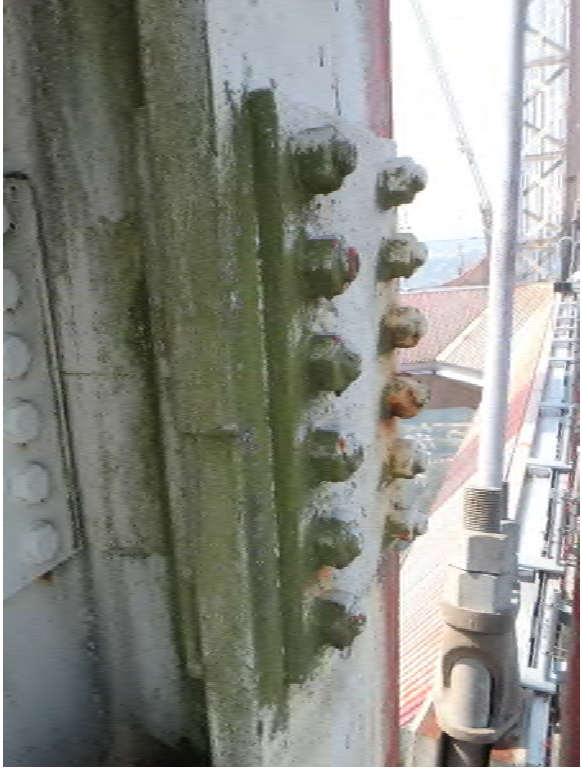
NE Leg C, Level 3.5-3.6, Ca
	CONCERN:
	Moderate/severe rust on column bolts
	RECOMMENDED ACTION:
	Surface prepare bolts and replace if material loss exceeds limits set in the 2014 Bolt Replacement Criteria, Tables 5 & 6. If material loss is within acceptable tolerances, repair and coat IAW STI-SOP-0001.
ADDITIONAL COMMENTS:	N/A

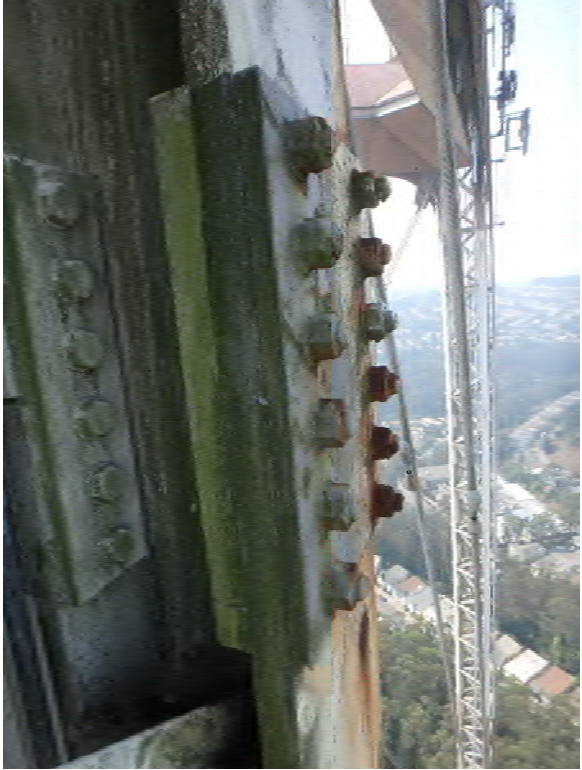
OBSERVATION 25:	LOCATION:

NE Leg C, Level 2.36-2.37, Ca
	CONCERN:
	Moderate/severe rust on column bolts
	RECOMMENDED ACTION:
Surface prepare bolts and replace if material loss exceeds limits set in the 2014 Bolt Replacement Criteria, Tables 5 & 6. If material loss is within acceptable tolerances, repair and coat IAW STI-SOP-0001.	ADDITIONAL COMMENTS:
N/A	
OBSERVATION 26:	LOCATION:

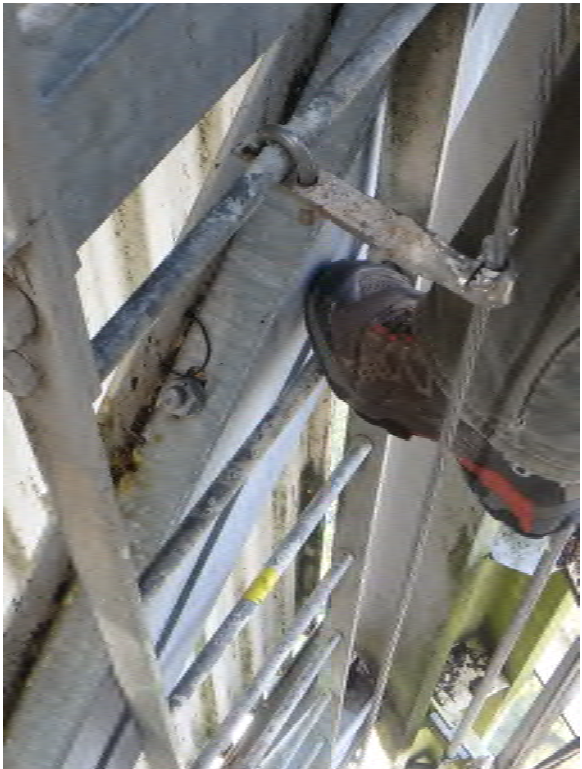
NE Leg C, Level 2.32-3.0, X-Face
	CONCERN:
	Climbing ladder rung footing clearance obstructed by installed reinforcement (1-1/2" footing clearance)
	RECOMMENDED ACTION:
Rework ladder attachments to provide adequate clearance, or install warning signage above and below to notify climbers of obstructed path	ADDITIONAL COMMENTS:
N/A

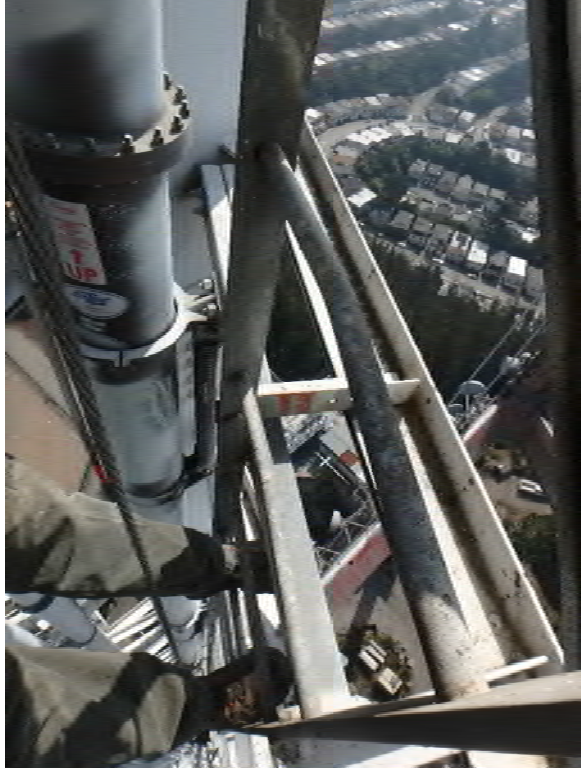
OBSERVATION 27:	LOCATION: NE Leg C, Level 2.25-2.26, X-Face

CONCERN: Bent climbing ladder rung
	RECOMMENDED ACTION: Field-straighten bent rung
	ADDITIONAL COMMENTS: N/A
OBSERVATION 28:	LOCATION: NE Leg C, Level 2.24-2.25, Ca

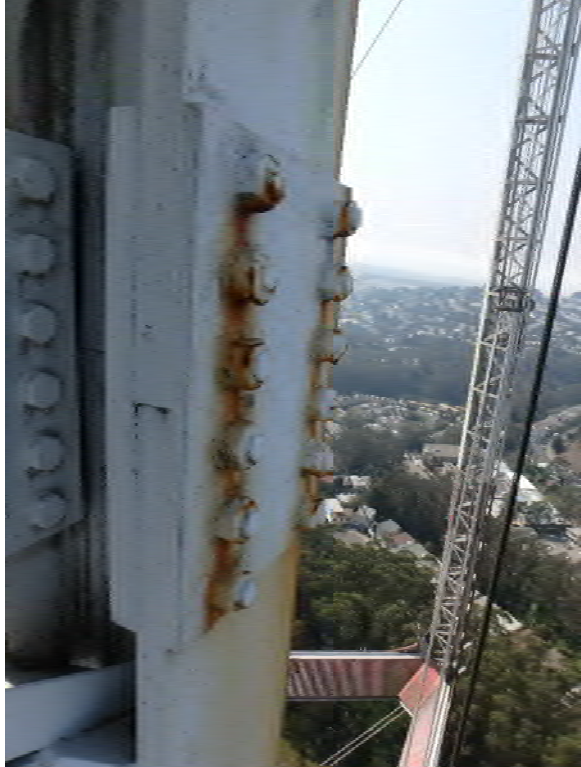
CONCERN: Moderate/severe rust on column bolts
	RECOMMENDED ACTION: Surface prepare bolts and replace if material loss exceeds limits set in the 2014 Bolt Replacement Criteria, Tables 5 & 6. If material loss is within acceptable tolerances, repair and coat IAW STI-SOP-0001.
	ADDITIONAL COMMENTS: N/A

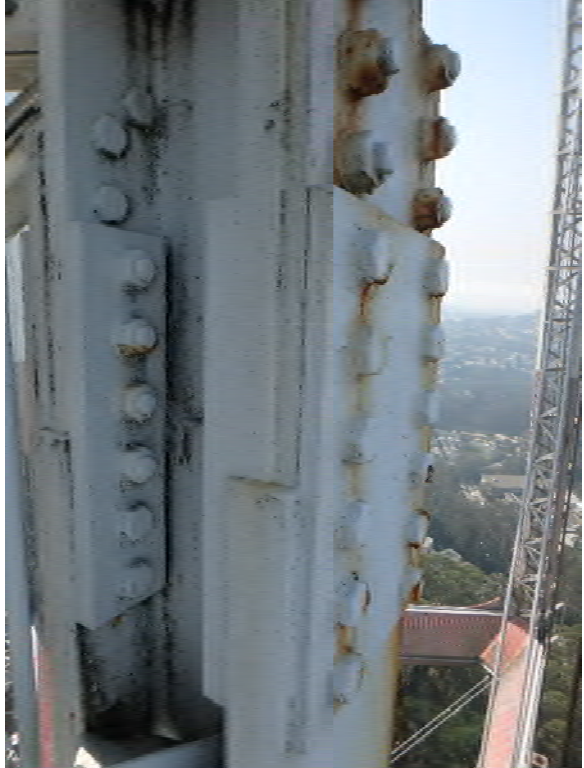
OBSERVATION 29:	LOCATION:

NE Leg C, Level 2.18-2.19, Ca
	CONCERN:
	Moderate/severe rust on column bolts
	RECOMMENDED ACTION:
Surface prepare bolts and replace if material loss exceeds limits set in the 2014 Bolt Replacement Criteria, Tables 5 & 6. If material loss is within acceptable tolerances, repair and coat IAW STI-SOP-0001.	ADDITIONAL COMMENTS:
N/A	
OBSERVATION 30:	LOCATION:

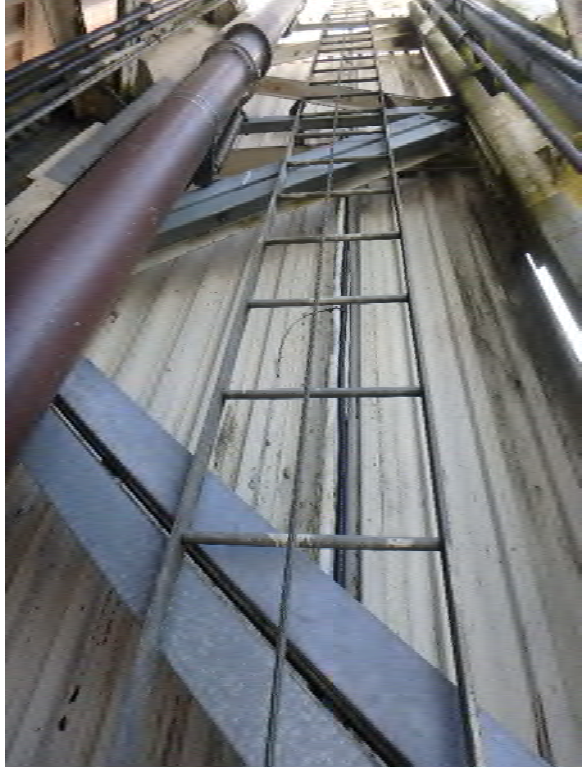
NE Leg C, Level 2.11-2.13, X-Face
	CONCERN:
	Climbing ladder rung footing clearance obstructed by installed reinforcement (1-1/2" footing clearance)
	RECOMMENDED ACTION:
Rework ladder attachments to provide adequate clearance, or install warning signage above and below to notify climbers of obstructed path	ADDITIONAL COMMENTS:
N/A

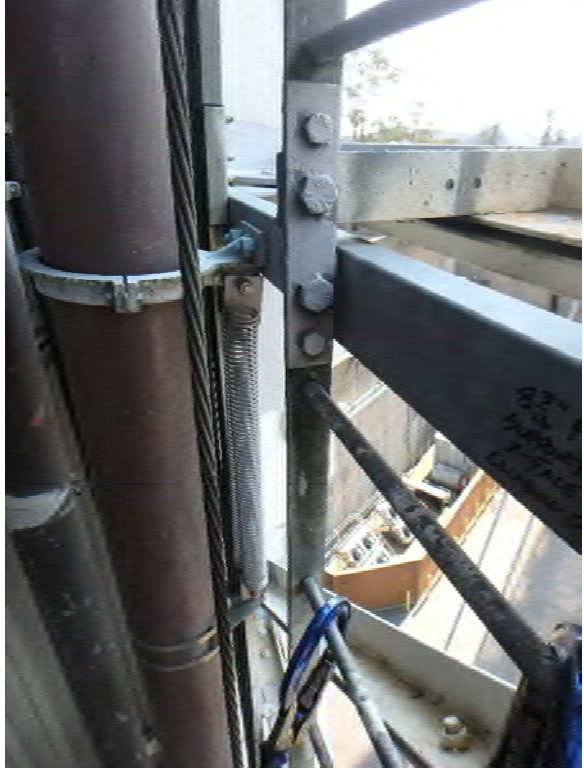
OBSERVATION 33:	LOCATION: NE Leg C, Level 1.13, X-Face

CONCERN: Climbing ladder rung footing clearance obstructed by installed 8-3/16" rigid line support
	RECOMMENDED ACTION: Reposition support to provide adequate clearance, or install warning signage above and below to notify climbers of obstructed path
	ADDITIONAL COMMENTS: N/A
OBSERVATION 34:	LOCATION: NE Leg C, Level 1.6-1.7, Ca

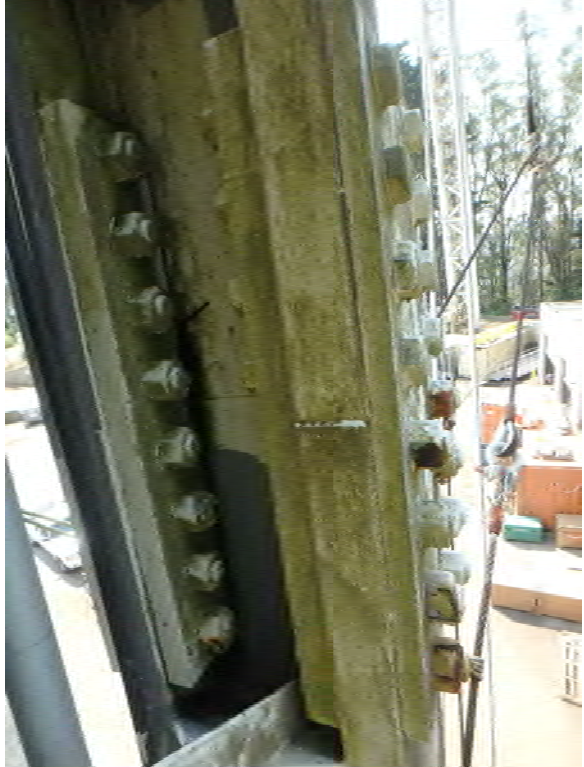
CONCERN: Moderate/severe rust on column bolts
	RECOMMENDED ACTION: Surface prepare bolts and replace if material loss exceeds limits set in the 2014 Bolt Replacement Criteria, Tables 5 & 6. If material loss is within acceptable tolerances, repair and coat IAW STI-SOP-0001.
	ADDITIONAL COMMENTS: N/A

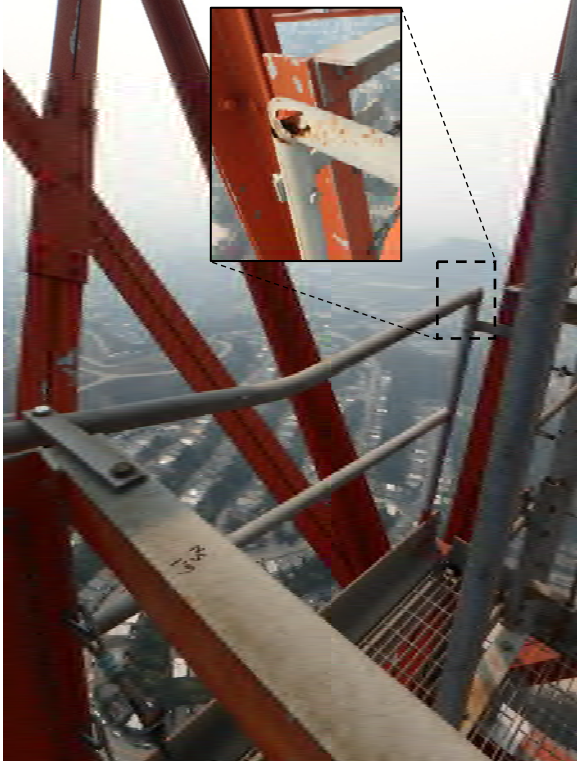
<p>OBSERVATION 35:</p>

<p>LOCATION: South Truss Level 6, Panel 6.1</p> <p>CONCERN: Damaged top rail (bent and severely rusted at corner)</p> <p>RECOMMENDED ACTION: Replace rail assembly</p> <p>ADDITIONAL COMMENTS: N/A</p>
--	--

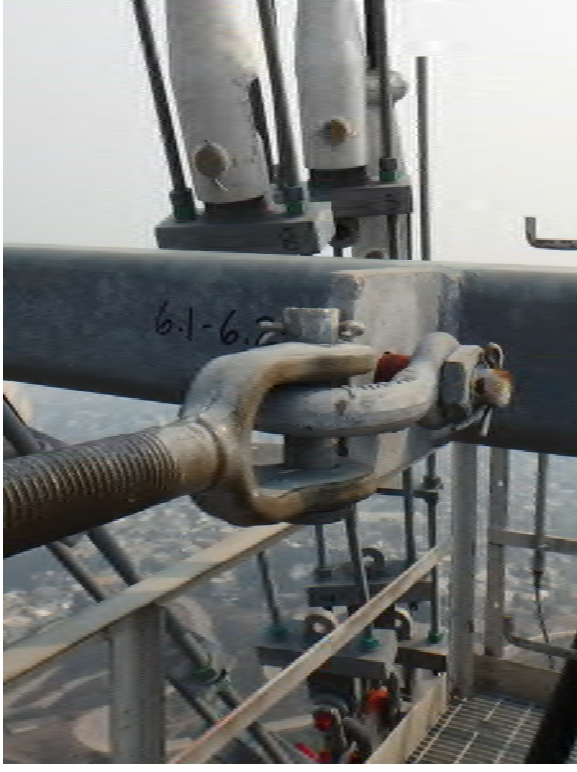
<p>OBSERVATION 36:</p>

<p>LOCATION: South Truss Level 6, Panel 6.1-6.2</p> <p>CONCERN: Mild rust on HLL shackle bolt</p> <p>RECOMMENDED ACTION: Surface prepare and treat IAW STI-SOP-0001</p> <p>ADDITIONAL COMMENTS: N/A</p>
--	---

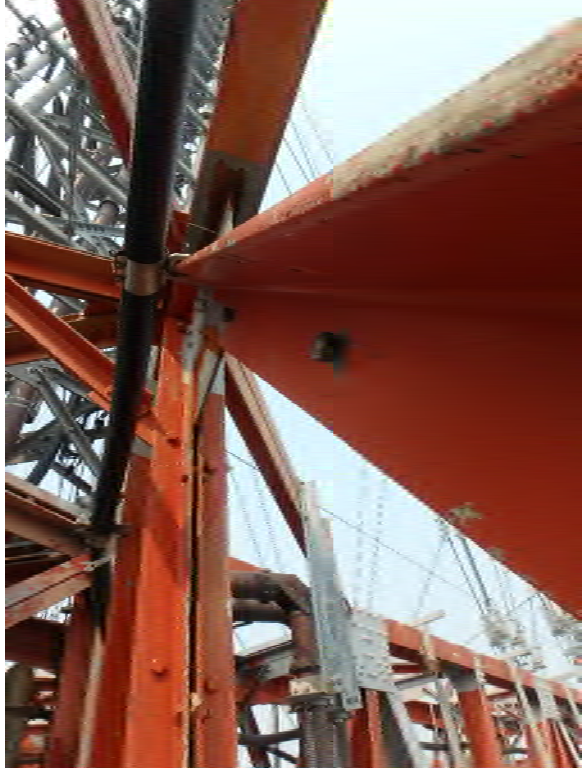
<p>OBSERVATION 37:</p>

<p>LOCATION: South Truss Level 6, Panel 6.4-6.5</p> <p>CONCERN: Loose stitch bolt (x2); diag</p> <p>RECOMMENDED ACTION: Stitch bolts loosened to facilitate gusset reinforcement which was in progress during inspection; check and ensure stitch bolts are fully retightened</p> <p>ADDITIONAL COMMENTS: N/A</p>
<p>OBSERVATION 38:</p>

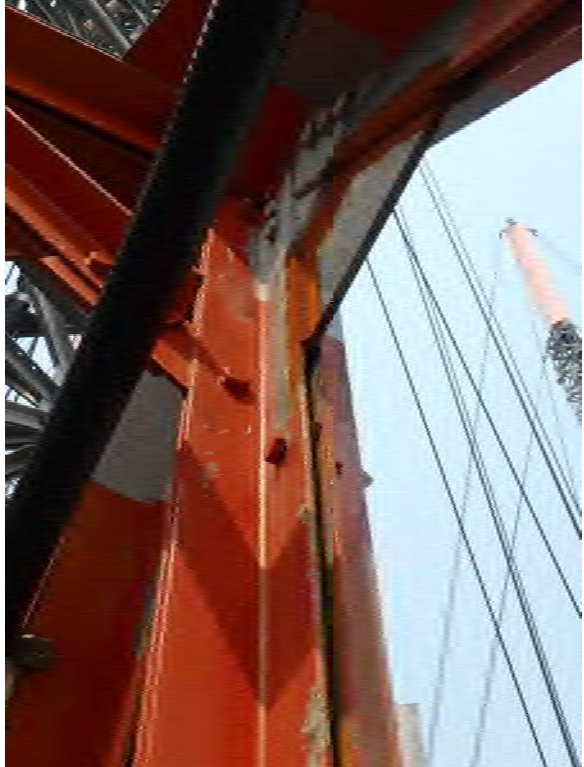
<p>LOCATION: South Truss Level 6, Panel 6.5</p> <p>CONCERN: Loose stitch bolt (x2); vertical</p> <p>RECOMMENDED ACTION: Stitch bolts loosened to facilitate gusset reinforcement which was in progress during inspection; check and ensure stitch bolts are fully retightened</p> <p>ADDITIONAL COMMENTS: N/A</p>

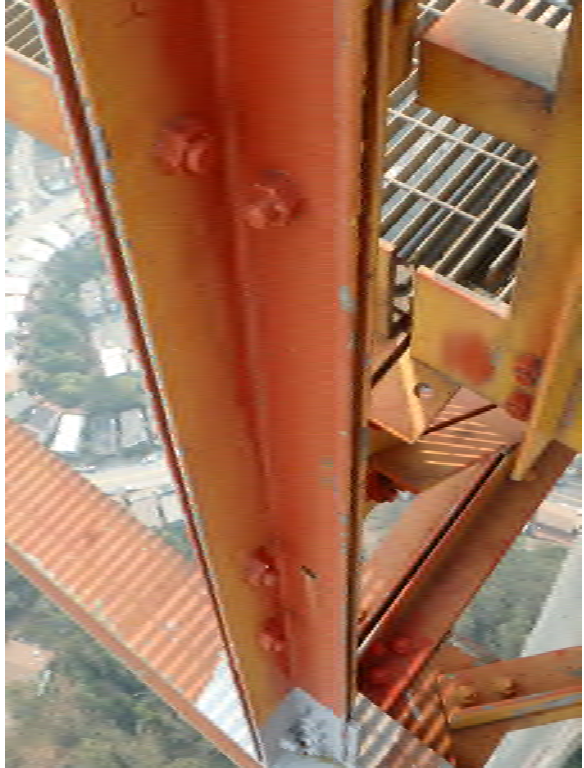
<p>OBSERVATION 39:</p>

<p>LOCATION: South Truss Level 6, Panel 6.5</p> <p>CONCERN: Missing stitch bolt; vertical</p> <p>RECOMMENDED ACTION: Install stitch bolt</p> <p>ADDITIONAL COMMENTS: N/A</p>
<p>OBSERVATION 40:</p>

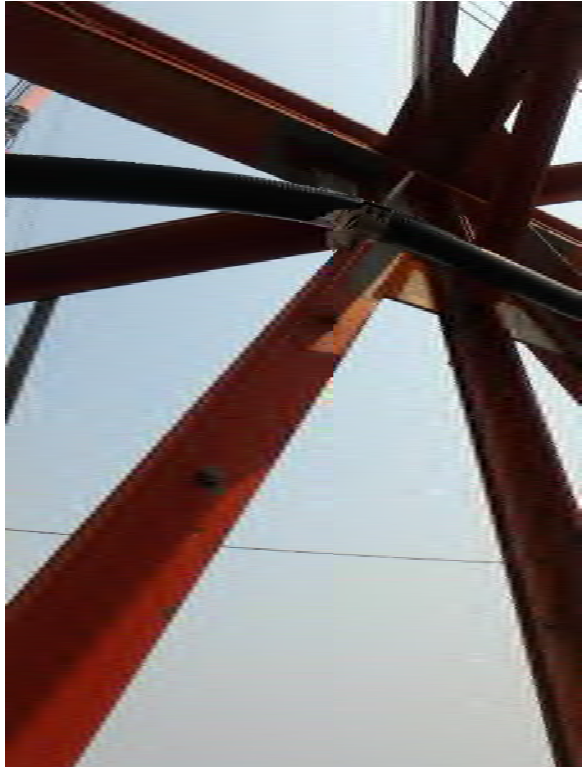
<p>LOCATION: South Truss Level 6, Panel 6.5-6.6</p> <p>CONCERN: Loose stitch bolt (x2); diag</p> <p>RECOMMENDED ACTION: Stitch bolts loosened to facilitate gusset reinforcement which was in progress during inspection; check and ensure stitch bolts are fully retightened</p> <p>ADDITIONAL COMMENTS: N/A</p>

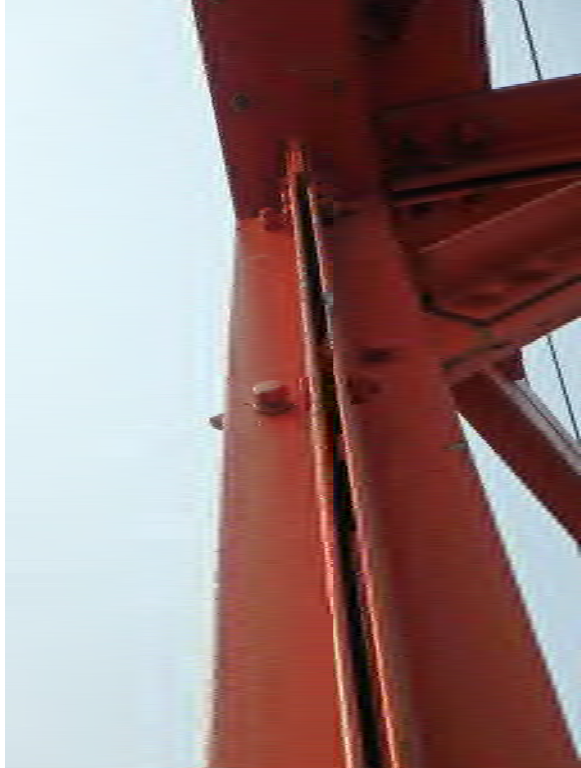
OBSERVATION 43:	LOCATION:

South Truss Level 6, Panel 6.24
	CONCERN:
	Loose bolt; wind brace
	RECOMMENDED ACTION:
	Retighten or replace bolt
	ADDITIONAL COMMENTS:
	N/A

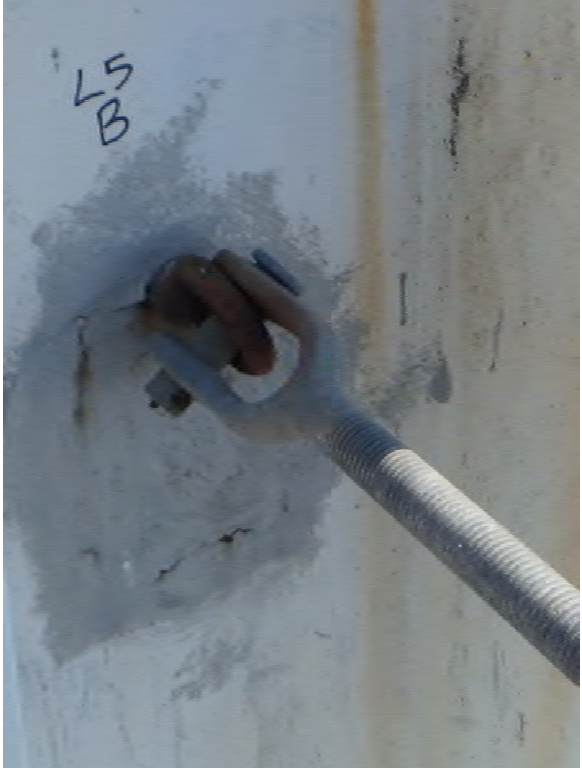
OBSERVATION 44:	LOCATION:

South Truss Level 5, A & B Leg
	CONCERN:
	Mild rust on HLL eye bolt
	RECOMMENDED ACTION:
	Surface prepare and treat IAW STI-SOP-0001
	ADDITIONAL COMMENTS:
	N/A
OBSERVATION 45:	LOCATION:
 	South Truss Level 5, Panel 5.6
	CONCERN:
	Minor rust; antenna mount bolts
	RECOMMENDED ACTION:
	Surface prepare and treat IAW STI-SOP-0001
	ADDITIONAL COMMENTS:
	N/A

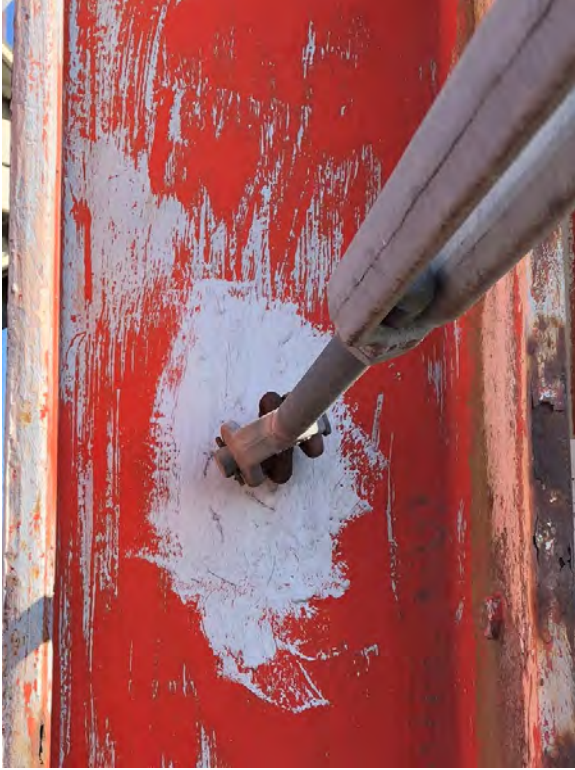
OBSERVATION 46:

South Truss Level 4, A & B Leg

Minor rust; antenna mount bolts

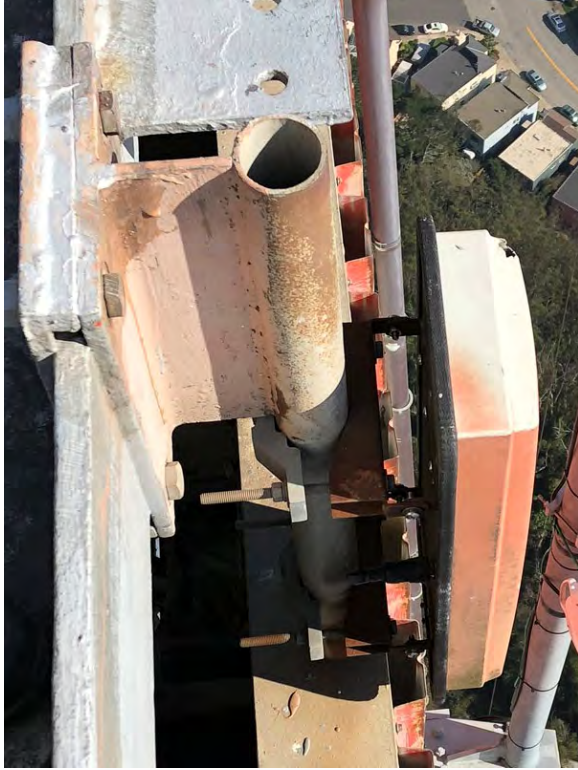
OBSERVATION 47:

South Truss Level 4, Panel 4.2-4.3

Minor rust; antenna mount bolts

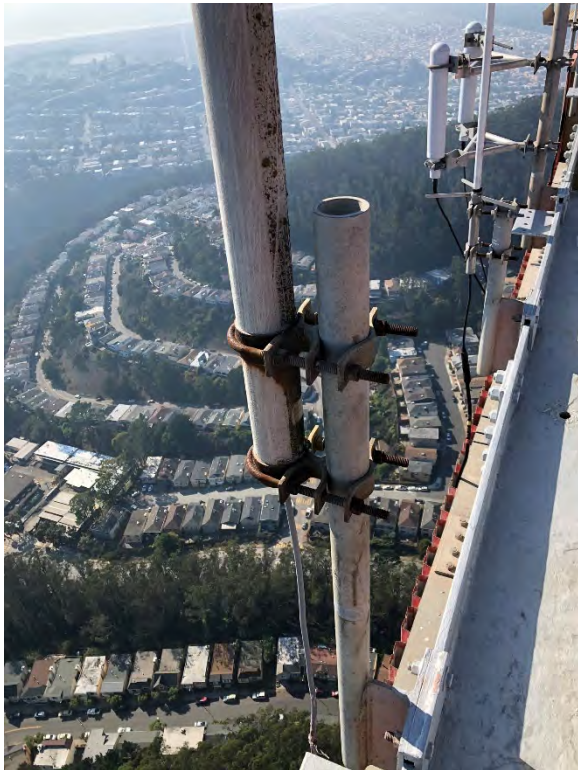
OBSERVATION 48:

Minor rust; antenna mount bolts

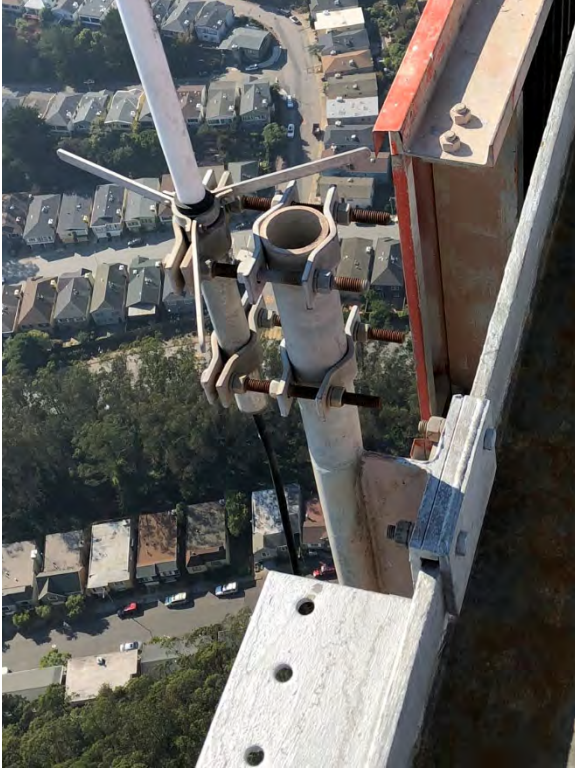
OBSERVATION 49:

Minor rust; antenna mount bolts

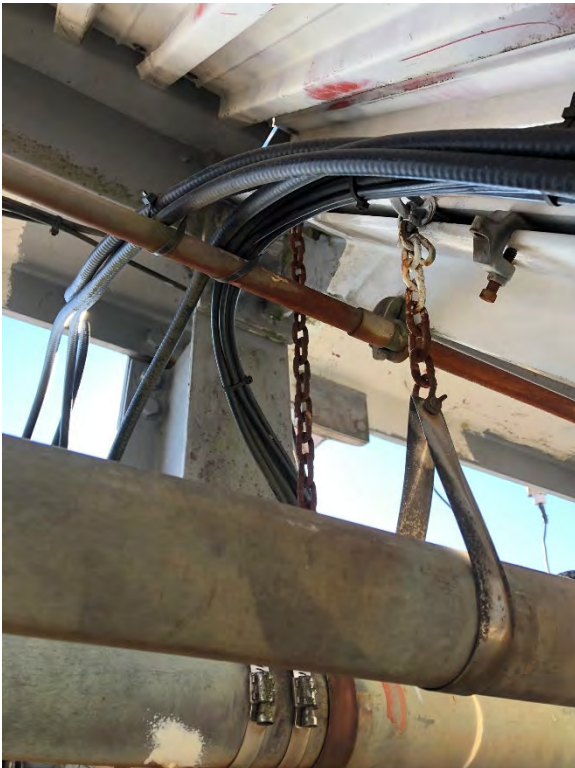
OBSERVATION 50:

Minor rust; rigid line chain supports & conduit

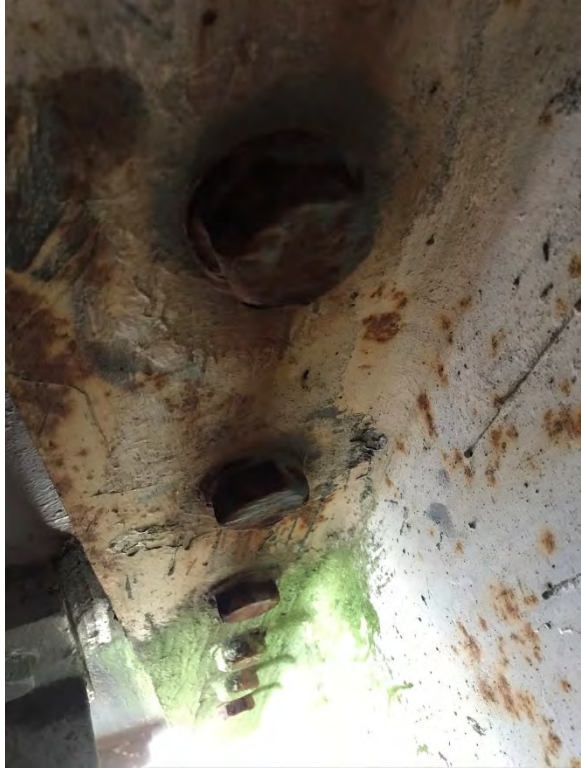
OBSERVATION 51:	LOCATION: South Truss Level 3, Panel 3.1

CONCERN: Moderate/severe rust on column bolts
	RECOMMENDED ACTION: Surface prepare bolts and replace if material loss exceeds limits set in the 2014 Bolt Replacement Criteria, Tables 5 & 6. If material loss is within acceptable tolerances, repair and coat IAW STI-SOP-0001.
	ADDITIONAL COMMENTS: N/A
OBSERVATION 52:	LOCATION: South Truss Level 3, Panel 3.2-3.3

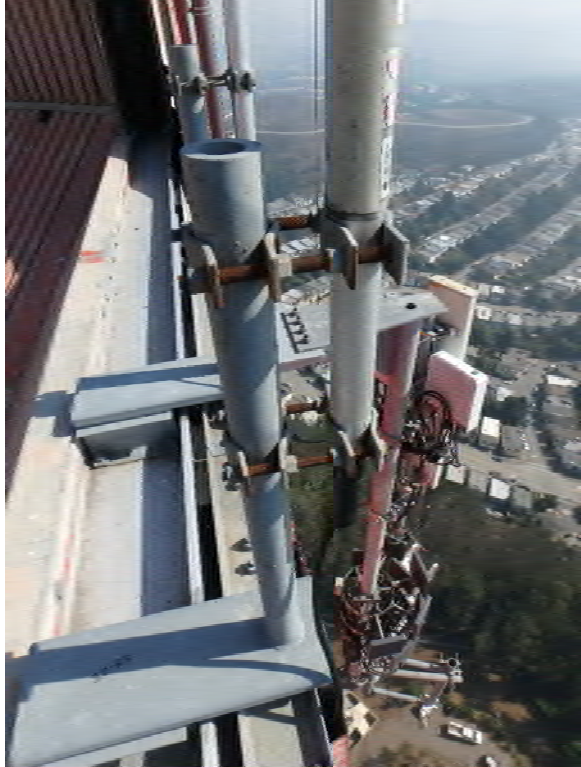
CONCERN: Minor rust; antenna mount bolts
	RECOMMENDED ACTION: Surface prepare and treat IAW STI-SOP-0001
	ADDITIONAL COMMENTS: N/A

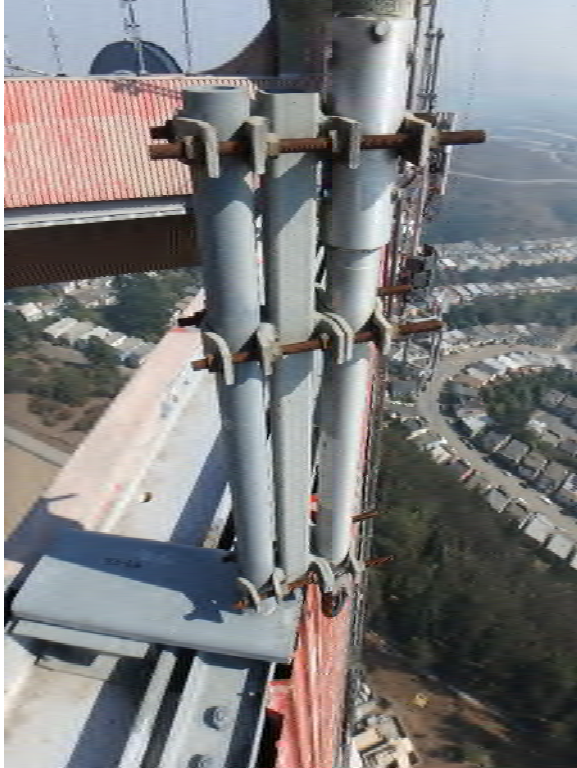
OBSERVATION 53:

Minor rust; antenna mount bolts
