FIELD INSPECTION REPORT

NE STACK C, NE LEG C & SOUTH TRUSS LEVELS 2-6

SEPTEMBER 1, 2021

ERI PROJECT 38470/38471
977 FT SELF-SUPPORT TOWER
SAN FRANCISCO, CA
ASRN 1001289

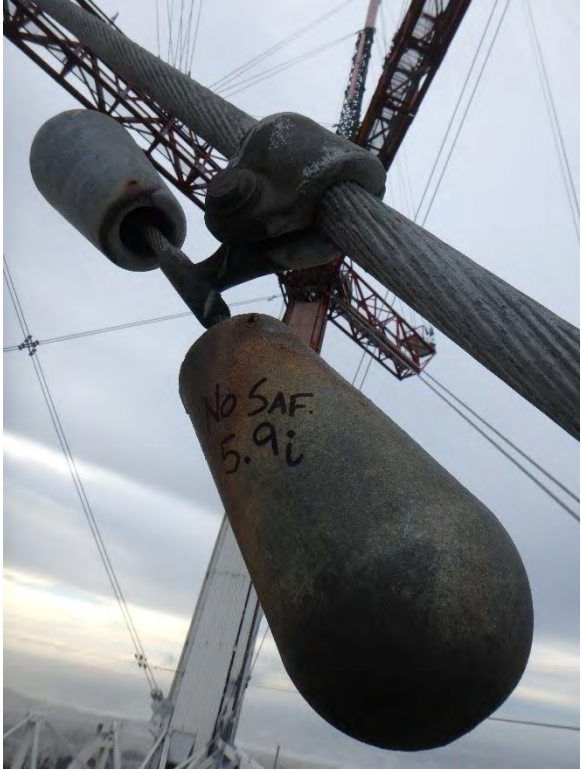
<p>OBSERVATION 54:</p>

<p>LOCATION: Column Strand Bracing</p> <p>CONCERN: Strand high frequency dampers throughout structure exhibit broken/degraded safeties, stiff/corroded damper cables, and/or missing components.</p> <p>RECOMMENDED ACTION: Replace high frequency strand dampers</p> <p>ADDITIONAL COMMENTS: N/A</p>
<p>OBSERVATION 55:</p>

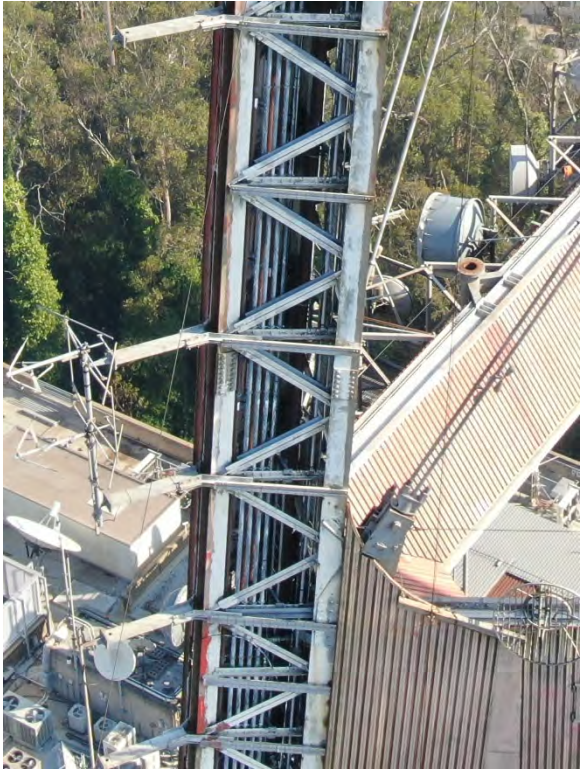
<p>LOCATION: Columns</p> <p>CONCERN: With cladding removed, flex transmission line supports should be evaluated to comply with minimum attachment intervals to prevent wind damage</p> <p>RECOMMENDED ACTION: Add line supports along with messenger conduits as needed to maintain adequate attachment intervals; unless otherwise noted by a specific line supplier, secure lines at maximum intervals of 3 feet to the supporting structure or messenger conduit</p> <p>ADDITIONAL COMMENTS: N/A</p>
