# FIELD INSPECTION REPORT

## SE STACK B, SE LEG B & EAST TRUSS LEVELS 2-6

### MARCH 8, 2019

ERI PROJECT 36434/A  
977 FT SELF-SUPPORT TOWER  
SAN FRANCISCO, CA  
ASRN 1001289

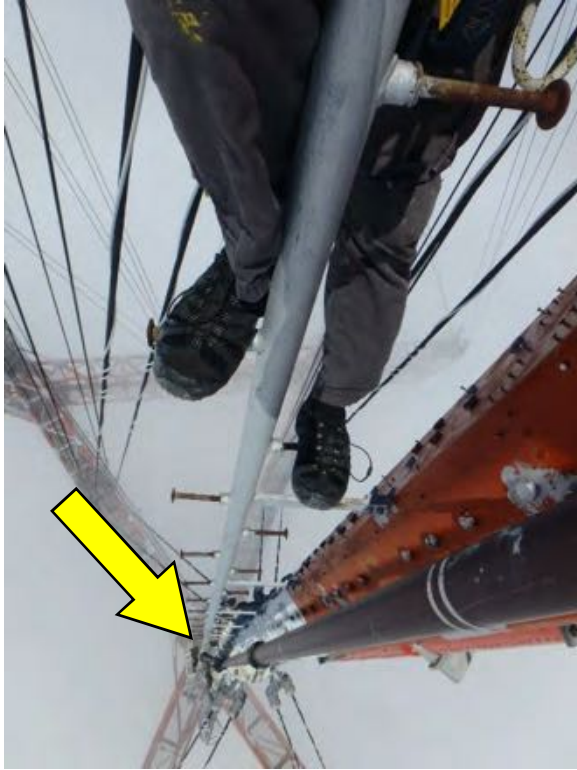
Picture 1: OBSERVATION 1

OBSERV. NO.	Location/Identification			Photo No.	<sup>2</sup> OBSERVATION COMMENTS	RECOMMENDED CORRECTIVE ACTION (CA)
	Column	Elevation	<sup>1</sup> Item			
1	N/A	6.22	O	1	Missing step bolt at base of climbing pole	Replace missing step bolt

*Missing Step Bolt Near Base at Climbing Pole*

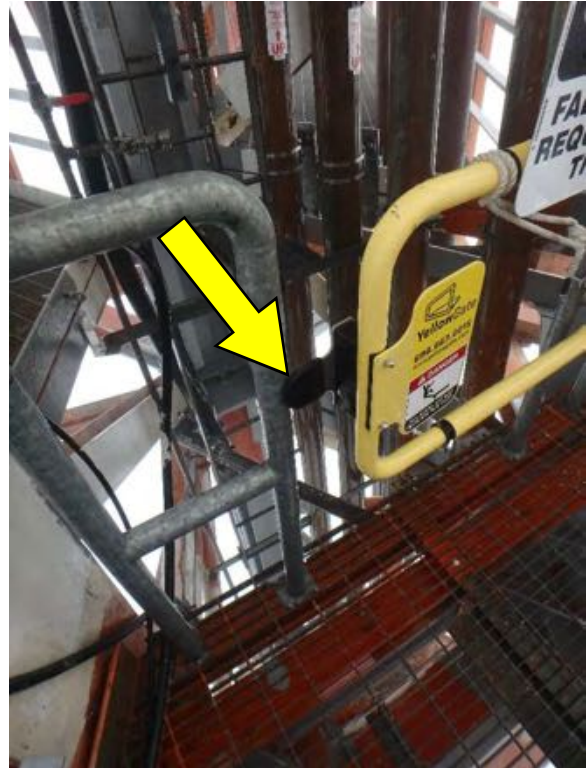
Picture 360: OBSERVATION 360

OBSERV. NO.	Location/Identification			Photo No.	<sup>3</sup> OBSERVATION COMMENTS	RECOMMENDED CORRECTIVE ACTION (CA)
	<sup>1</sup> Chord	Horiz. Location	<sup>2</sup> Item			
360	'C' LEG	'C' LEG	O	360	Safety gate does not properly latch closed	Adjust gate to ensure proper closure
363	---	6.18-6.19	O	363	Railing post out of out alignment with adjacent railing	Shim post at toe board attachment to re-align
365	---	6.9-6.10	O	365	Railing post out of out alignment with adjacent railing	Shim post at toe board attachment to re-align
367	'B' LEG	'B' LEG	O	367	Safety gate does not properly latch closed, and signage rotated upside down	Adjust gate to ensure proper closure, and rotate signage
371	---	6.23	O	371	Cut out opening in walkway flooring	Repair flooring with patch, or replace grating piece
372	---	6.23	O	372	Top safety cable bracket cocked to side due to interference with the horiz lifeline	Recommend installing shorter top safety bracket, or consider removing this short safety cable run and require use of standard PPE y-lanyards in place of safety sleeve to maintain 100% tie-off when using ladder

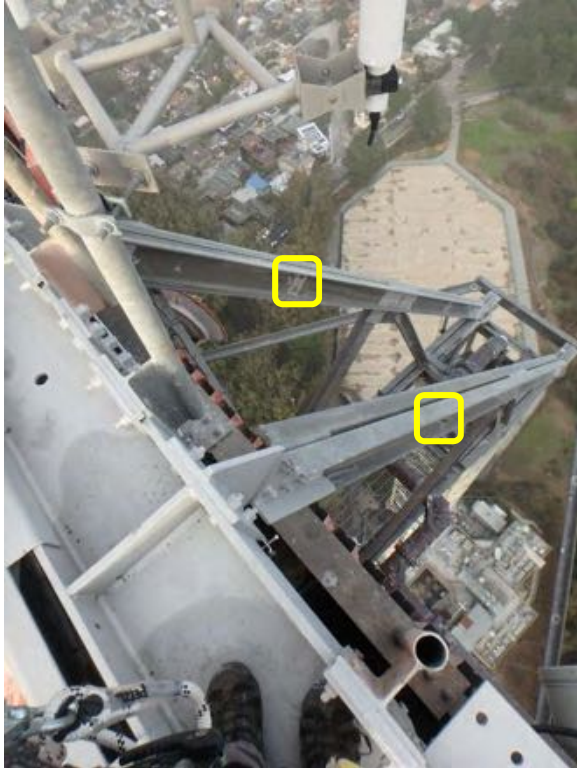
Picture 437: OBSERVATION 437

*Minor Rust on Multiple Bolts Throughout Mount*

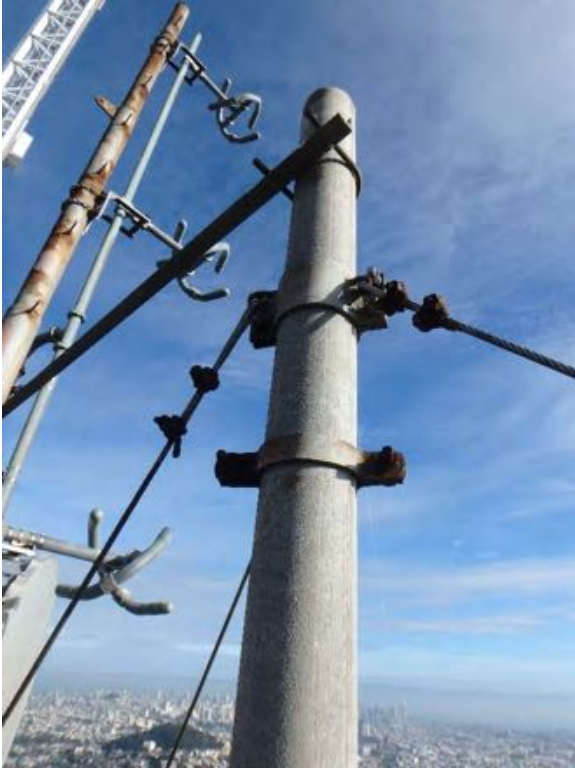
Picture 473: OBSERVATION 473

*Minor Rust on Multiple Bolts Throughout Mount*

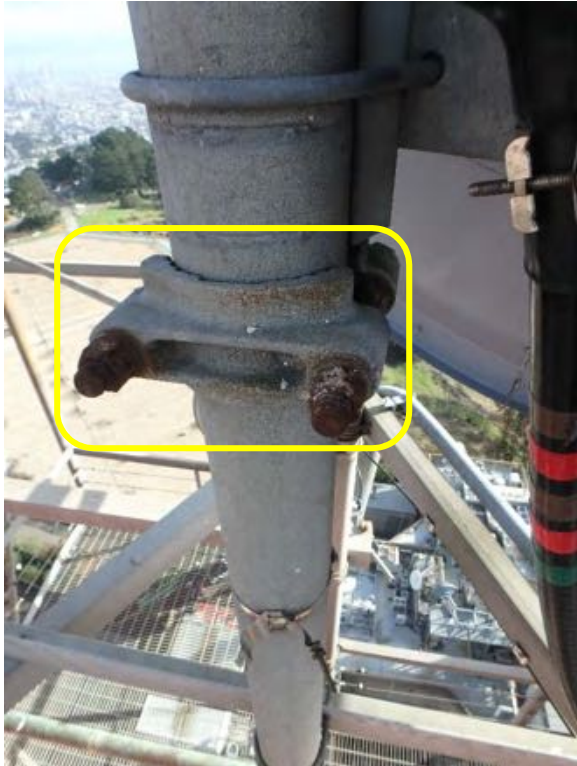
Picture 479: OBSERVATION 479

*Minor Rust on Multiple Bolts Throughout Mount*

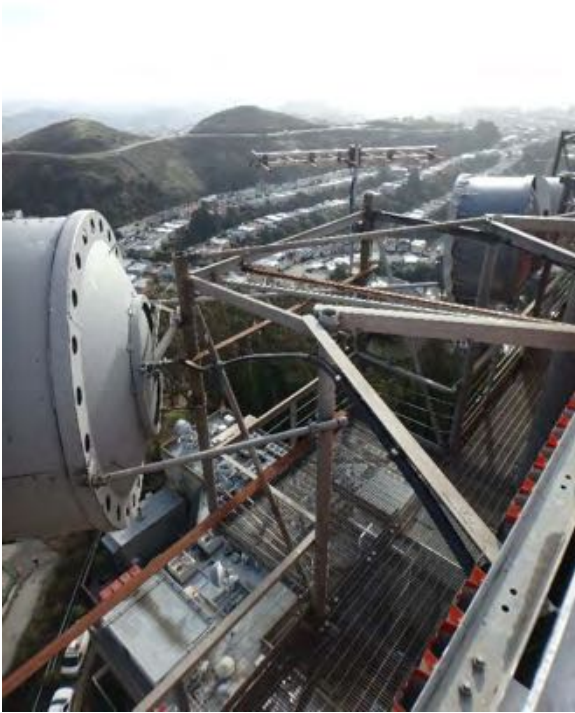
Picture 489: OBSERVATION 489

*Minor Rust Throughout Mounts*
