FIELD INSPECTION REPORT

WEST STACK A & NORTH TRUSS (LEVEL 6)

APRIL 13, 2018

ERI PROJECT 35473, ADDENDUM 1
977 FT SELF-SUPPORT TOWER
SAN FRANCISCO, CA
ASRN 1001289

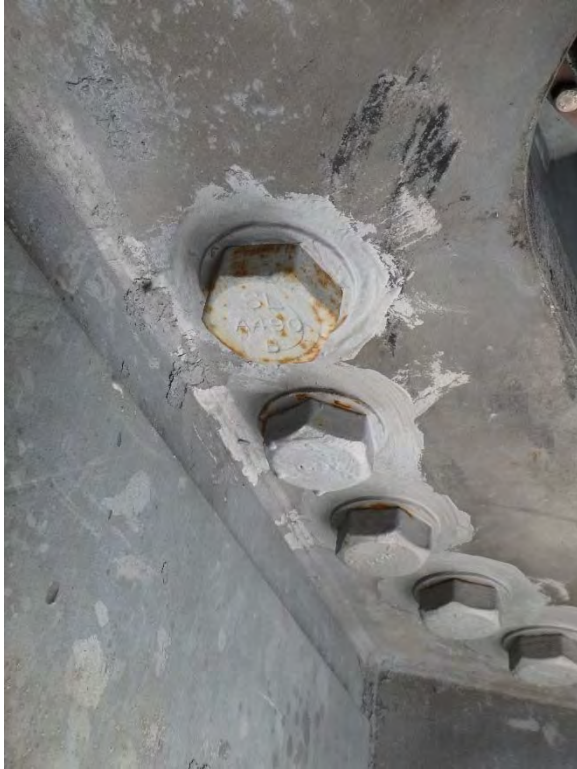
Picture 1: OBSERVATION 1

WEST STACK 'A' LATTICE MAST						
OBSERV. NO.	Location/Identification			Photo No.	OBSERVATION COMMENTS	RECOMMENDED CORRECTIVE ACTION (CA)
	Column	Elevation	Item			
1	A11	6.40	C	1	Minor Rust On Bolts, MRB (X6), Antenna Bolts	Surface prepare and treat
2	A2	6.40	H	2	Minor Rust On Inner Channel	Surface prepare and treat
3	A3	6.36	C	3	Short Bolt, SB (X1), ANCO Pin Not Fully Engaged, Leg Bolt	Replace with longer bolts, or remove flat washer to allow full engagement of ANCO locking pin
4	A2	6.36	C	4	SB (X2), ANCO Pin Not Fully Engaged, Leg Bolt	Replace with longer bolts, or remove flat washer to allow full engagement of ANCO locking pin
5	Z-FACE	6.36	C	5	Small Gouge In Gusset Plate (X1)	Lightly grind surface smooth and treat
6	(Inside)	6.34	O	6	J-Box Missing Plugs (X2)	Install missing plugs to keep weather-tight
7	Z-FACE	6.34	C	7	Hot Dip Galv, HDG, Coating Damaged (X2), Gusset Plate	Surface prepare and treat

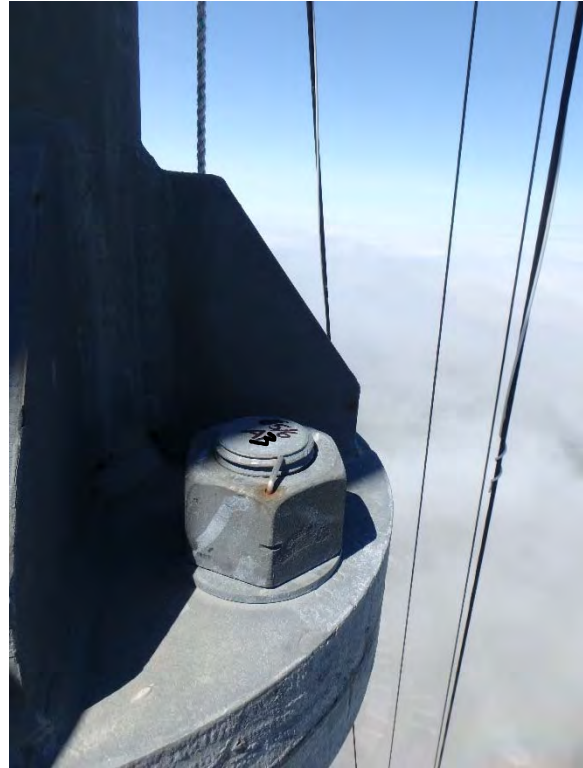
Picture 8: OBSERVATION 8

8	A3	6.32	C	8	SB (X1), ANCO Pin Not Fully Engaged, Leg Bolt	Replace with longer bolts, or remove flat washer to allow full engagement of ANCO locking pin
9	X-FACE	6.30	C	9	MRB (X2), Horiz Bolts	Surface prepare and treat
10	Y-FACE	6.30	C	10	MRB (X1), Diag Bolt	Surface prepare and treat
11	A1	6.24	C	11	SB (X2), ANCO Pin Not Fully Engaged, Leg Bolt	Replace with longer bolts, or remove flat washer to allow full engagement of ANCO locking pin
12	Y-FACE	6.22	C	12	MRB (X1), Diag Bolt	Surface prepare and treat
13	Y-FACE	6.20	C	13	MRB (X1), Diag Bolt	Surface prepare and treat
14	(Inside)	6.20	O	14	Minor Rust On J-Box Plugs (X2)	Replace plugs in near future
15	X-FACE	6.20	C	15-16	HDG Coating Damaged (X2), Gusset Plate	Surface prepare and treat
16	A2	6.16	C	17	SB (X2), ANCO Pin Not Fully Engaged, Leg Bolt	Replace with longer bolts, or remove flat washer to allow full engagement of ANCO locking pin
17	Y-FACE	6.16	O	18	Missing Rigid Line Spring Hanger (X1)	Corrected By Sutro Staff ~ Hanger installed 8/22/17

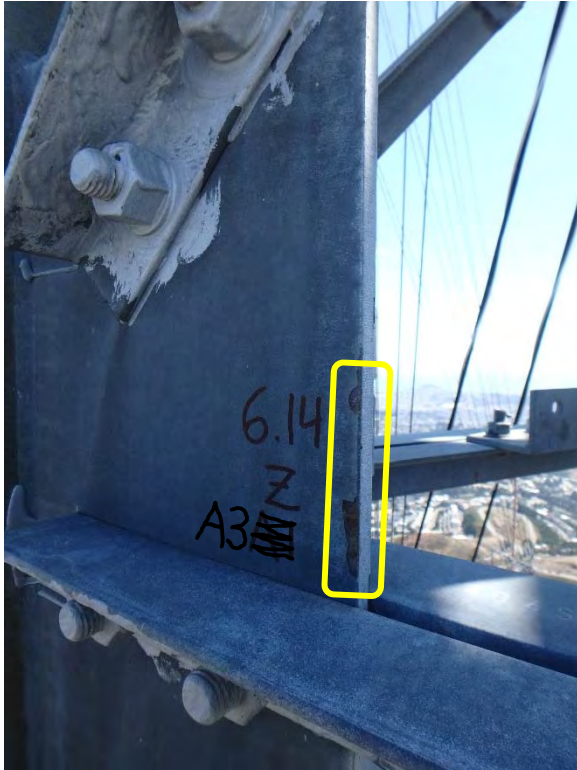
Picture 19: OBSERVATION 18

18	Z-FACE	6.14	C	19	HDG Coating Damaged (X2), Gusset Plate	Surface prepare and treat
19	X-FACE	6.6	C	20	HDG Coating Damaged (X1), Gusset Plate	Surface prepare and treat
20	Y-FACE	6.6	O	21-22	Rigid Line Spring Hanger Setting Off (X1)	Adjust hanger setting (34-3/8" at 40-80deg F)
21	(Inside)	6.2	O	23	SO J-Box Connector Broken (X1)	Replace connector
22	(Inside)	6	O	24	Minor Rust On 90° J-Box Connector	Replace connector in near future
23	Y-FACE	6	O	25	Standing Water In Gusseted Rigging Weldment	Drill drainage holes

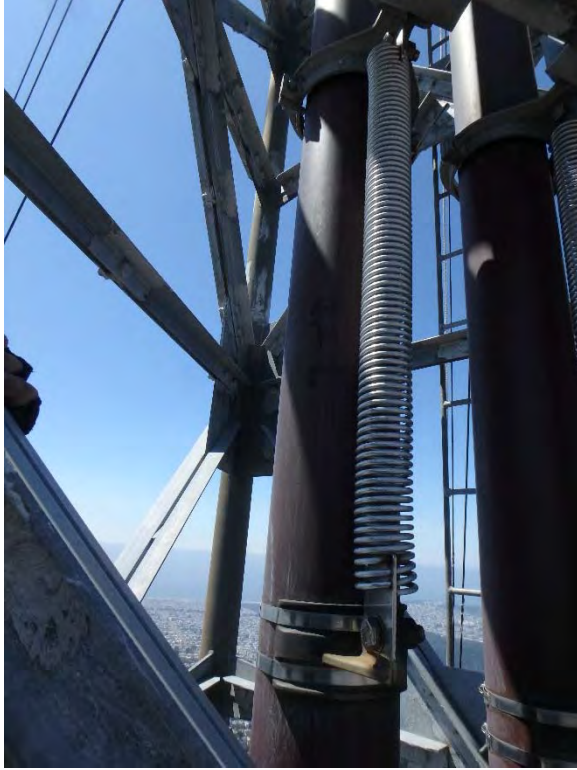
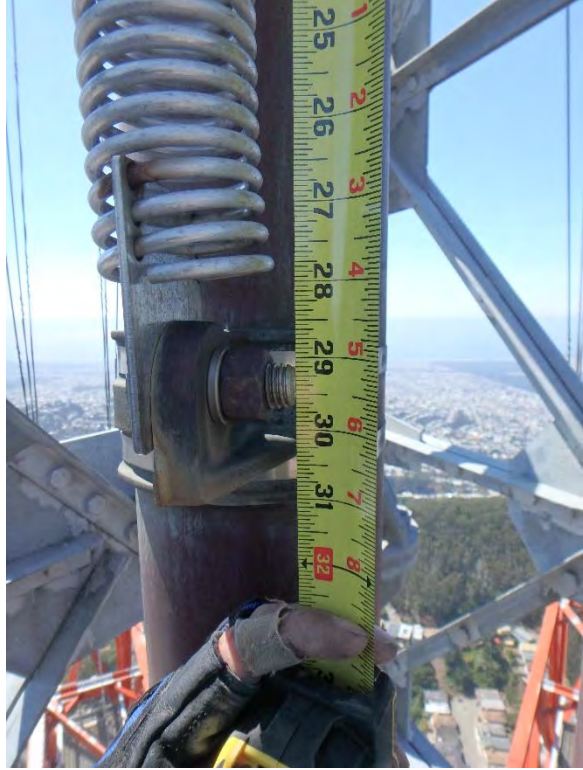
Picture 21: OBSERVATION 20

Picture 22: OBSERVATION 20

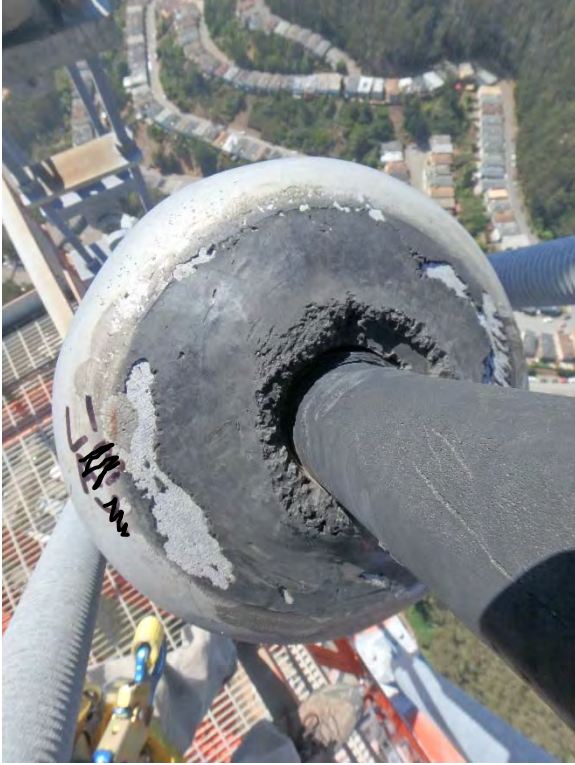
Picture 26: OBSERVATION 24 (TYP. ANCHOR END)

WEST STACK 'A' GUYING SYSTEM						
OBSERV. NO.	Location/Identification			Photo No.	OBSERVATION COMMENTS	RECOMMENDED CORRECTIVE ACTION (CA)
	Chord	Horiz. Location	Item			
24	Guying	All	O	26-27	Silicone Sealant At Socketed Corona Ends Has Split And Separated From The Cable And Socket At Most Locations Both At The Mast And Anchor Attachment Locations ~ No Damage Noted To Polyurethane Jackets Or Poured Resin	Remove loose silicone and debris and inject fresh pure black silicone ~ High quality pure black silicone from a local paint distributor may be used
25	Guying	All	O	-	Mild High Frequency Aeolian Vibration Noted On Multiple Cables During Inspection	Consider installing additional PLP spiral vibration dampers (SVD) to mitigate vibration ~ Recommend trial installation on single cable to compare with adjacent cable(s) prior to placing large order for SVD's to ensure adequate mitigation ~ Note, per discussion with Phillystran, high frequency aeolian vibration is not a structural concern for the Phillystran guying systems, but rather a general concern primarily for supported structures utilizing incandescent lighting where operational issues may arise from premature wear on filaments and electrical contact points imposed by the induced vibrations

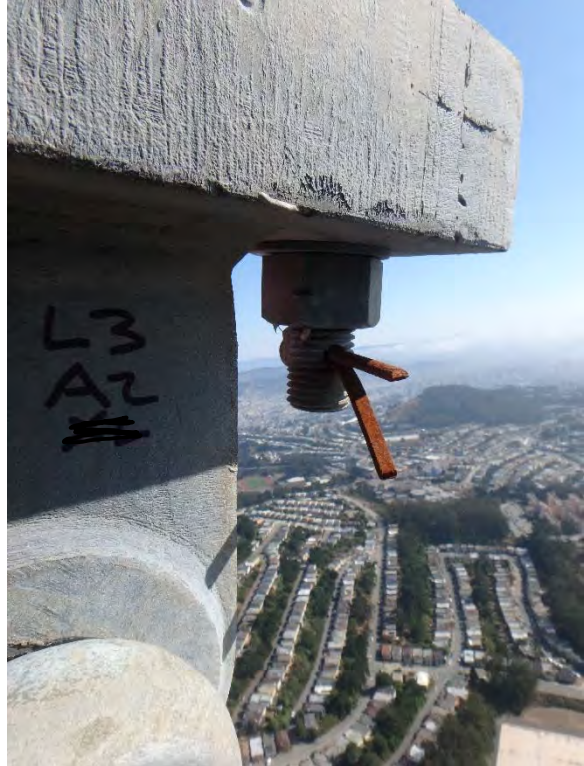
Picture 29: OBSERVATION 26

26	Guying	L1-L3, A2, YL & YR	O	28-29	Minor Rust On All-Thread Cotter Pins (x12)	Replace cotter pins in near future
27	Guying	L3, A1, X	O	30	Top Lock Nuts Not Tightened Down	Run down and tighten top lock nuts
28	Guying	L3, A2, YL	O	31	All-Thread Out By ~1/2"	Adjust all-thread to balance load
29	Guying	L3, A2, YR	O	31	All-Thread Out By ~1/4"	Adjust all-thread to balance load
30	Guying	L2, A3, YR	O	31	All-Thread Out By ~1/4"	Adjust all-thread to balance load
31	Guying	L1, A2, X	O	31	All-Thread Out By ~1/4"	Adjust all-thread to balance load
32	Guying	L2, A2, X	O	31	All-Thread Out By ~1/2"	Adjust all-thread to balance load
33	Guying	L3, A2, X	O	31	All-Thread Out By ~1/4"	Adjust all-thread to balance load
34	Guying	L3, A3, Z	O	31	All-Thread Out By ~1/2"	Adjust all-thread to balance load
35	Guying	L3, A1, Z	O	31	All-Thread Out By ~1/4"	Adjust all-thread to balance load

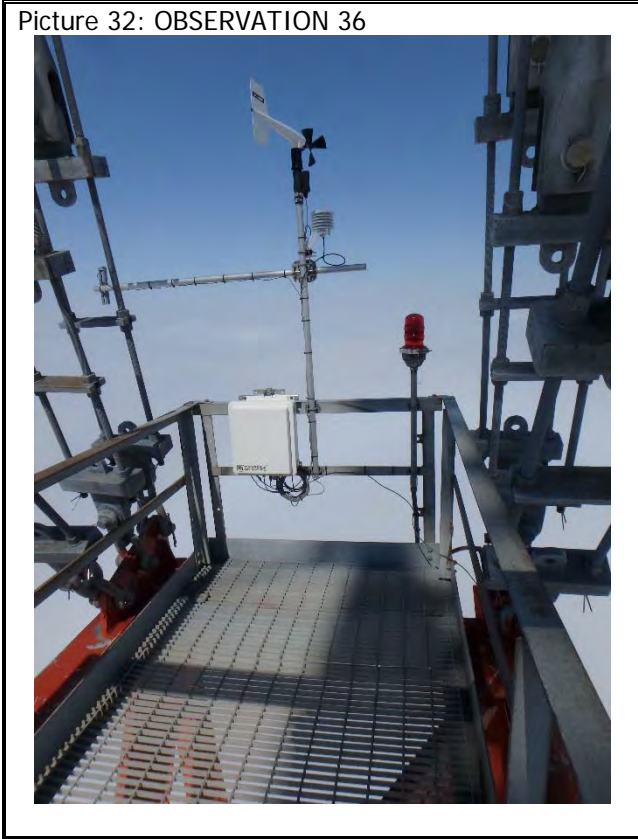
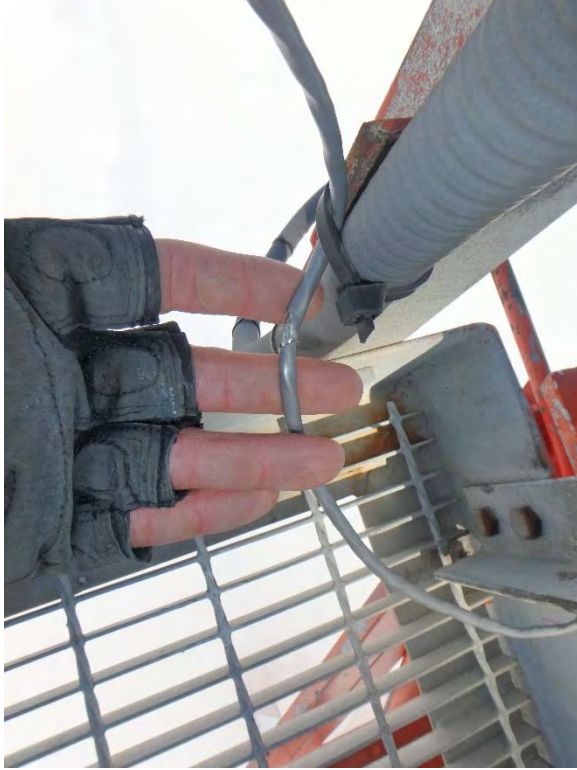
NORTH TRUSS (LEVEL 6)						
OBSERV. NO.	Location/Identification			Photo No.	OBSERVATION COMMENTS	RECOMMENDED CORRECTIVE ACTION (CA)
	Chord	Horiz. Location	Item			
36	IU	NW Outrigger	O	32-33	Damaged Cable, Apparrent Bird Damage	Consider running cable in flexible conduit to protect ~ Replace cable as needed
37	IU	6.3	C	34-35	MRB (X5), Leg & Diag Bolts	Surface prepare and treat
38	OU	6.3	C	36	MRB (X1), Leg Bolt	Surface prepare and treat
39	OL	6.10	C	37-38	MRB (X1), Leg Bolt	Surface prepare and treat
40	O	6.12	C	39-40	Loose Stitch Bolt Near Midspan, Leg	Properly drive stitch bolt and tighten
41	IU	6.12-6.13	D	41	Damaged Angle Reinforced Using Bolt-On Brace, Wind Brace	Issue previously assessed by EOR and deemed acceptable
42	IL	6.13	C	42-43	Loose Stitch Bolt Near Outer Leg, Wind Brace	Properly drive stitch bolt and tighten
43	IL	6.18-6.21	C	44-45	MRB (X4), Diag Bolts	Surface prepare and treat
44	IL	6.19	V/H	46-47	Minor Rust At Leg To Wind Brace Horiz Joint	Surface prepare and treat

Picture 32: OBSERVATION 36

Picture 33: OBSERVATION 36

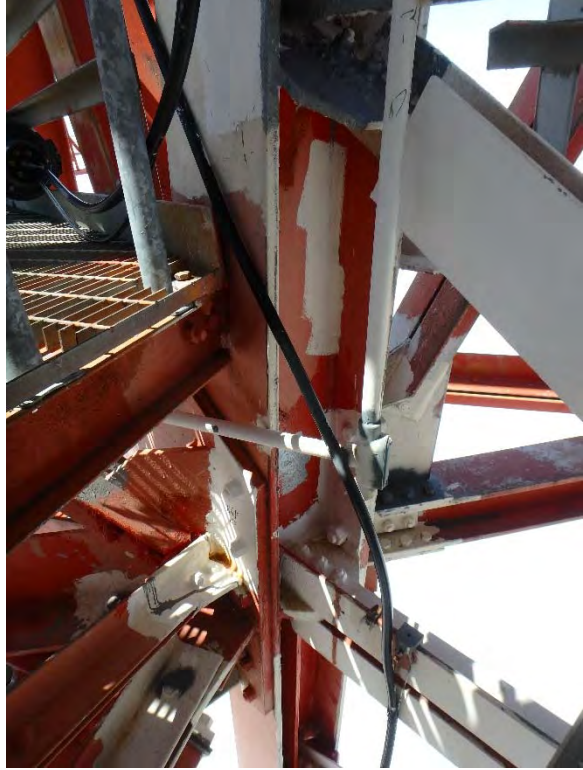
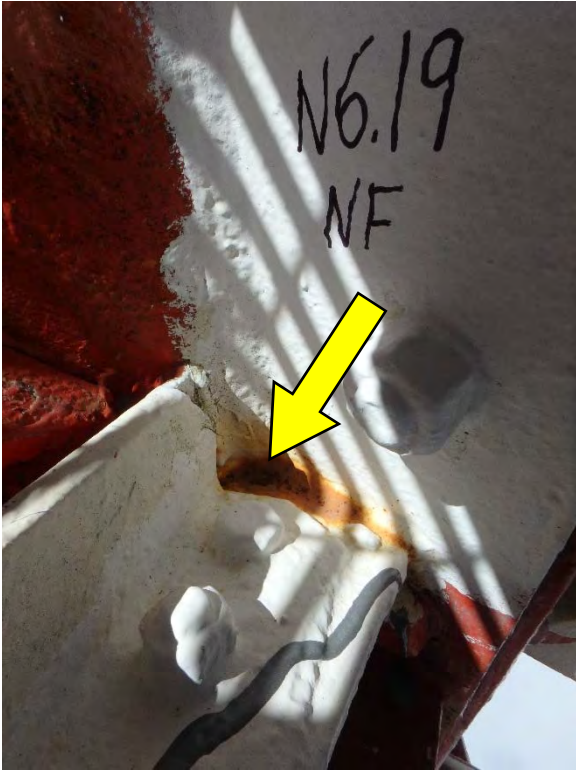
Picture 46: OBSERVATION 44

Picture 47: OBSERVATION 44

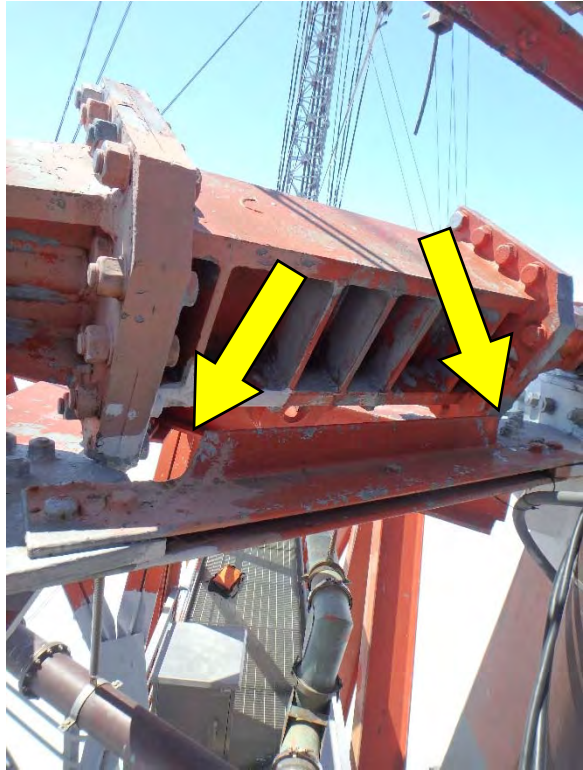
Picture 48: OBSERVATION 45

Additionally, pre-existing member damage was identified in three specific locations which should be further evaluated by Simpson Gumpertz & Heger Inc. serving as the structure’s engineer of record (EOR) to determine if corrective action measures are warranted (see Observations 45, 52, & 53 in Appendix II).

45	IU	6.19-6.21	O	48	Wind Brace Angle Legs Torch Cut To Facilitate Rigging Weldment	Contact EOR to determine if any CA is warranted
46	I	6.21	V/D	49-50	Leg To Diag Joint Holding Water	Clear drain hole or re-drill to allow positive drainage
47	OU	6.21	C	51-52	MRB (X1), Horiz Bolt	Surface prepare and treat
48	I	6.21	V/H	53-54	Minor Rust At Leg To Horizontal Joint	Surface prepare and treat
49	I	6.21	C	55-56	MRB (X6), Horiz Bolts	Surface prepare and treat
50	I	6.21	V/D	57-58	Leg To Diag Joint Holding Water	Clear drain hole or re-drill to allow positive drainage
51	I	6.21	V	59	HDG Coating Damaged, Leg	Surface prepare and treat
52	O	6.23	V	60	Bent Angle Leg Near Midspan Stitch Bolt, Leg	Contact EOR to determine if any CA is warranted
53	OU	6.25-6.26	D	61	Bent Angle Leg, Upper End, Diag	Contact EOR to determine if any CA is warranted
54	IL	6.26	O	62	Moderate/Severe Corrosion On Top Guard Rail	Repair or replace guard rail in near future

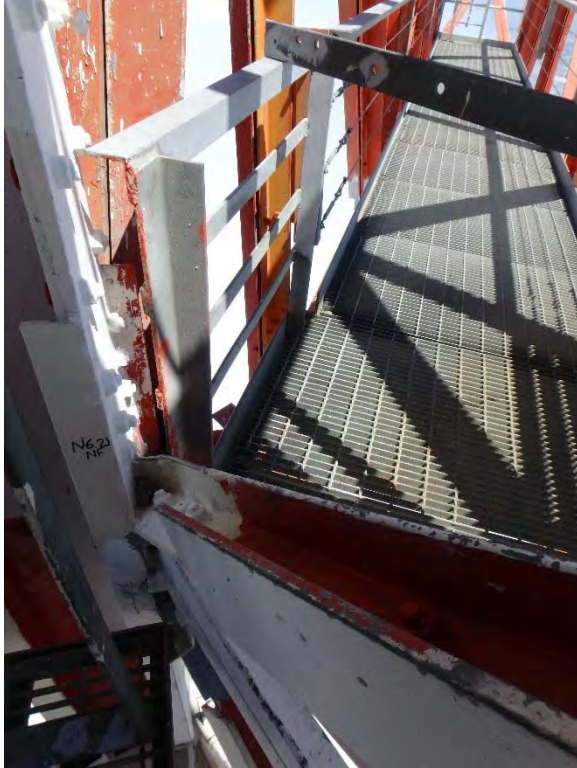
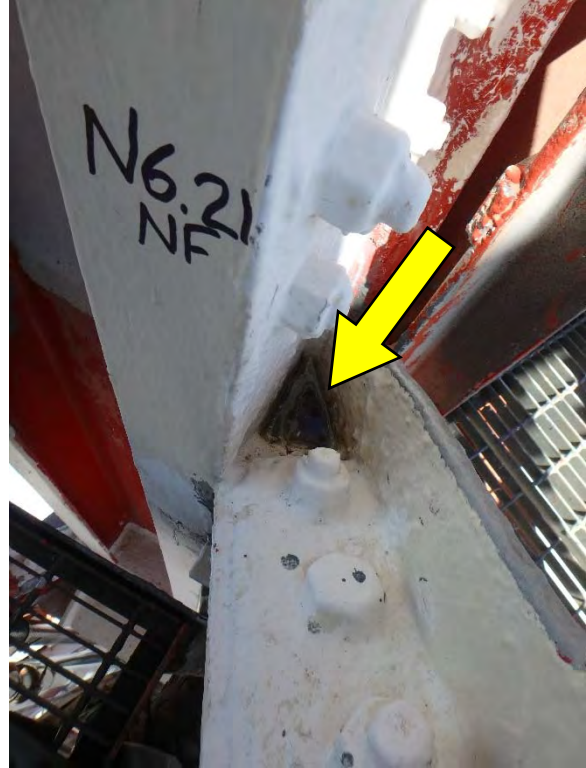
Picture 49: OBSERVATION 46

Picture 50: OBSERVATION 46

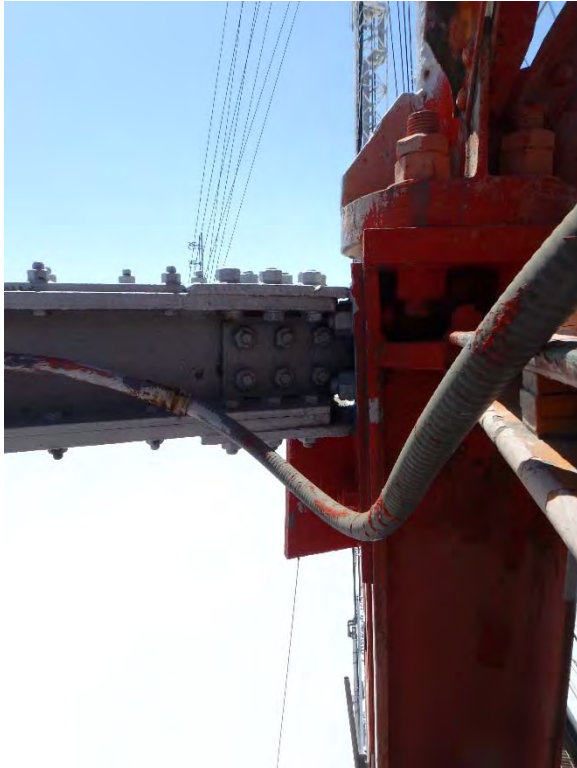
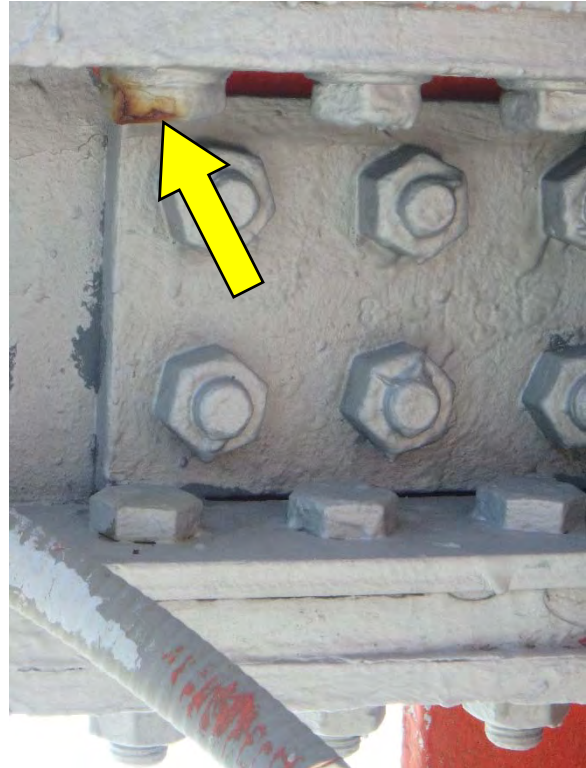
Picture 51: OBSERVATION 47

Picture 52: OBSERVATION 47

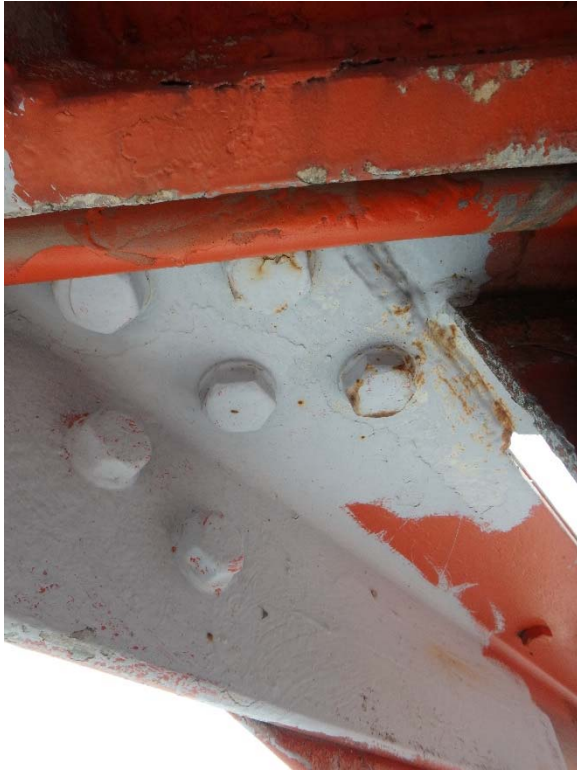
Picture 63: OBSERVATION 55

55	IU	6.27	C	63	MRB (X2), Horiz Bolts	Surface prepare and treat
56	IU	6.27	C	64-66	MRB (X3), Wind Bracing Bolts	Surface prepare and treat
