POST-MAINTENANCE INSPECTION REPORT

(SE STACK B, SE LEG B & E TRUSS LEVELS 2-6)

SEPTEMBER 29, 2021

ERI PROJECT 36434/A
SUTRO TOWER
977 FT SELF-SUPPORT TOWER
SAN FRANCISCO, CA
ASRN 1001289

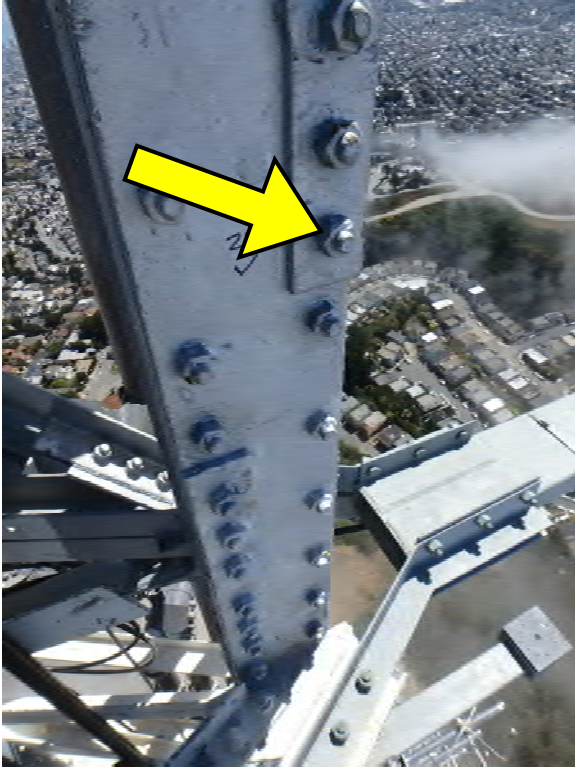
ITEM 1: OBSERV. NO. 23

Column Ba, Level 5.3-5.4, Conn.

Loose bolt in column

Bolt properly tightened

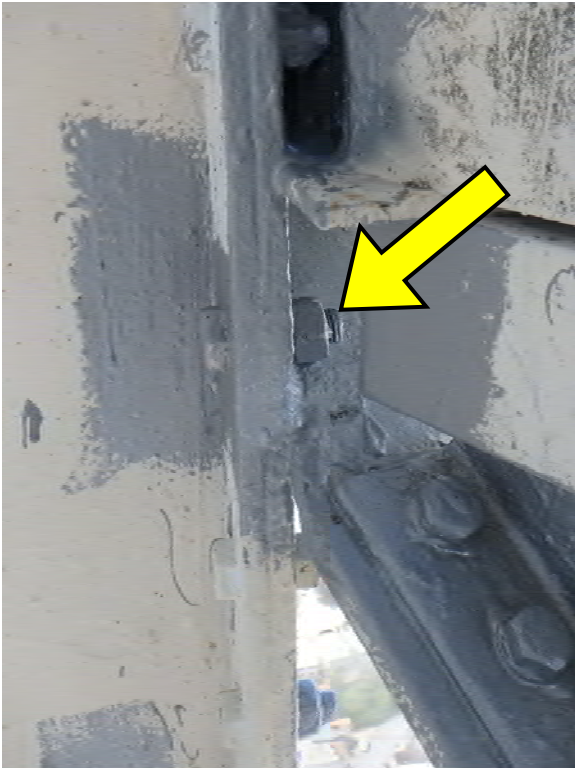
ITEM 2: OBSERV. NO. 34

Column Bb, Level 5.0, Conn.

Loose bolt in column

Bolt properly tightened

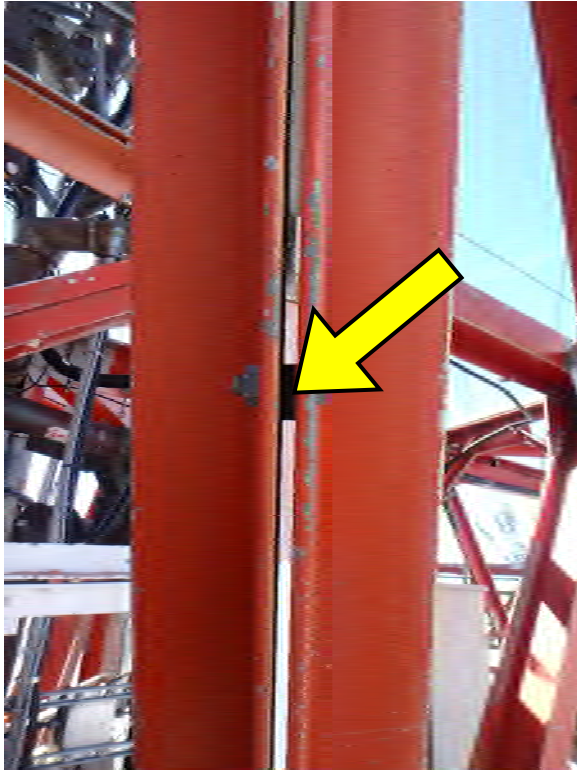
ITEM 3: OBSERV. NO. 353

E Truss Level 6, Outer Chord, 6.5-6.6, Connection

Diag stitch bolt spacer plate too thin

Spacer plate replaced

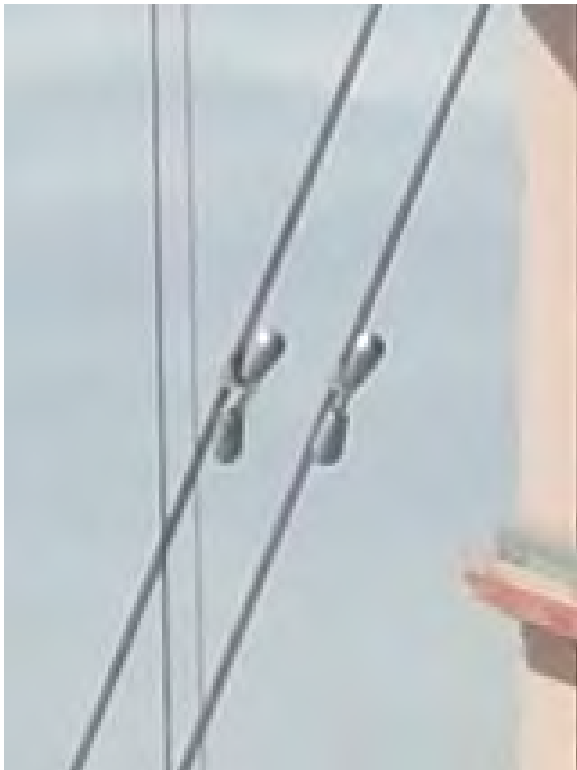
ITEM 4: OBSERV. NO. 518

Strands

Strand high frequency dampers are in poor condition throughout structure (numerous broken/degraded safeties, stiff/corroded damper cables, missing dampers, etc.)

High frequency dampers replaced
