POST-MAINTENANCE INSPECTION REPORT (W STACK A, W LEG A & N TRUSS LEVELS 2-6)

SEPTEMBER 29, 2021

ERI PROJECT 35473/A
SUTRO TOWER
977 FT SELF-SUPPORT TOWER
SAN FRANCISCO, CA
ASRN 1001289

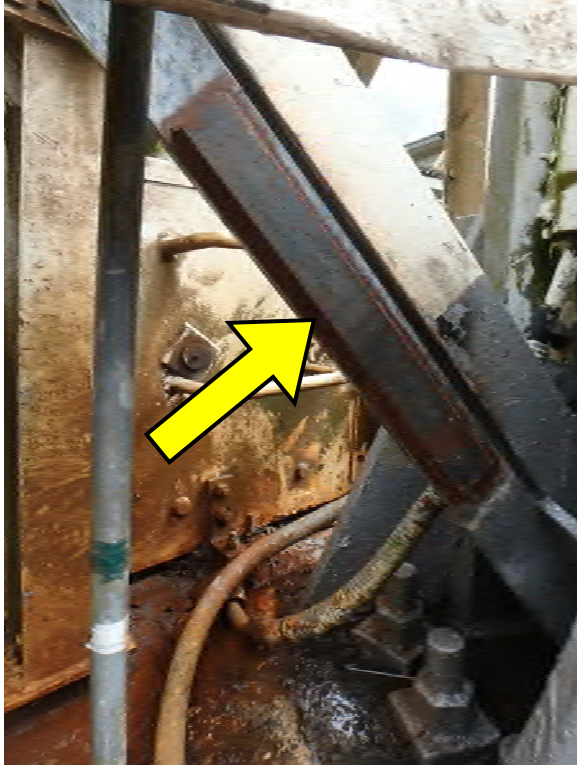
ITEM 1: OBSERV. NO. 60

W Leg A, Y-Face, Level 1.0-1.1

Damaged/bent angle leg on diagonal

Reinforcement bar welded over damaged angle leg

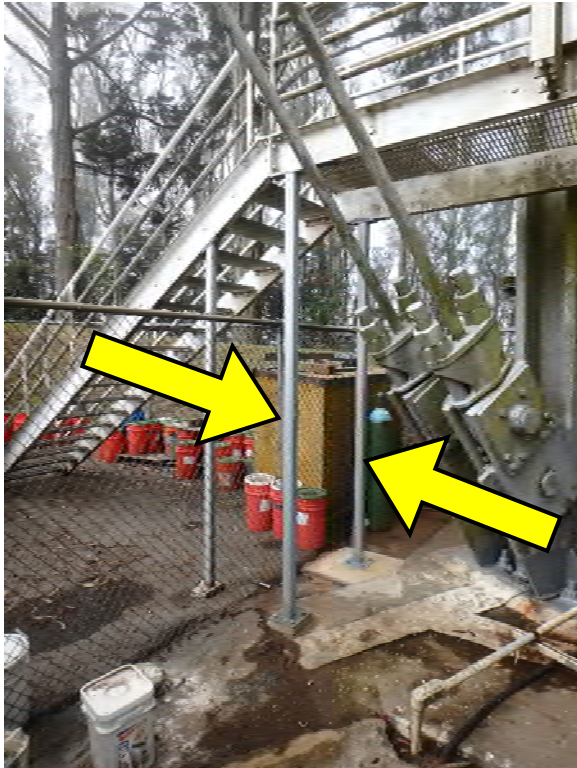
ITEM 2: OBSERV. NO. 140

Leg A Base Staircase

The existing staircase leading to the Leg A base access is not properly supported, and one of the supporting posts is not adequately anchored to the ground

Two new posts installed
