January 9, 2017

Sutro Tower, Inc.  
1 La Avanzada Street  
San Francisco, CA 94131-1124

Re: Review of Annual Maintenance  
977-ft Self-Support Tower  
San Francisco, California  
TCI Project Number 16.082.001

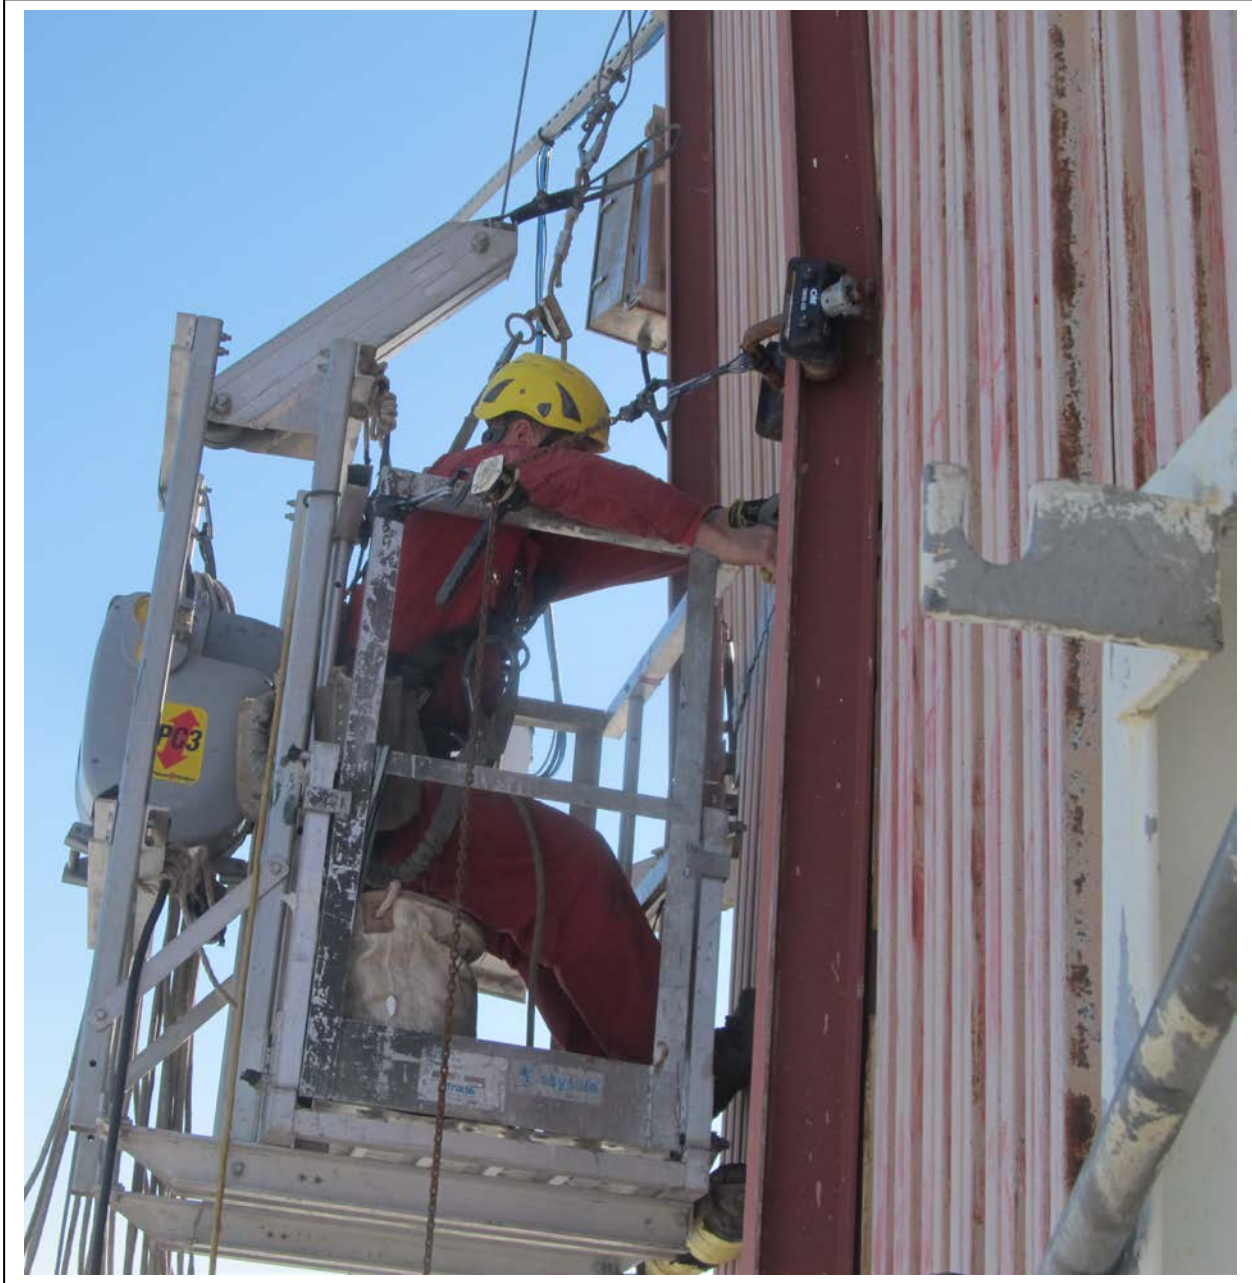
**Photo No. 2**

Photo No. 2 shows maintenance work performed on leg C.

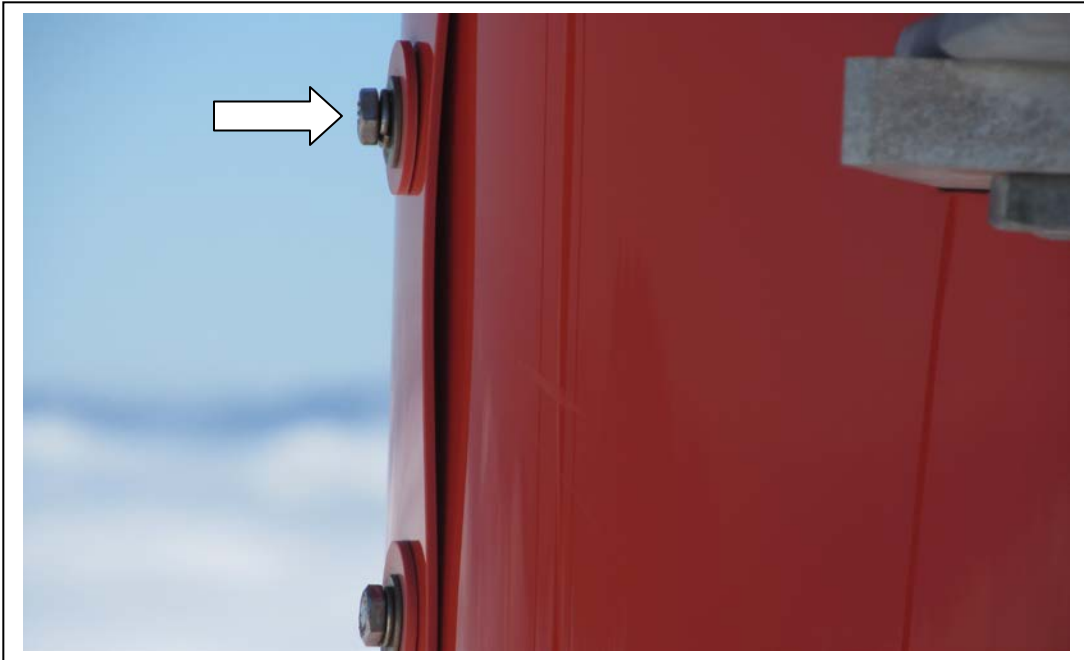
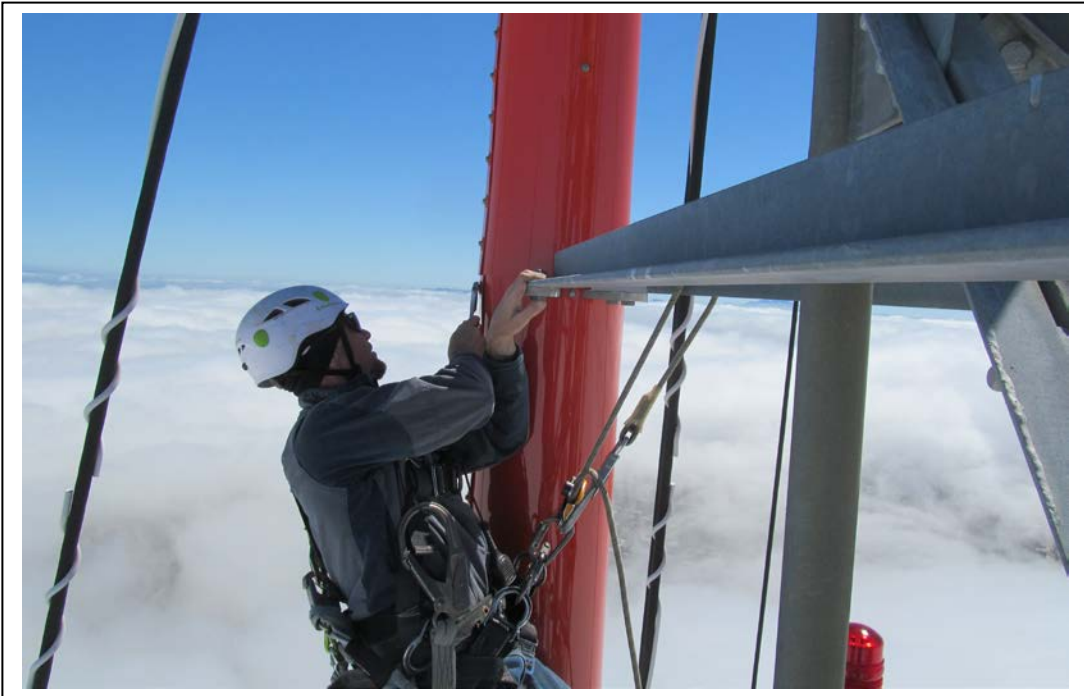
Photo Nos. 3 and 4 show the side mounted TV antenna on stack C before and after radome bolt tightening.

1. Address all issues found during the 2016 annual inspection at level 6 and stack C. All loose radome bolts for the side mounted TV antenna on stack C were properly tightened (Photo Nos. 3 and 4). A top skin support horizontal member on leg A was replaced with new stronger member (Photo Nos. 5 and 6).

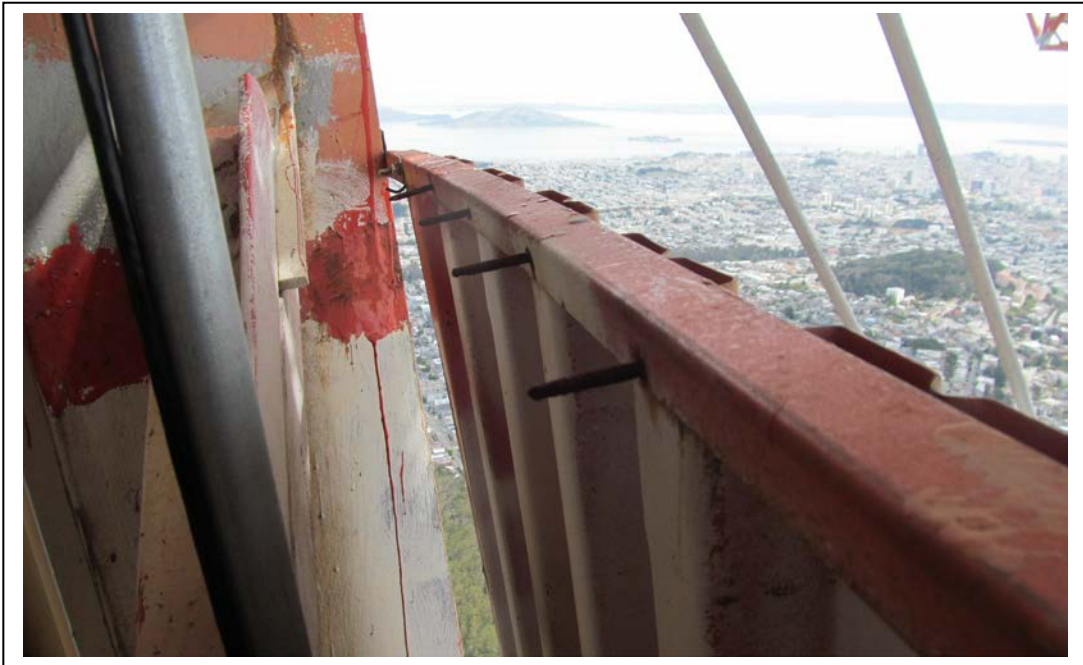
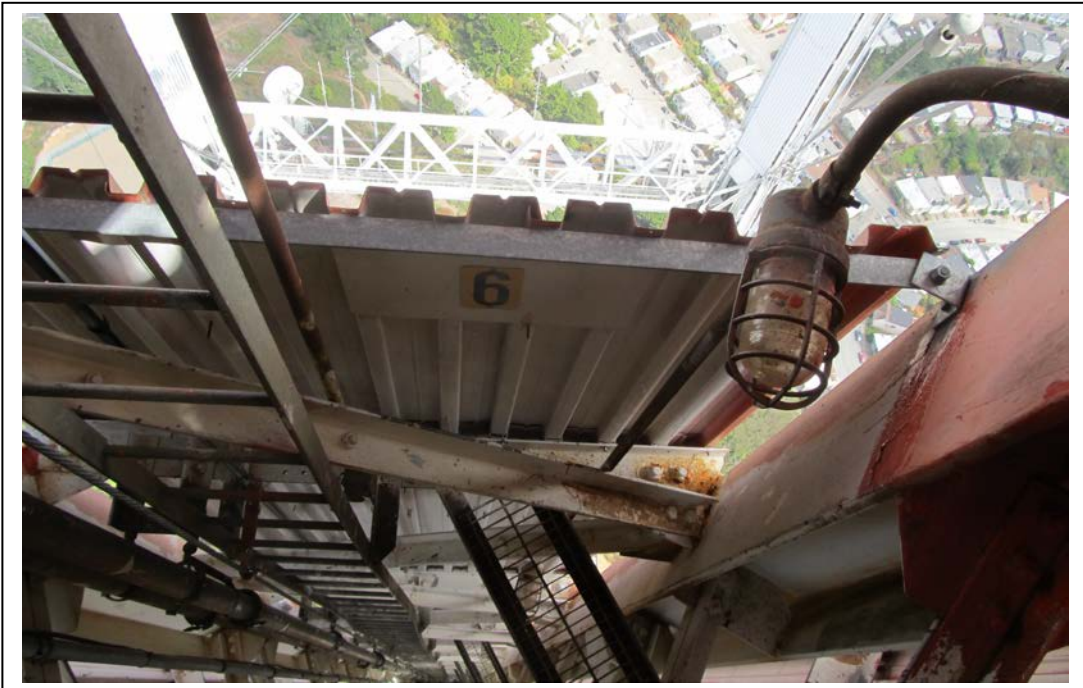
Photo Nos. 5 and 6 show the new skin support horizontal just below level 6 on leg A before and after angle replacement.

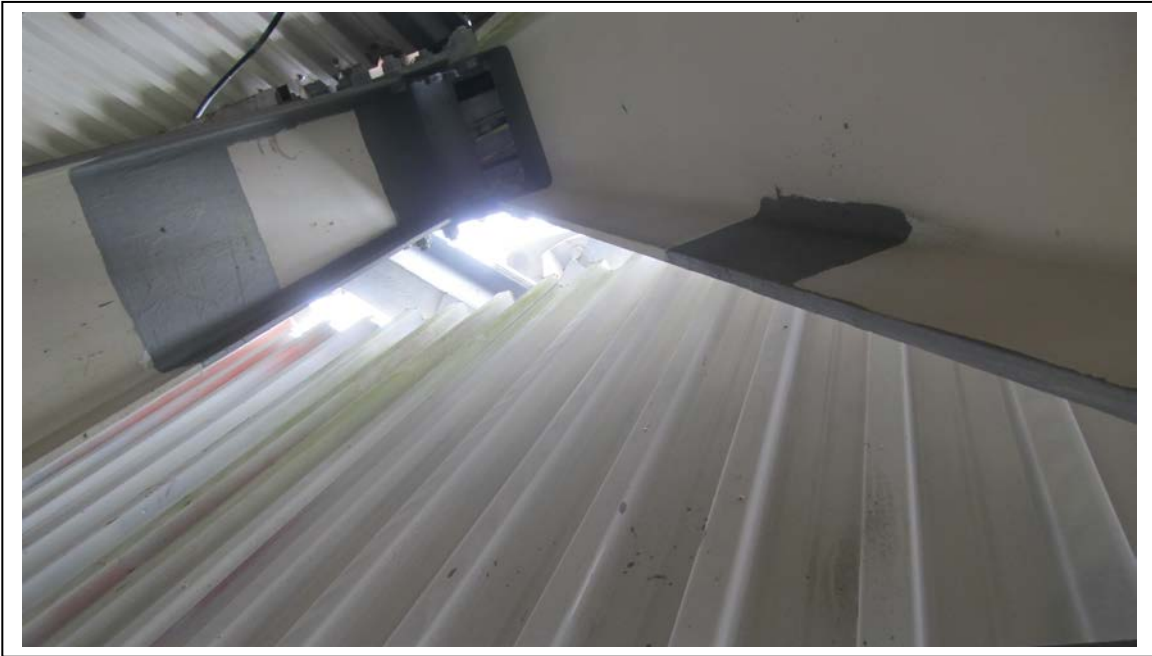
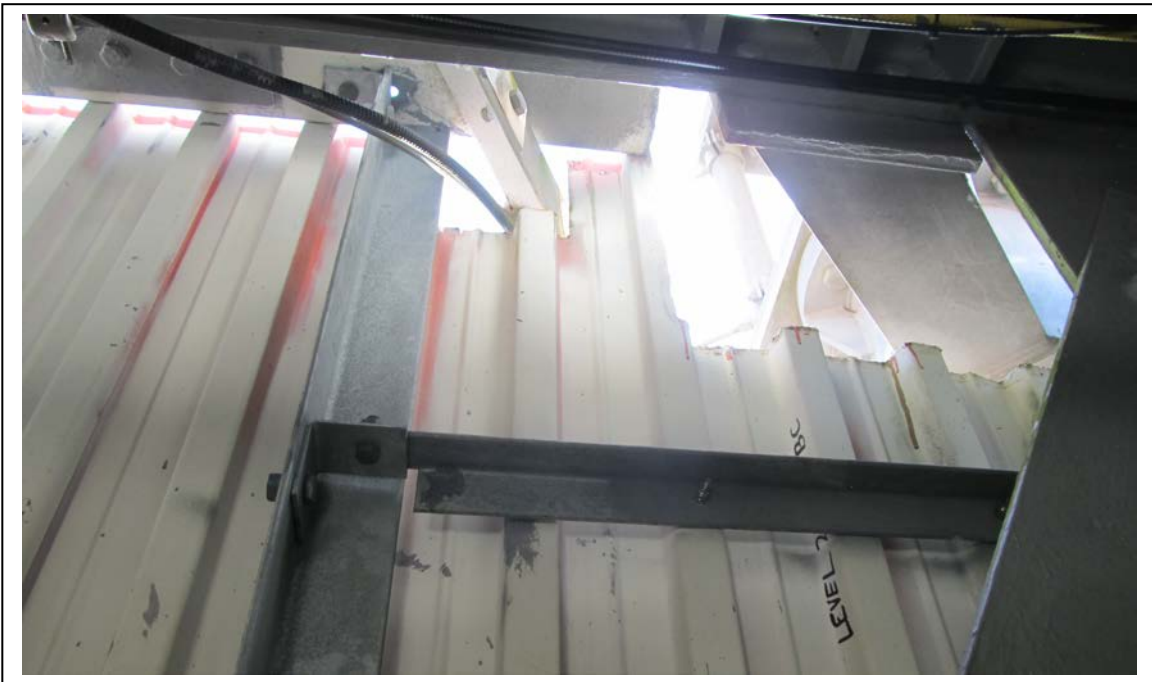
Photo Nos. 7 and 8 show the skin panel reinforcing at level 2 before and after frame installation.

3. Install new frames around the openings in skin to provide stable skin connections to the tower. New steel frames were installed around the openings in skin at level 2 and level 3 during the maintenance project (Photo Nos. 7 - 10).

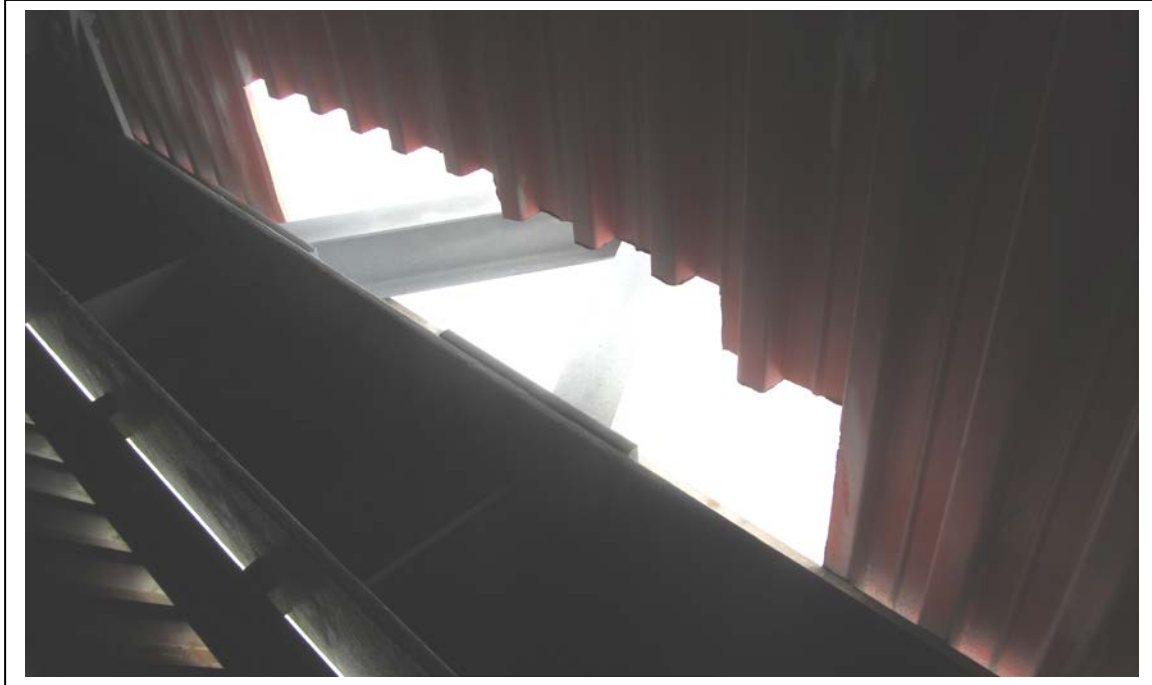
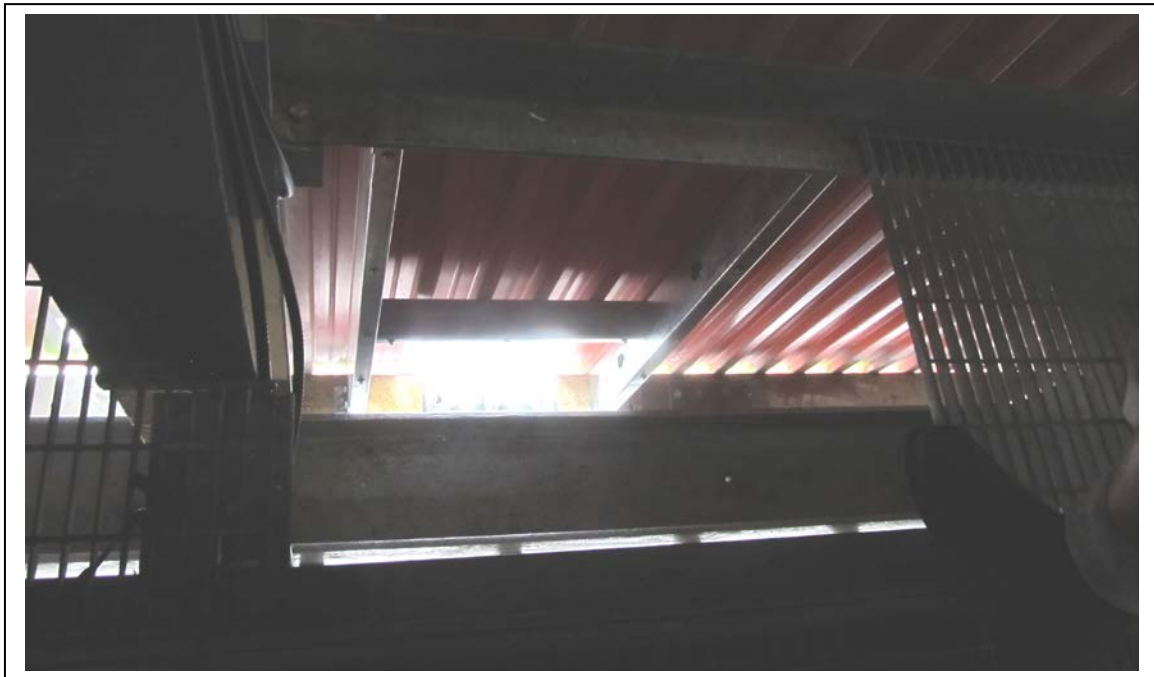
Photo Nos. 9 and 10 show skin panel reinforcing at level 3 before and after frame installation.

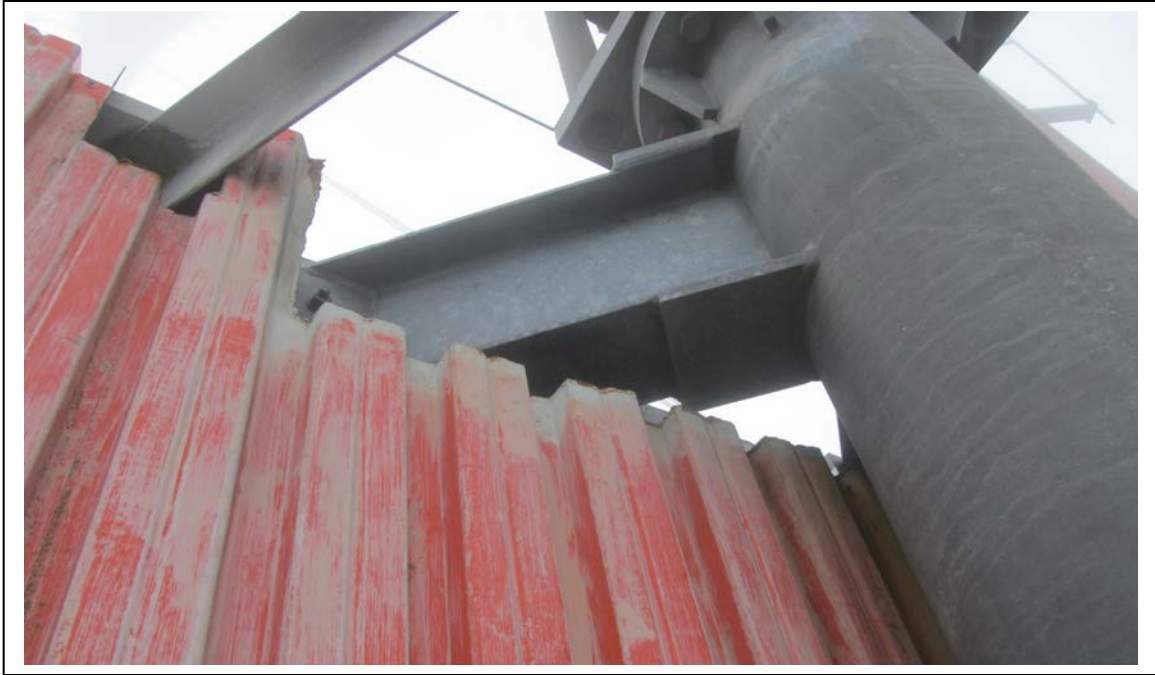
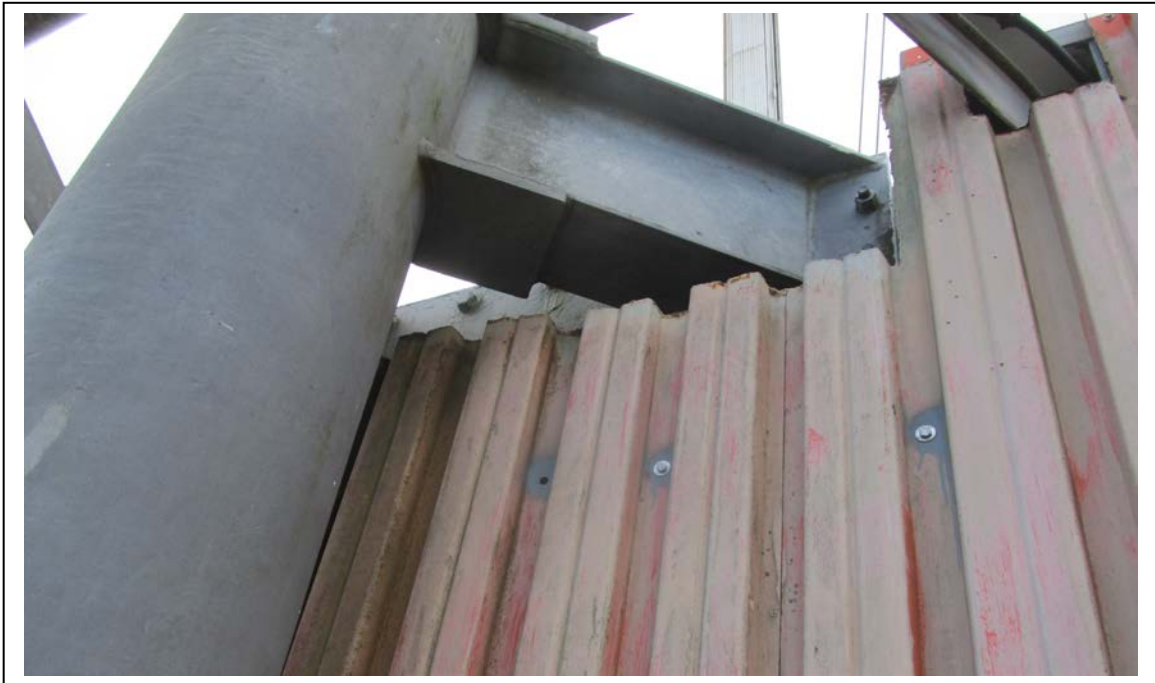
Photo Nos. 11 and 12 show the skin panel on face BC at level 2 before and after panel reinforcing.

2. Properly secure all loose skin panels to the tower members throughout the tower height. More than one thousand new connection bolts and self-tapping screws were installed on the tower at various locations to secure the existing skin panels to the tower legs and tower faces during the maintenance project (Photo Nos. 11 - 17). A typical panel was secured to the tower by placing bolts or screws at each corrugation on the top and bottom sides and by adding screws or bolts on the sides of the panel at 30" intervals.

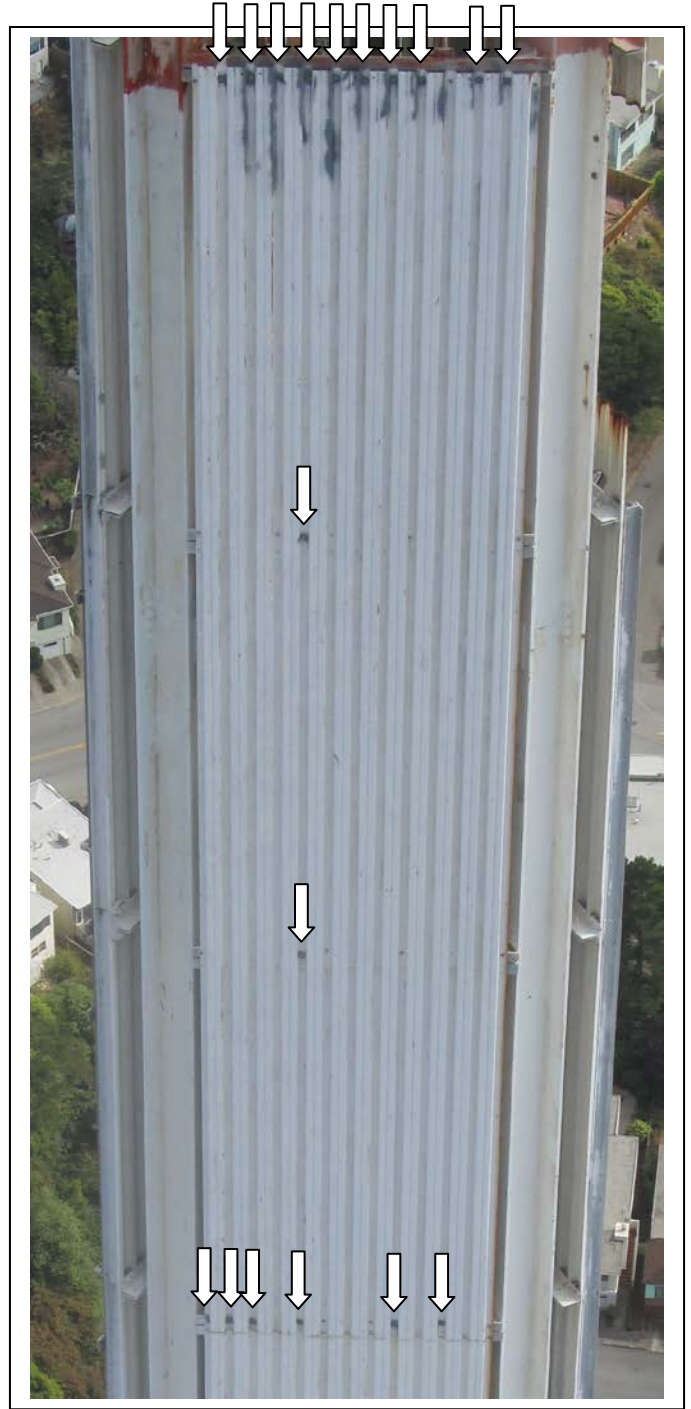
Photo Nos. 13 and 14 show the skin panels before and after panel reinforcing by adding more connection bolts. The arrows show the locations of the new connection bolts.

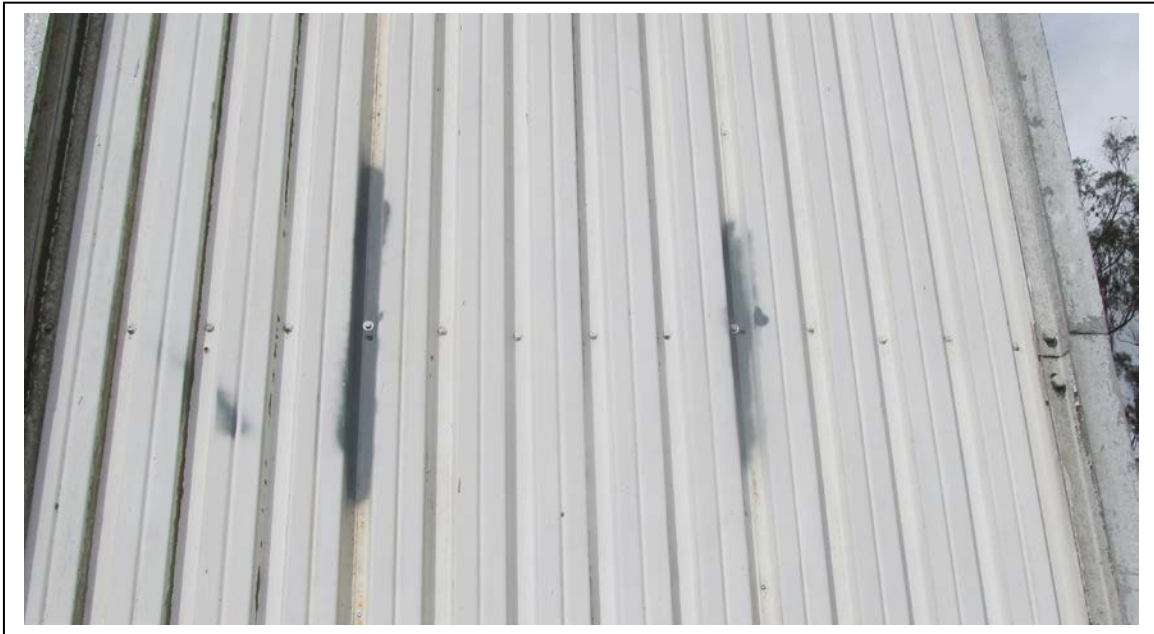
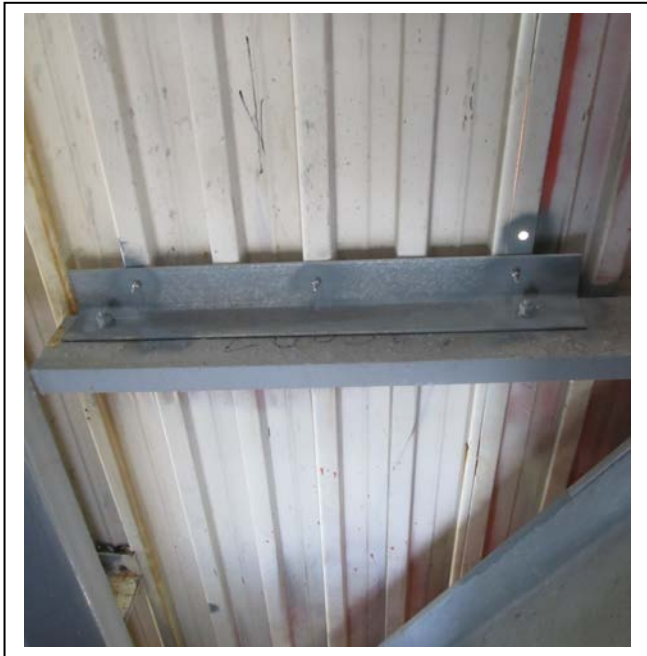
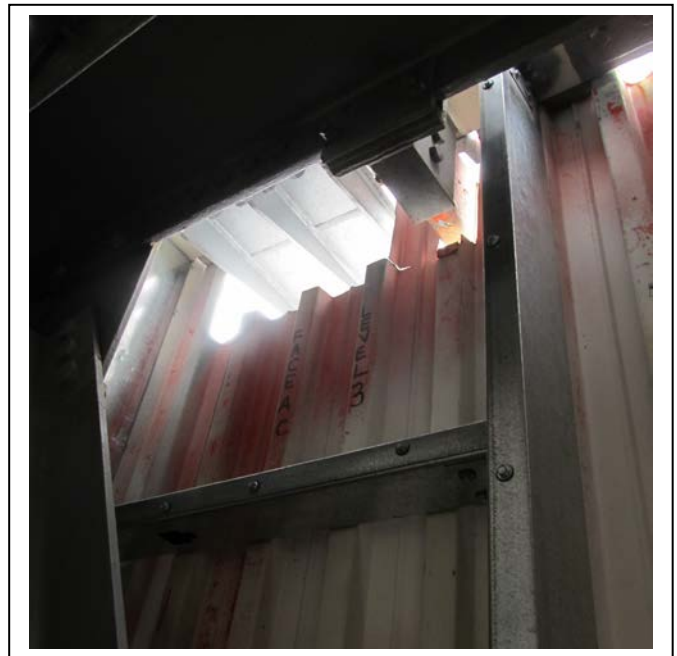
Photo Nos. 15 - 17 show the skin panel reinforcing at various levels after the recent repair work.

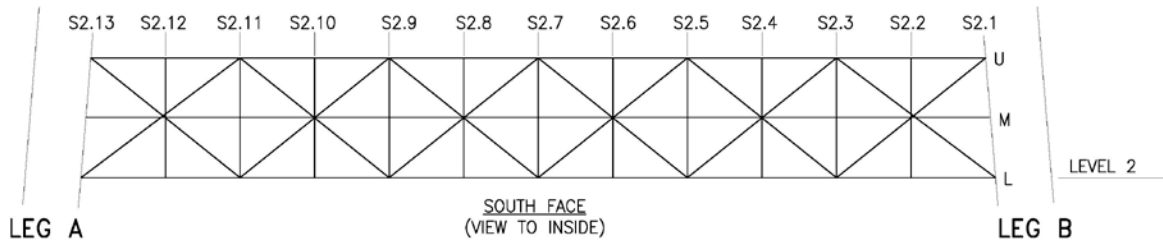
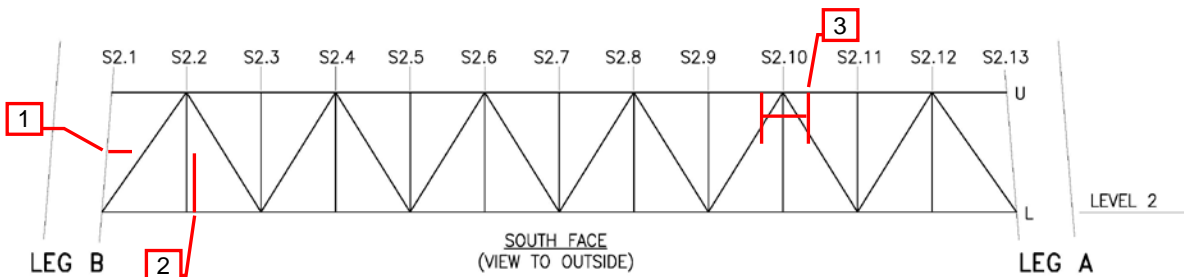
## Inspection Data Sheet: South Truss (Level 2)

Observ. No.	Location/Identification			Photo No.	Observation Comments
	Chord <sup>1</sup>	Horiz. Location	Item <sup>2</sup>		
1	M	2.1	O	1	SKIN REINFORCEMENT FRAME INSTALLED
2	L	2.2	O	2	SKIN REINFORCEMENT INSTALLED
3	U	2.10	O	3	SKIN REINFORCEMENT FRAME INSTALLED
<i>Sutro Tower</i>				Signature: _____	Page: <u>  1  </u> of <u>  3  </u>
<i>San Francisco, CA</i>				File: _____	Date: 1-9-17

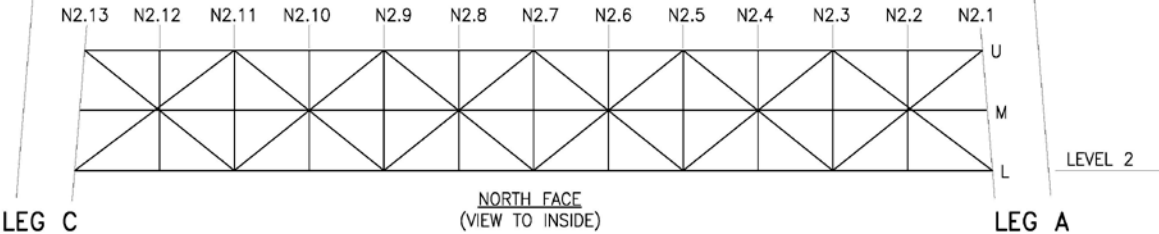
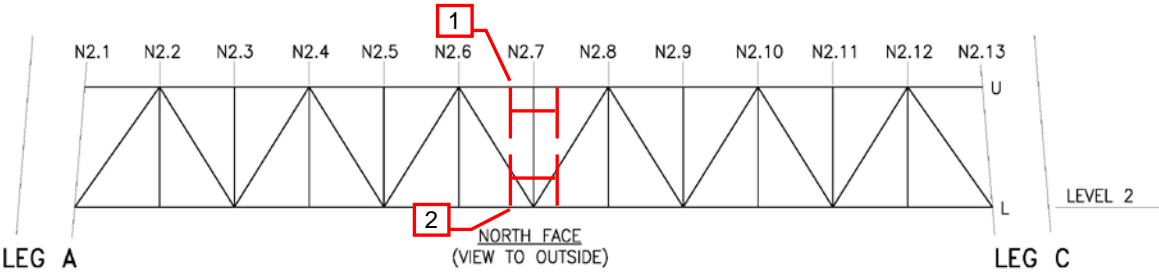
## Inspection Data Sheet: North Truss (Level 2)

Observ. No.	Location/Identification			Photo No.	Observation Comments
	Chord <sup>1</sup>	Horiz. Location	Item <sup>2</sup>		
1	U	2.7	O	1	SKIN REINFORCEMENT FRAME INSTALLED
2	L	2.7	O	2	SKIN REINFORCEMENT FRAME INSTALLED
<i>Sutro Tower</i>				Signature: _____	Page: <u>  2  </u> of <u>  3  </u>
<i>San Francisco, CA</i>				File: _____	Date: 1-9-17

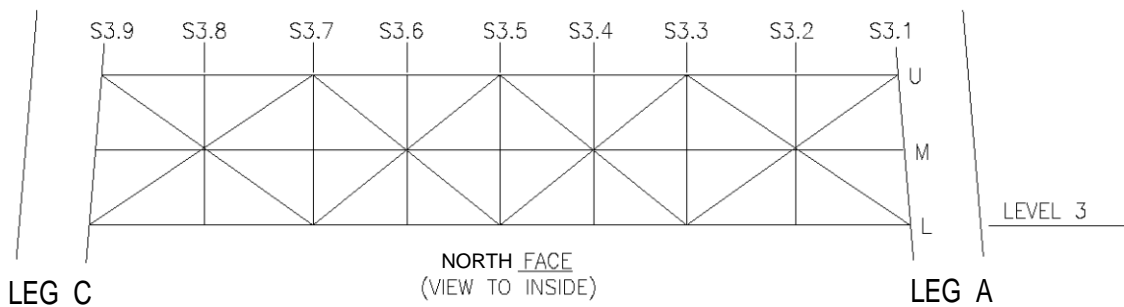
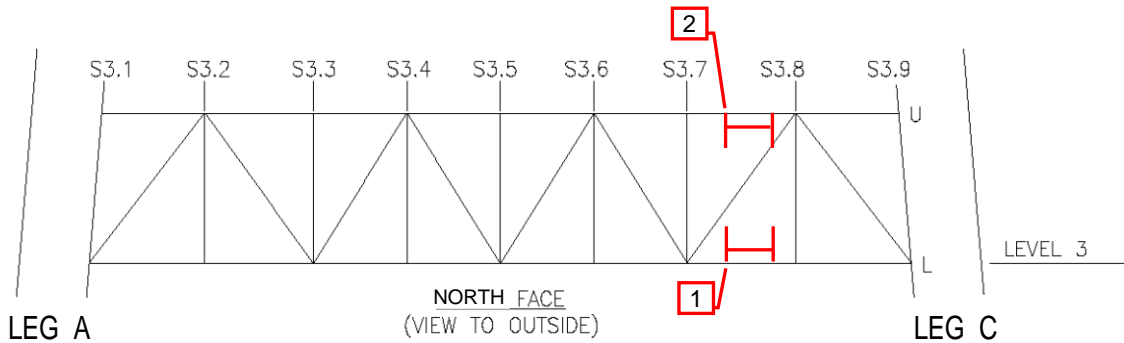
## Inspection Data Sheet: North Truss (Level 3)

Observ. No.	Location/Identification			Photo No.	Observation Comments
	Chord <sup>1</sup>	Horiz. Location	Item <sup>2</sup>		
1	L	3.75	O	1	SKIN REINFORCEMENT FRAME INSTALLED
2	U	3.75	O	2	SKIN REINFORCEMENT FRAME INSTALLED
<b>Sutro Tower</b>				Signature:	Page: <u>  3  </u> of <u>  3  </u>
<b>San Francisco, CA</b>				File:	Date: 1-9-17
