Re: **Field Evaluation of Existing  
977-Foot Self-Support Tower  
San Francisco, California  
TCI Project Number 14.082.001**

Tower Consultants Incorporated was retained by Sutro Tower Company to conduct a field observation of the 977-foot self-support tower. The inspection work has been performed in accordance with the requirements of the ANSI/TIA-222-G standard.

The purpose of the field observation was to visually evaluate the condition and structural integrity of the tower. A routine inspection was performed of leg C, the south face trusses, the strands and the bases and stack C above the 6<sup>th</sup> level.

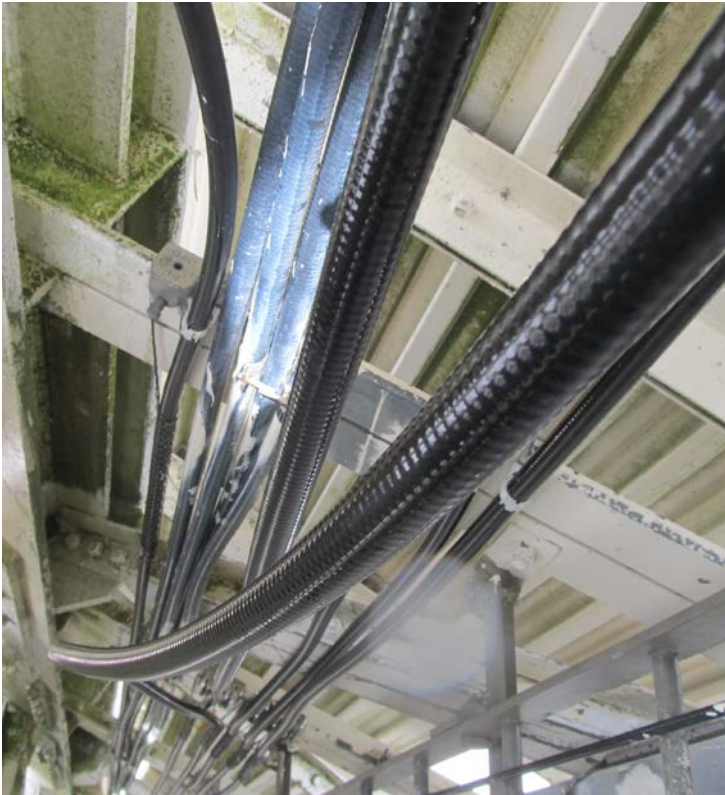
Photo 1.JPG  
5/23/2014

Observ. No.	Location / Identification			Photo No.	Observation Comments	
	Column	Elevation	Item <sup>1</sup>			
1	Y-FACE	3.32	O	1	3" FLEX LINE IS ABANDONED	
2	Z-FACE	3.32	C	2	RF(1), FOR SKIN SUPPORT	
3	C1	3.34	C	3	RF(1), LEG BOLT	
4	C2	3.34	C	4	RF(1), GUSSET TO LEG BOLT	
5	C1	3.34	C	5	RF(5), GUSSET TO LEG CONNECTION	
6	CENTER	3.33	O	6	RUST ON LIGHT CONDUIT	
7	Z-FACE	3.30	O	7	ABANDONED 1/4" CABLE	
8	C2	3.28	C	8	RF(3), LEG SPLICE	
9	Y-FACE	3.22	C	9	RF(1) AND RUSTED SPOT ON LEG	
10	Y-FACE	3.17	D	10	RUST ON DIAGONAL GUSSET	
11	C3	3.10	L	11	RUST ON LEG	
12	Y-FACE	3-4	H	12	RUST ON SKIN SUPPORT ANGLE	
13	Y-FACE	3.4	D	13	RUST ON DIAGONAL GUSSET	
14	X-FACE	3.3	O	14	COVER IS MISSING FOR LIGHT	
15	X-FACE	3.2	O	15	BROKEN LIGHT & LIGHT COVER	
16	Z-FACE	3	O	16	BROKEN GROUND FOR 1 5/8" LINE	
<b>Sutro Tower</b>					Signature: _____	Page: <u>1</u> of <u>1</u>
<b>San Francisco, CA</b>					File: _____	Date: <u>11/9/15</u>

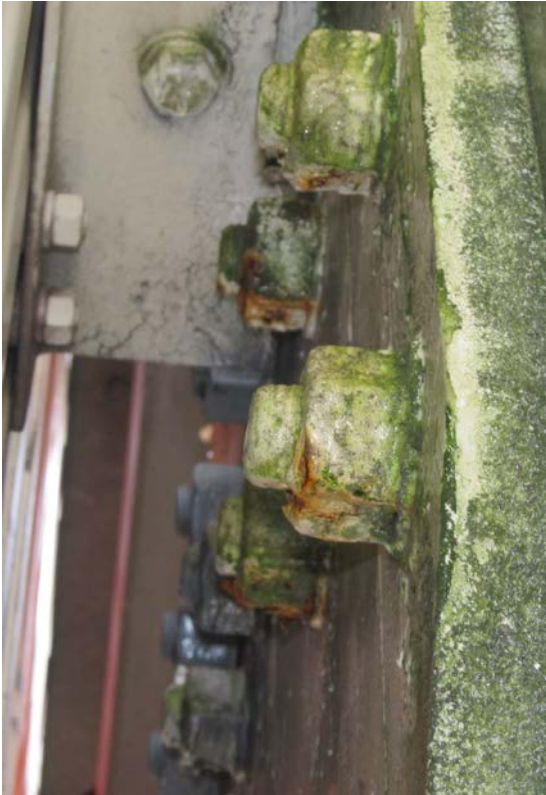
Photo 01.JPG  
7/11/2014

Observ. No.	Location / Identification			Photo No.	Observation Comments
	Column	Elevation	Item <sup>1</sup>		
1	C1	1.29	C	1	RF(3), LEG BOLTS
2	C1	1.29	L	2	RUST ON GUSSET PLATE
3	C3	1.21	L	3	MINOR RUST ON GUSSET PLATE
4	C1	1.23	C	4	RF(2), LEG BOLTS
5	Y-FACE	1.17	O	5	RUSTED CONDUIT
6	C1	1.15	L	6	RUSTED GUSSET
7	Y-FACE	1.14	C	7	RF(1), DIAGONAL BOLT
8	C3	1.13	L	8	RUST ON GUSSET
9	C2	1.11	C	9	RF(4), LEG BOLTS
10	C1	1.11	L	10	RUST ON GUSSET
11	C3	1.9	C	11	RF(3), DIAGONAL BOLTS
12	C3	1.9	L	12	RUSTED GUSSET PLATE
13	C2	1.5	C	13	RF(4), LEG BOLTS
14	C1	1.5	L	14	RUSTED GUSSET PLATE
<b>Sutro Tower</b>				Signature: _____	Page: <u>1</u> of <u>1</u>
<b>San Francisco, CA</b>				File: _____	Date: <u>1/9/15</u>
