February 11, 2015

Re: **Field Evaluation of Existing  
977-Foot Self-Support Tower  
San Francisco, California  
TCI Project Number 14.082.001**

# Inspection Summary – Year 2015

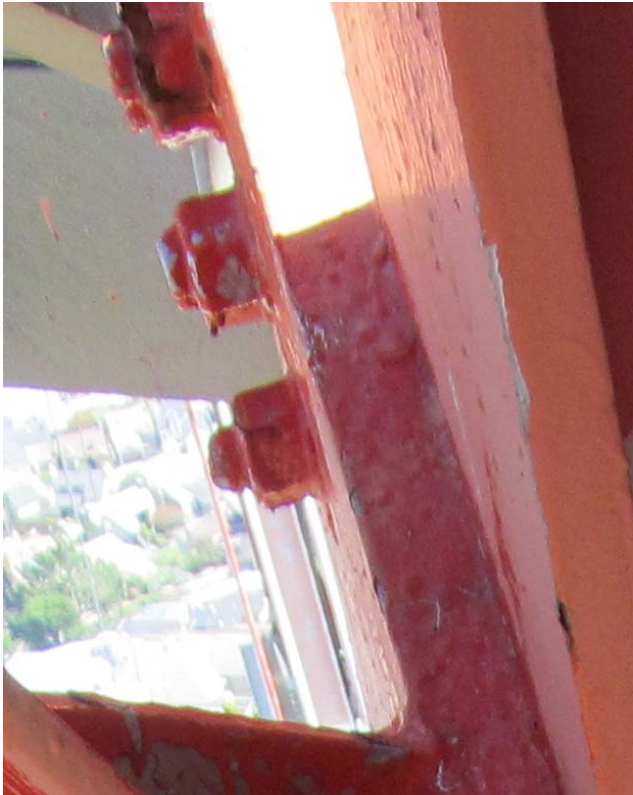
Photo 01.JPG  
8/27/2014

Observ. No.	Location / Identification			Photo No.	Observation Comments
	Column	Elevation	Item <sup>1</sup>		
1	A1	6	C	1	RF(3), LEG BOLTS
2	A2	6	C	2	RF(2), LEG BOLTS
3	A3	6	C	3	RF(3), LEG BOLTS
4	X-FACE	6	O	4	JUNCTION BOX HAS ONE LOOSE BOLT
5	A1	6	C	5	MAIN GUSSET PLATE IS RUSTED
6	Y-FACE	6	C	6	RF(2), DIAGONAL BOLTS
7	X-FACE	5.16	C	7	MINOR RUST ON LEG SPLICE BOLTS
8	ALL FACES	5-6	O	8	DRAINAGE HOLES NEED TO BE CLEANED
9	ALL FACES	5.15	C	9	MINOR RUST ON DIAG. & HORIZ. CONN. BOLTS
10	CENTER	5.15	O	10	MAJOR RUST ON ELEVATOR CABLE KEEPERS
11	X-FACE	5.15	C	11	RF(1), HORIZONTAL BOLT
12	Y-FACE	5.14	C	12	RF(1), DIAGONAL BOLT
13	Y-FACE	5.14	O	13	(2) 1 5/8" CABLE SUPPORT U-BOLTS ARE RUSTED
14	Y-FACE	5.14	C	14	RF(1), DIAGONAL BOLT
15	Z-FACE	5.13	C	15	RF(2), HORIZONTAL BOLTS
16	Y-FACE	5.13	C	16	RF(1), DIAGONAL BOLT
17	A1	5.10	C	17	RF(1), LEG BOLT
<b>Sutro Tower</b>				Signature: _____	Page: <u>1</u> of <u>2</u>
<b>San Francisco, CA</b>				File: _____	Date: <u>1/9/15</u>

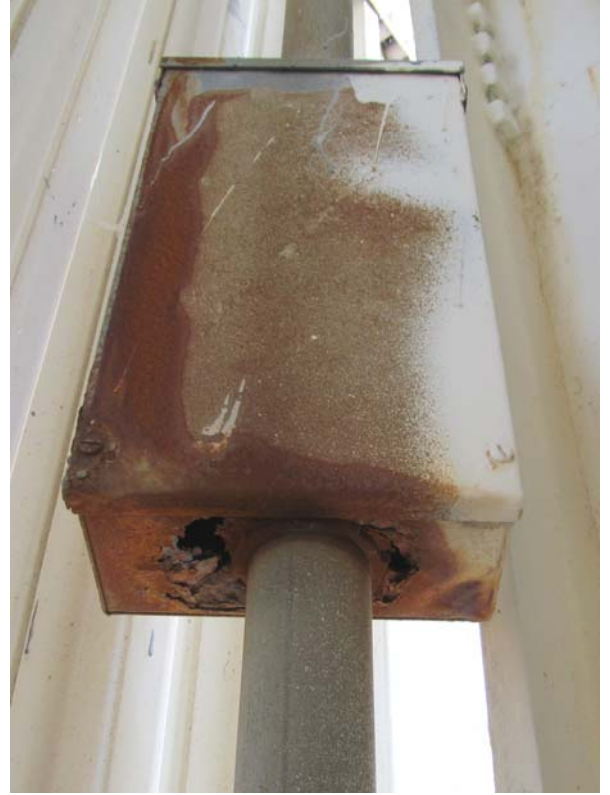
Photo 18.JPG  
8/27/2014

Observ. No.	Location / Identification			Photo No.	Observation Comments
	Column	Elevation	Item <sup>1</sup>		
18	Z-FACE	5.10	O	18	RUSTED JUNCTION BOX
19	A3	5.8	C	19	RF(10), LEG BOLTS
20	Y-FACE	5.8	C	20	RF(1), DIAGONAL BOLT
21	Z-FACE	5.9	C	21	RF(2), DIAGONAL BOLT
22	Z-FACE	5.7	C	22	RF(3), DIAGONAL BOLT
23	Z-FACE	5.5	C	23	RF(2), DIAGONAL BOLT
24	Z-FACE	5.4	C	24	RF(6), LEG BOLTS
25	A2	5.4	C	25	RF(2), LEG BOLTS
26	A1	5.3	C	26	RF(5), LEG BOLTS
27	A2	5.3	C	27	RF(3), LEG BOLTS
28	A1	5.3	C	28	GUSSET PLATE IS RUSTED
<b>Sutro Tower</b>				Signature:	Page: <u>2</u> of <u>2</u>
<b>San Francisco, CA</b>				File:	Date: <u>11/9/15</u>

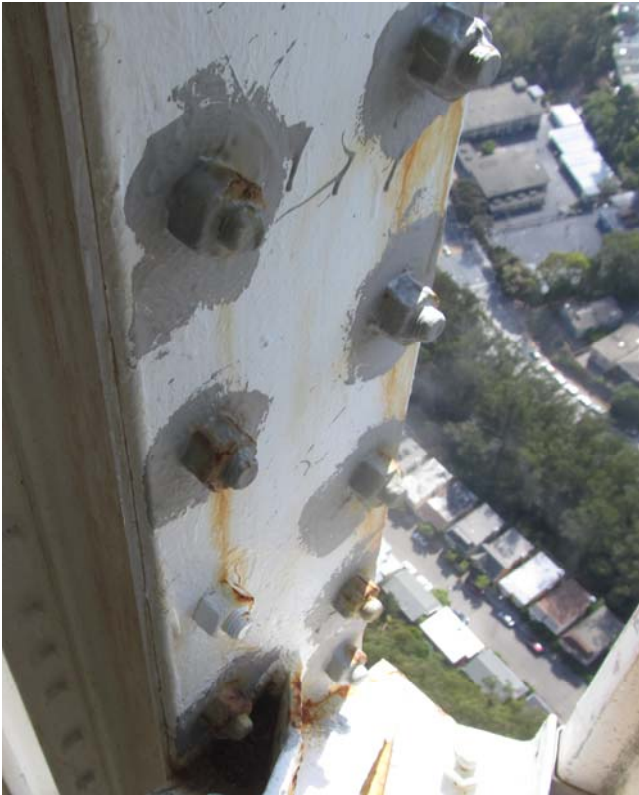
Photo 01.JPG  
8/27/2014

Observ. No.	Location / Identification			Photo No.	Observation Comments
	Column	Elevation	Item <sup>1</sup>		
1	A3	5	C	1	MANY BOLTS FOR LEG UPGRADE ARE RUSTED
2	Y-FACE	4.19	C	2	RF(2), DIAGONAL BOLTS
3	Y-FACE	4.19	C	3	RF(2), HORIZONTAL BOLTS
4	X-FACE	4.17	C	4	RF(9), LEG BOLTS
5	Z-FACE	4.19	C	5	RF(3), DIAGONAL BOLTS
6	Z-FACE	4.16	C	6	RF(2), DIAGONAL BOLTS
7	Z-FACE	4.15	C	7	RF(1), DIAGONAL BOLTS
8	Y-FACE	4.16	C	8	RF(2), DIAGONAL BOLTS
9	Y-FACE	4.17	C	9	RF(3), DIAGONAL BOLTS
10	X-FACE	4.13	C	10	RF(2), HORIZONTAL BOLTS
11	Z-FACE	4.13	C	11	RF(1), DIAGONAL BOLT
12	Z-FACE	4.13	C	12	RF(2), HORIZONTAL BOLTS
13	Y-FACE	4.13	C	13	RF(2), SKIN SUPPORT ANGLE BOLTS
14	X-FACE	4.12	C	14	RF(1), DIAGONAL BOLT
15	Z-FACE	4.11	C	15	RF(2), HORIZONTAL BOLTS
16	A3	4.10	C	16	RF(7), LEG BOLTS
17	AZ	4.10	C	17	RF(2), LEG BOLTS
<b>Sutro Tower</b>				Signature: _____	Page: <u>1</u> of <u>2</u>
<b>San Francisco, CA</b>				File: _____	Date: <u>11/9/15</u>
