SUTRO TOWER REPORT
ROUTINE INSPECTION OF LEG A AND NORTH FACE
SAN FRANCISCO, CA
FOR
SUTRO TOWER, INC

Project No. D50541

SUBJ: Sutro Tower – Routine Inspection of Leg A and North Face – November, 2009
San Francisco, CA

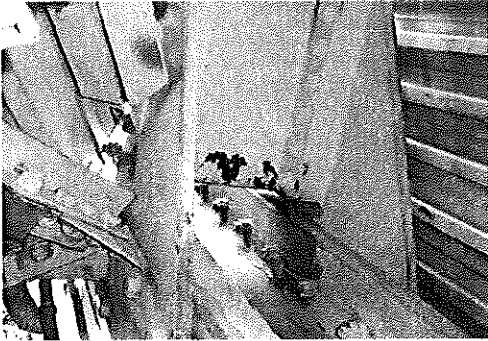
PB101404
11/10/2009

Observ. No.	Location / Identification			Photo No.	Inspection Comments
	Chord ¹	Horiz. Location	Item ²		
1	U	2.1	H	1	RF(3), Peeling Paint/Rust on Chord
2	U	2.9	C	2	RF
3	U	2.5-2.8	H	3	Rust on Beam Flange
4	U	2.10	C	4	RF(3)
5	L	2.12	C	5	RF(3)
6	U	2.13	C	6	RF
Sutro Tower				Signature: _____	Page: _____ of _____
San Francisco, CA				File: _____	Date: _____

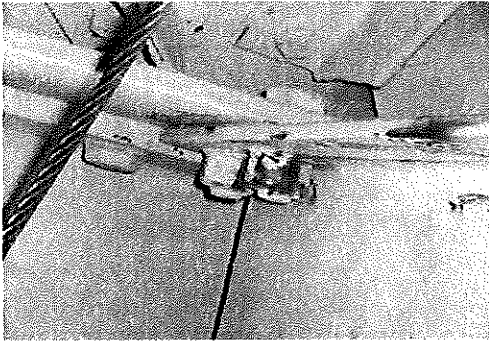
PB101414
11/10/2009

Observ. No.	Location / Identification			Photo No.	Inspection Comments
	Chord ¹	Horiz. Location	Item ²		
1	U	3.3	C	1	RF(2)
2	U	3.7	C	2,3	RF(2)
3	U	3.8	C	4	RF
Sutro Tower				Signature: _____	Page: _____ of _____
San Francisco, CA				File: _____	Date: _____

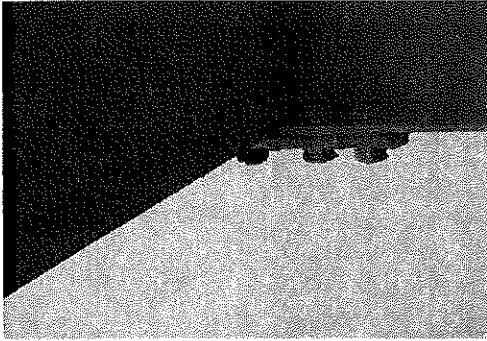
PB101419
11/10/2009

Observ. No.	Location / Identification			Photo No.	Inspection Comments
	Chord ¹	Horiz. Location	Item ²		
1	U	S.3	C	1	RF
2	L	S.5	C	2,3	RF
3	U	S.7	C	4	RF(2)
4	M	S.9	C	5	RF(2)
Sutro Tower				Signature: _____	Page: ____ of ____
San Francisco, CA				File: _____	Date: _____
