26 January 2017

Project 067199.11 – Condition Assessment of Sutro Tower, 2017 Inspections
2016 Maintenance and Inspection Program

Photo Log

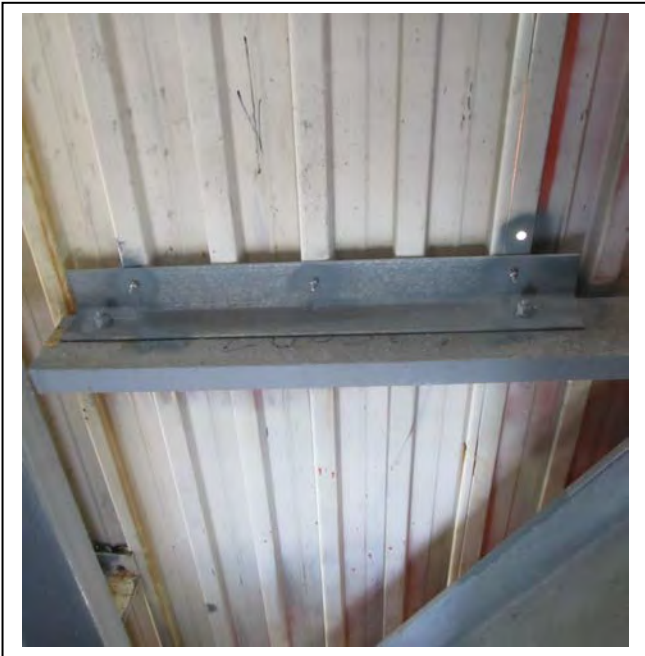
Photo No. 16 (After)

Photo Nos. 15 - 17 show the skin panel reinforcing at various levels after the recent repair work.

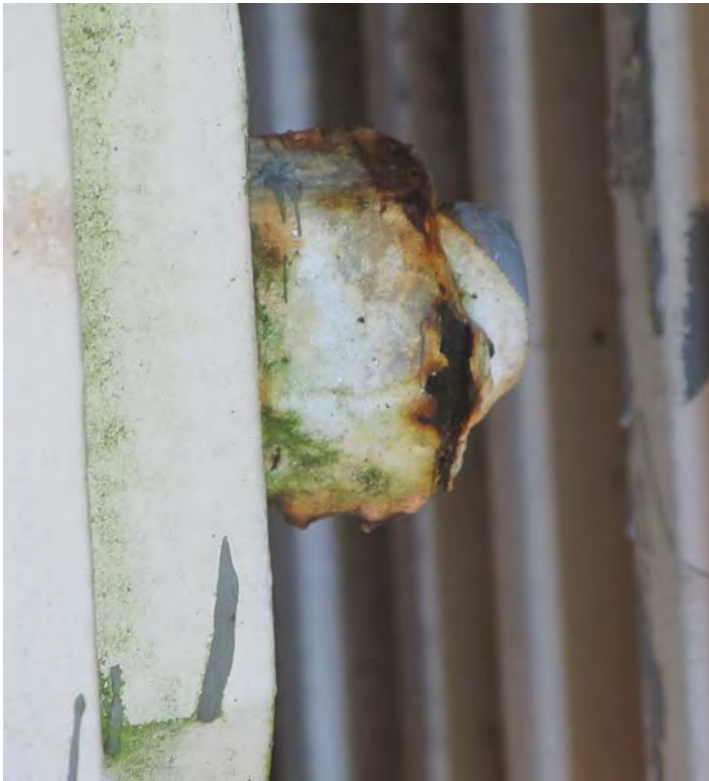
Photo 1.JPG
8/9/2016

Observ. No.	Location/Identification			Photo No.	Observation Comments
	Column	Elevation	Item ¹		
1	Y-FACE	2	C	1	RF(4)
2	Y-FACE	1.33	C	2	RF(1), SKIN SUPPORT ANGLE BOLT
3	Z-FACE	1.33	C	3	RF(2), SKIN SUPPORT BOLTS AND ONE BOLT IS MISSING
4	Z-FACE	1.33	C	4	RF(1), HORIZONTAL BOLT
5	Y-FACE	1.33	C	5	RUSTED DIAGONAL GUSSET
6	X-FACE	1.33	C	6	RF(1), DIAGONAL BOLT
7	Z-FACE	1.33	C	7	RUST ON TWO GUSSETS
8	X-FACE	1.33	C	8	RUST ON LEG AND GUSSET
9	X-FACE	1.31	L	9	RUST ON LEG
10	Z-FACE	1.31	C	10	ONE LOOSE BEAM CONNECTION BOLT
11	Z-FACE	1.31	C	11	RF(1), DIAGONAL BOLT AND RUST ON GUSSET
12	C2	1.31	C	12	RF(3), LEG BOLTS
13	Y-FACE	1.31	L	13	RUST ON LEG
14	C1	1.31	C	14	RF(4), LEG BOLTS
15	C3	1.31	C	15	RF(3), LEG BOLTS
16	Z-FACE	1.29	C	16	TWO BEAM CONNECTION BOLTS ARE LOOSE
17	Y-FACE	1.29	C	17	RF(1), SKIN SUPPORT ANGLE
Sutro Tower				Signature:	Page: <u> 1 </u> of <u> 8 </u>
San Francisco, CA				File:	Date: 1-11-17

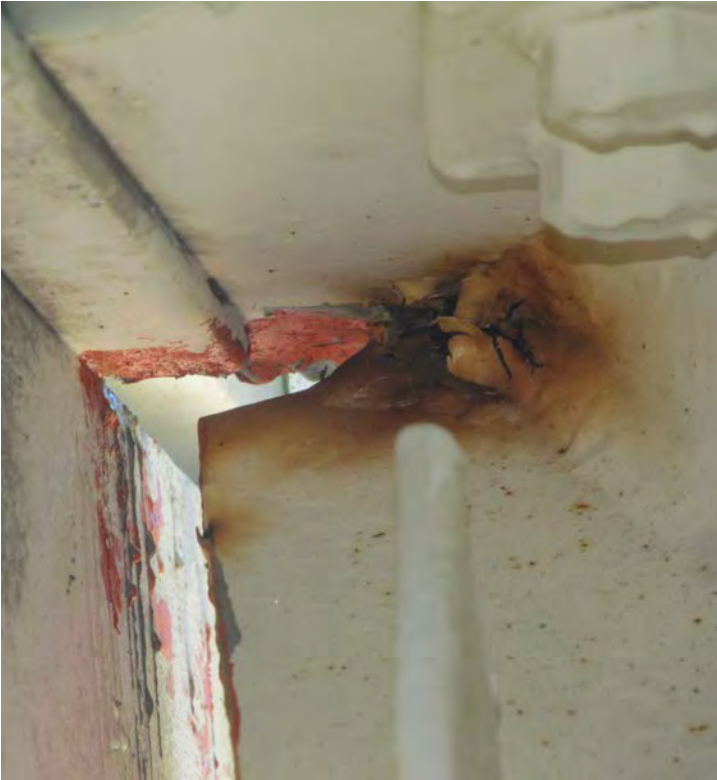
Photo 5.JPG
8/9/2016

- There are two rusted gussets between levels 1 and 2 that will have to be cleaned, evaluated and painted or replaced.
- Many diagonal connections to leg members have drain holes that are plugged causing standing water that will lead to rusted steel. These drain holes should be unplugged and inspected next year to evaluate their condition.

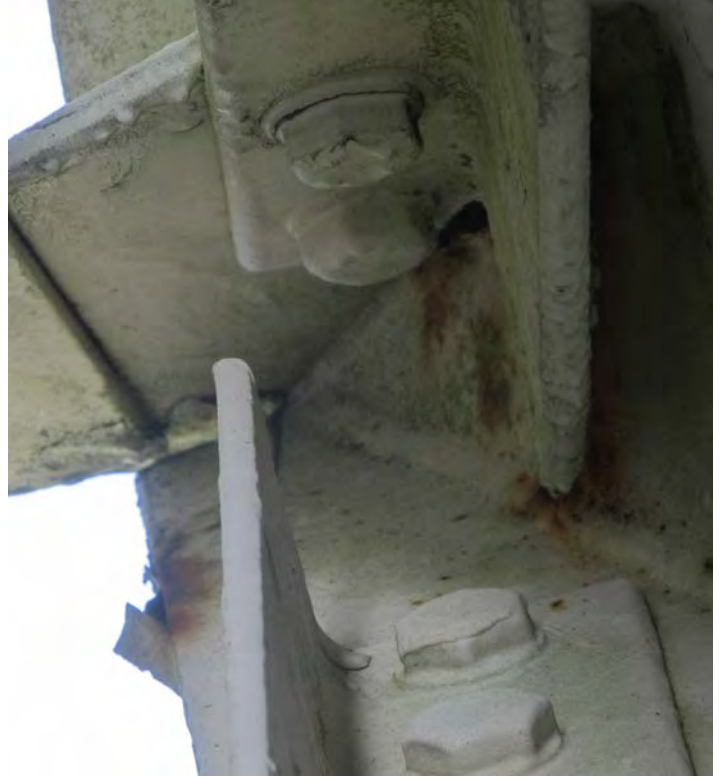
Photo 18.JPG
8/9/2016

Observ. No.	Location/Identification			Photo No.	Observation Comments
	Column	Elevation	Item ¹		
18	Y-FACE	1.29	C	18	RUST ON GUSSET
19	C2	1.28	L	19	RUST ON LEG
20	Z-FACE	1.27	O	20	CONDUIT HAS RUSTED HARDWARE AND JUNCTION BOX HAS BROKEN CONNECTORS
21	Z-FACE	1.27	C	21	RF(1), HORIZONTAL BOLT
22	Y-FACE	1.27	C	22	RF(1), DIAGONAL BOLT
23	Y-FACE	1.27	C	23	RF(2), SKIN SUPPORT ANGLE BOLT
24	Y-FACE	1.28	C	24	RUST ON DIAGONAL GUSSET
25	X-FACE	1.28	C	25	RUST ON DIAGONAL GUSSET
26	X-FACE	1.27	O	26	TWO SCREWS ARE MISSING FOR JUNCTION BOX CONDUIT
27	X-FACE	1.27	C	27	RF(1), DIAGONAL BOLT
28	Z-FACE	1.26	C	28	RUST ON DIAGONAL GUSSET
29	Y-FACE	1.25	C	29	RF(2), SKIN SUPPORT ANGLE BOLTS
30	C2	1.25	C	30	RF(5), LEG BOLTS
31	Y-FACE	1.24	C	31	RF(1), DIAGONAL BOLT AND RUST ON GUSSET
32	C1	1.25	C	32	RF(5), LEG BOLTS
33	Y-FACE	1.25	C	33	RF(2), SKIN SUPPORT BOLTS AND BOLT IS LOOSE
34	Y-FACE	1.23	C	34	RF(1), DIAGONAL BOLT & RF(1), SKIN SUPPORT ANGLE BOLT

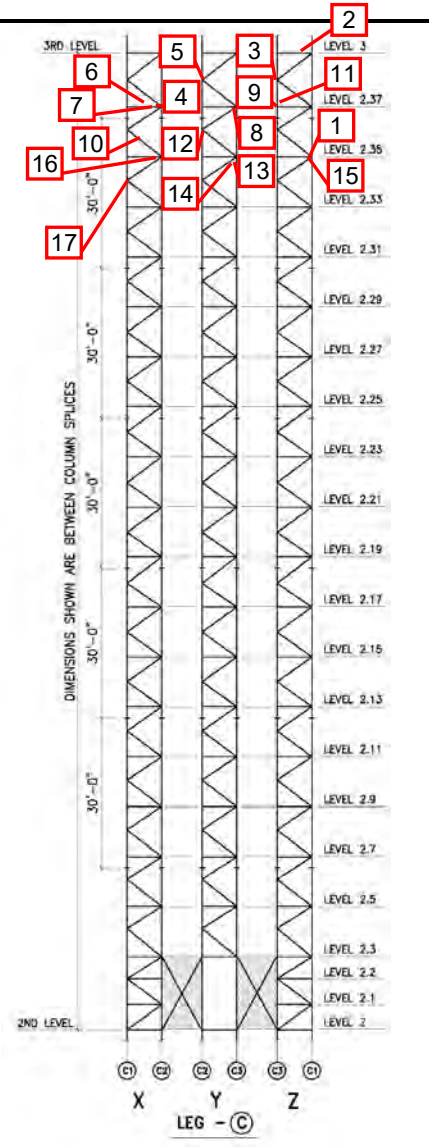
Inspection Data Sheet: Leg C (Level 2 to Level 3)

Observ. No.	Location/Identification			Photo No.	Observation Comments
	Column	Elevation	Item ¹		
1	C1	2.35	C	1	RF(9), LEG BOLTS
2	Z-FACE	3	O	2	FOUR AUXILIARY FEEDLINES
3	C3	2.38	L	3	RUST ON LEG
4	C2	2.37	C	4	RF(12)
5	Y-FACE	2.38	C	5	RUST ON DIAGONAL GUSSET PLATE
6	X-FACE	2.37	C	6	BOTH HORIZONTAL GUSSETS ARE RUSTED
7	X-FACE	2.37	C	7	RF(1), DIAGONAL BOLT
8	Y-FACE	2.37	C	8	RUSTED DIAGONAL GUSSET
9	C3	2.37	L	9	RUST ON TOWER LEG
10	X-FACE	2.36	O	10	BROKEN LIGHT
11	C3	2.37	C	11	RF(2), LEG BOLTS
12	Y-FACE	2.36	C	12	GUSSET SHOWS SIGN OF RUST
13	Y-FACE	2.35	C	13	DIAGONAL GUSSET IS RUSTED
14	Y-FACE	2.35	C	14	RF(1), HORIZONTAL BOLT
15	Z-FACE	2.35	C	15	MINOR RUST ON DIAGONAL GUSSET PLATES
16	X-FACE	2.35	C	16	RF(1), HORIZONTAL BOLT
17	X-FACE	2.34	O	17	RUST ON JUNCTION BOXES AND HARDWARE
Sutro Tower				Signature: _____	Page: <u> 1 </u> of <u> 7 </u>
San Francisco, CA				File: _____	Date: 1-11-17

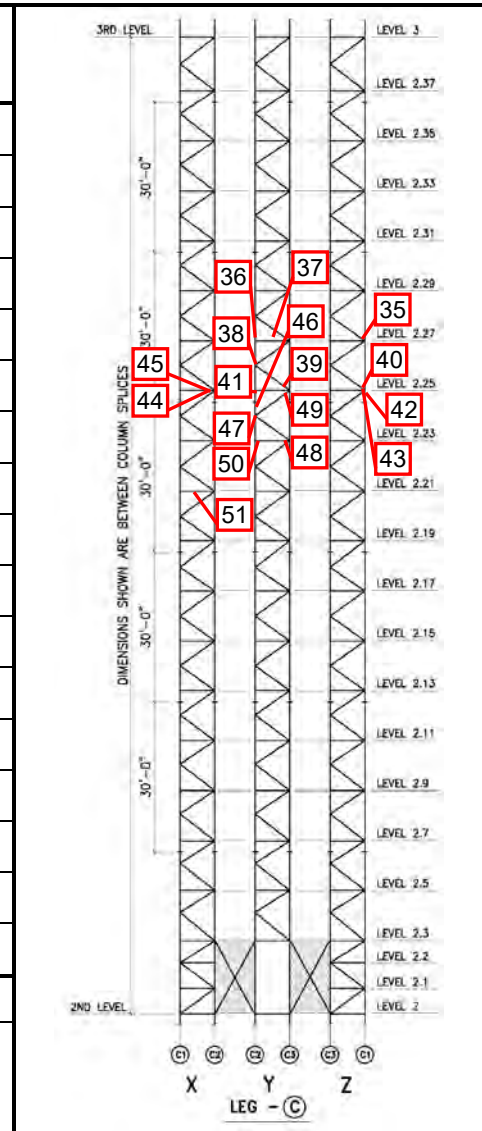
Inspection Data Sheet: Leg C (Level 2 to Level 3)

Observ. No.	Location/Identification			Photo No.	Observation Comments
	Column	Elevation	Item ¹		
35	Z-FACE	2.27	C	35	TWO BOLTS ARE LOOSE FOR SKIN SUPPORT ANGLE
36	Y-FACE	2.27	C	36	RUST ON HORIZONTAL GUSSET
37	Y-FACE	2.27	C	37	RF(1), SKIN SUPPORT ANGLE
38	Y-FACE	2.26	C	38	RUST ON TWO GUSSETS
39	Y-FACE	2.25	C	39	MINOR RUST ON THREE GUSSETS
40	C1	2.25	C	40	RF(3), LEG BOLTS
41	C2	2.25	C	41	RF(12), LEG BOLTS
42	Z-FACE	2.25	C	42	RF(1), DIAGONAL BOLT
43	C1	2.25	L	43	RUST ON LEG
44	X-FACE	2.25	C	44	MINOR RUST ON DIAGONAL GUSSET
45	C2	2.25	L	45	MINOR RUST ON LEG
46	C2	2.24	L	46	MINOR RUST ON LEG
47	Y-FACE	2.24	C	47	RF(1), DIAGONAL BOLT AND RUST ON GUSSET
48	Y-FACE	2.23	C	48	THREE RUSTED GUSSETS
49	C3	2.25	C	49	RF(4), LEG BOLTS AND RUST ON LEG
50	Y-FACE	2.23	C	50	RF(1), SKIN SUPPORT ANGLE AND RUSTED HORIZONTAL GUSSET
51	X-FACE	2.21	O	51	DAMAGED JUNCTION BOX AND CABLE NOT PROPERLY ATTACHED
Sutro Tower				Signature: _____	Page: <u>3</u> of <u>7</u>

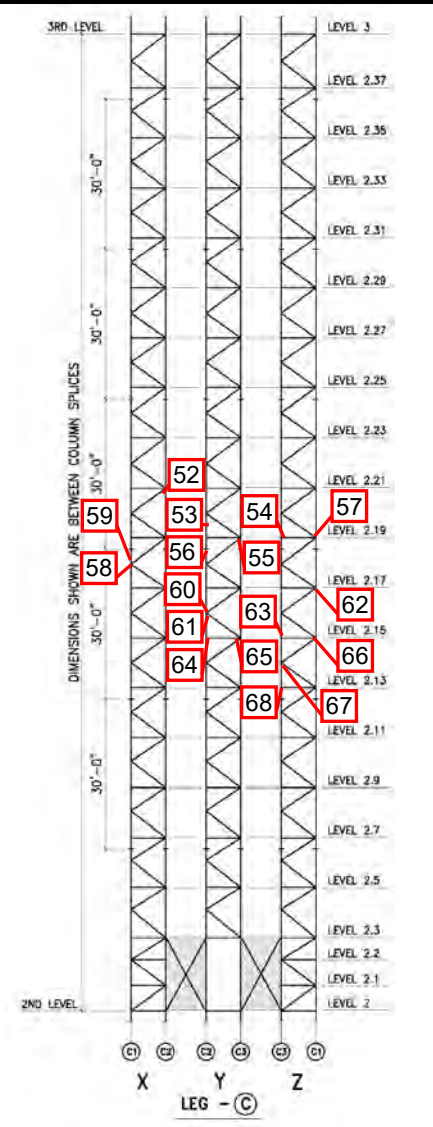
Inspection Data Sheet: Leg C (Level 2 to Level 3)

Observ. No.	Location/Identification			Photo No.	Observation Comments
	Column	Elevation	Item ¹		
52	C2	2.19 – 2.21	C	52	MEDIUM RUST ON DIAGONAL GUSSET
53	C2	2.19 – 2.21	L	53	MEDIUM RUST ON LEG
54	Z-FACE	2.19	C	54	TWO BOLTS ARE MISSING FOR SKIN SUPPORT CHANNEL
55	Y-FACE	2.19	D	55	MINOR RUST ON DIAGONAL MEMBER
56	C2	2.19	C	56	RF(12), LEG BOLTS
57	Z-FACE	2.19	C	57	RUST ON GUSSETS
58	X-FACE	2.18	O	58	ELECTRICAL BOX IS MISSING COVER
59	X-FACE	2.18	C	59	RF(1), DIAGONAL BOLT
60	C2	2.16	L	60	RUST ON LEG
61	Y-FACE	2.16	C	61	MINOR RUST ON DIAGONAL GUSSET
62	Z-FACE	2.17	C	62	MEDIUM RUST ON HORIZONTAL GUSSET
63	Z-FACE	2.15	C	63	RF(1), SKIN SUPPORT ANGLE
64	Y-FACE	2.15	C	64	RF(2), AND MINOR RUST ON GUSSET
65	Y-FACE	2.15	C	65	RF(2), HORIZONTAL BOLT AND ALL THREE GUSSETS ARE RUSTED
66	Z-FACE	2.15	C	66	RF(1), DIAGONAL BOLT AND MINOR RUST ON HORIZONTAL GUSSET
67	Z-FACE	2.14	C	67	RF(1), DIAGONAL BOLT
68	Z-FACE	2.13	C	68	FOUR LOOSE BOLTS FOR SKIN BEAM CONNECTION

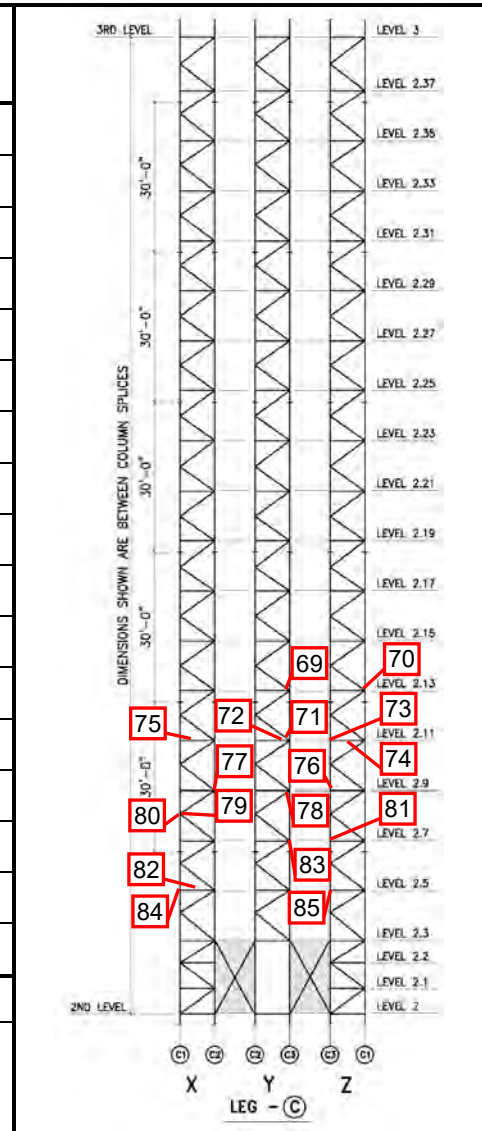
Inspection Data Sheet: Leg C (Level 2 to Level 3)

Observ. No.	Location/Identification			Photo No.	Observation Comments
	Column	Elevation	Item ¹		
69	Y-FACE	2.13	C	69	MEDIUM RUST ON GUSSETS
70	Z-FACE	2.13	C	70	RUST ON GUSSET AND LEG
71	Y-FACE	2.11	C	71	MEDIUM RUST ON GUSSET PLATES
72	Y-FACE	2.11	C	72	RF(2), HORIZONTAL BOLTS
73	Z-FACE	2.11	C	73	FOUR LOOSE BOLTS FOR BEAM
74	Z-FACE	2.11	O	74	ANTENNA SUPPORT CONNECTION BOLTS ARE RUSTED
75	X-FACE	2.11	C	75	MEDIUM RUST ON GUSSET
76	Z-FACE	2.9	C	76	ONE SKIN BEAM BOLT IS LOOSE
77	X-FACE	2.9	C	77	RF(2), SKIN SUPPORT ANGLE BOLTS
78	Y-FACE	2.9	C	78	RUST ON WELD FOR DIAGONAL GUSSET
79	X-FACE	2.8	C	79	RUSTED GUSSET PLATES
80	X-FACE	2.8	C	80	DRAIN HOLES ARE PLUGGED FOR GUSSETS
81	Z-FACE	2.7	C	81	FOUR SKIN BOLTS ARE LOOSE
82	X-FACE	2.5	C	82	RUSTED GUSSETS
83	Y-FACE	2.7	C	83	ALL GUSSETS ARE RUSTED
84	X-FACE	2.5	L	84	MINOR RUST ON LEG
85	Z-FACE	2.5	C	85	FOUR LOOSE BEAM BOLTS
Sutro Tower				Signature: _____	Page: <u>5</u> of <u>7</u>

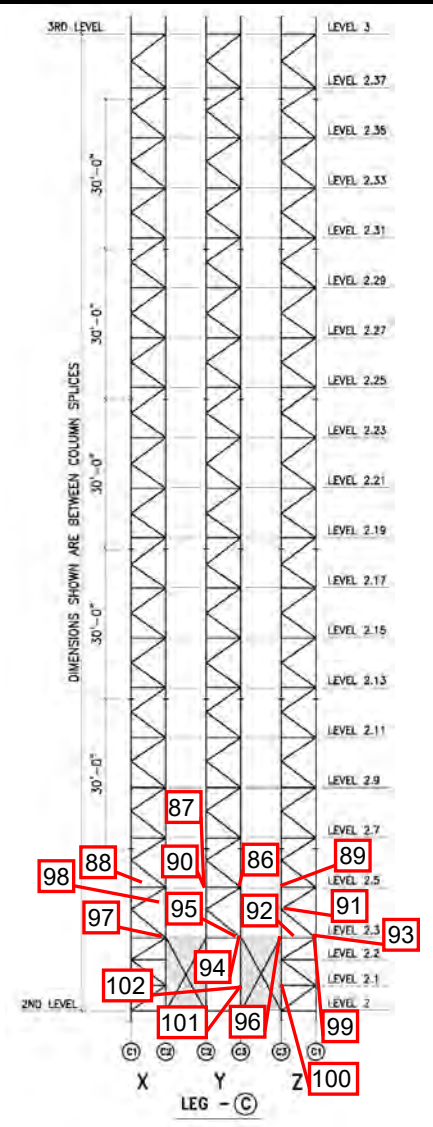
Inspection Data Sheet: Leg C (Level 2 to Level 3)

Observ. No.	Location/Identification			Photo No.	Observation Comments
	Column	Elevation	Item ¹		
86	Y-FACE	2.5	C	86	RF(2)
87	Y-FACE	2.5	C	87	RF(2), SKIN SUPPORT BOLTS
88	X-FACE	2.5	O	88	DAMAGED JUNCTION BOX AND BROKEN LIGHT
89	Z-FACE	2.5	C	89	RUST ON GUSSETS
90	Y-FACE	2.5	C	90	MINOR RUST ON HORIZONTAL GUSSET
91	Z-FACE	2.4	C	91	RF(1), DIAGONAL BOLT
92	Z-FACE	2.3	C	92	FOUR BEAM BOLTS ARE LOOSE
93	C1	2.3	C	93	RF(3)
94	Y-FACE	2.3	C	94	RUST ON GUSSETS
95	Y-FACE	2.3	C	95	RF(1), HORIZONTAL BOLT
96	Z-FACE	2.3	C	96	RUST ON HORIZONTAL MEMBER GUSSET
97	C2	2.3	C	97	RF(4)
98	C2	2.3 - 2.5	C	98	MEDIUM RUST ON DIAGONAL GUSSET
99	Z-FACE	2.3	C	99	RF(2)
100	Z-FACE	2.1	C	100	RUST ON HORIZONTAL GUSSET
101	Y-FACE	2.1	C	101	THREE RUSTED GUSSET PLATES
102	Y-FACE	2.1	O	102	ANTENNA MOUNT HAS ONE LOOSE CONNECTION BOLT
Sutro Tower				Signature: _____	Page: <u>6</u> of <u>7</u>
San Francisco, CA				File: _____	Date: 1-11-17

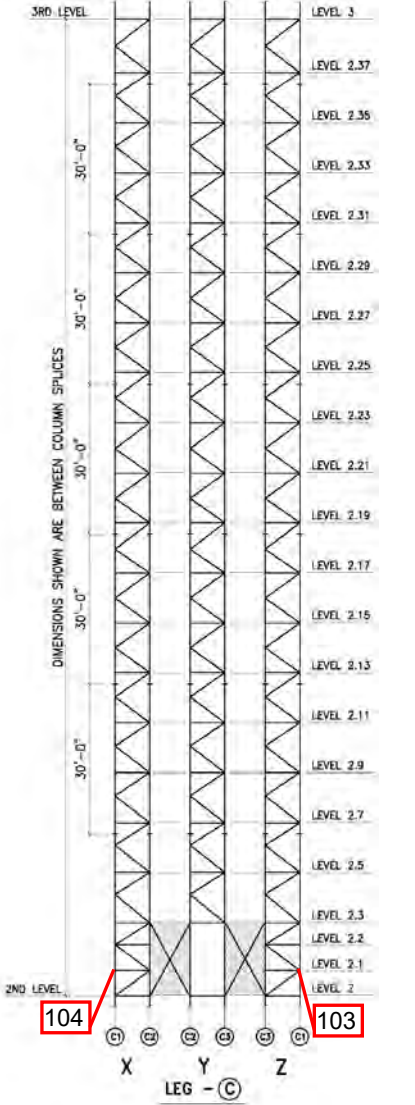
Inspection Data Sheet: Leg C (Level 2 to Level 3)

Observ. No.	Location/Identification			Photo No.	Observation Comments
	Column	Elevation	Item ¹		
103	Z-FACE	2.1	O	103	RIGID LINE HARDWARE IS RUSTED
104	X-FACE	2.1	H	104	BENT HORIZONTAL CHANNEL
<i>Sutro Tower</i>				Signature: _____	Page: <u>7</u> of <u>7</u>
<i>San Francisco, CA</i>				File: _____	Date: 1-11-17

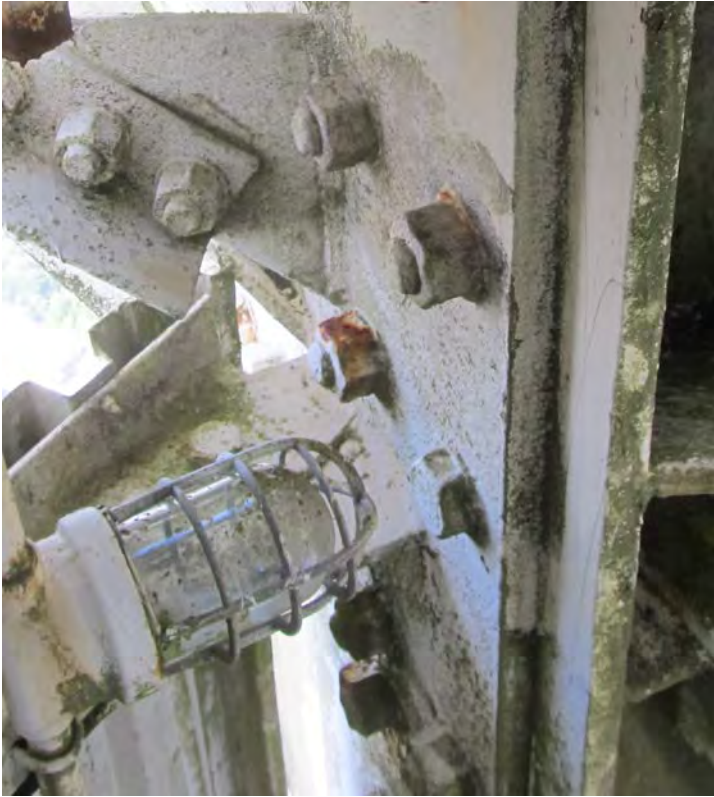
Photo 1.JPG
8/10/2016

Observ. No.	Location/Identification			Photo No.	Observation Comments
	Column	Elevation	Item ¹		
1	C2	5	C	1	RF(12), LEG BOLTS
2	C3	5	C	2	RF(3), LEG BOLTS
3	C1	5	C	3	RF(7), LEG REINFORCEMENT BOLTS AND RUST ON PLATE
4	Y-FACE	4.19	C	4	RF(1), AND RUST ON GUSSET
5	X-FACE	4.19	H	5	BENT HORIZONTAL
6	Y-FACE	4.18	C	6	RF(1), DIAGONAL BOLT
7	C3	4.18	C	7	RF(8), LEG REINFORCING BOLTS
8	Y-FACE	4.16	C	8	RF(5), LEG REINFORCING BOLTS
9	Y-FACE	4.13	C	9	MINOR RUST ON HORIZONTAL GUSSET
10	X-FACE	4.15	C	10	RF(2), HORIZONTAL BOLTS
11	Y-FACE	4.15	C	11	MINOR RUST ON HORIZONTAL GUSSET
12	C1	4.11	L	12	RUST ON LEG
13	C2	4.13	C	13	RF(7), LEG BOLTS
14	C3	4.13	C	14	RF(5), LEG BOLTS
15	Y-FACE	4.7	L	15	RUST ON LEG
16	Y-FACE	4.7	C	16	RF(1), DIAGONAL BOLT
17	C2	4.7	C	17	RF(6), LEG BOLTS
Sutro Tower				Signature: _____	Page: <u> 1 </u> of <u> 2 </u>
San Francisco, CA				File: _____	Date: 1-11-17

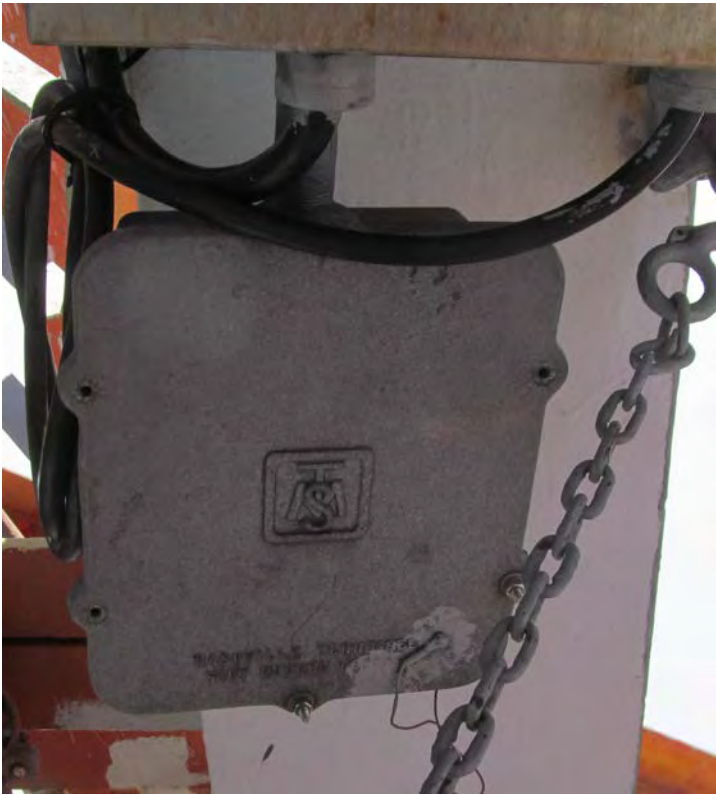
Photo 1.JPG
7/11/2016

Observ. No.	Location/Identification			Photo No.	Observation Comments
	Column	Elevation	Item ¹		
1	Z-FACE	6.2	O	1	JUNCTION BOX IS MISSING SCREWS
2	Y-FACE	6.3	O	2	LOOSE JUMPER CABLE
3	C3	6.3	L	3	RUST ON LEG
4	Z-FACE	6	O	4	ONE AUXILIARY CONDUIT
5	Z-FACE	6.2	O	5	BROKEN LIGHT
6	CENTER	6.3	O	6	RUSTED HARDWARE FOR SAFETY CABLE RAIL
7	C2	6	C	7	RF(2), HORIZONTAL BOLTS
8	C3	6	C	8	RF(6), LEG REINFORCEMENT BOLTS
9	X-FACE	6.1	C	9	RF(1), HORIZONTAL BOLT
10	C1	6.1	C	10	GUSSET SHOWS MINOR RUST
11	Y-FACE	6.05	O	11	ELECT. COND. JUNCTION BOX COVER IS RUSTED
12	C3	6	C	12	RF(3), HORIZONTAL BOLTS
13	C1	6	C	13	RF(1) AND ONE BOLT IS SHORT
14	X-FACE	6	C	14	COTTER PIN IS RUSTED ON RIGGING FAN PLATE
15	Y-FACE	6	C	15	RF(2), HORIZONTAL BOLTS & RF(1) DIAGONAL BOLT
16	Y-FACE	6	C	16	RF(1), DIAGONAL BOLT AND GUSSET IS RUSTED
17	Z-FACE	5.195	C	17	RUST ON TWO DIAGONAL GUSSETS
Sutro Tower				Signature: _____	Page: <u> 1 </u> of <u> 4 </u>
San Francisco, CA				File: _____	Date: 1-11-17

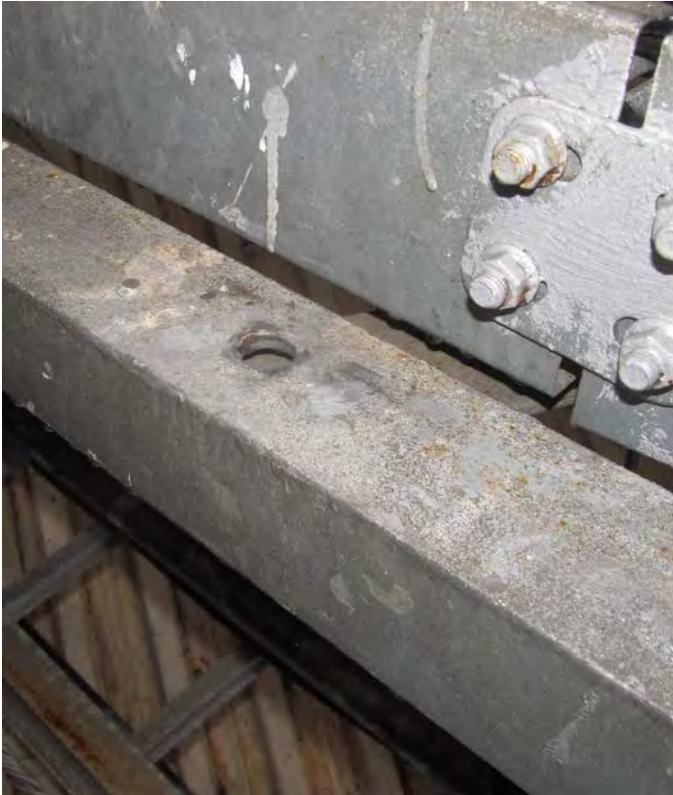
Photo 01.JPG
8/11/2016

Observ. No.	Location/Identification			Photo No.	Observation Comments
	Chord ¹	Horiz. Location	Item ²		
1	M	3.1	O	1	CATWALK HANDRAIL IS MISSING A BOLT
2	L	3.1	C	2	RF(1)
3	L	3.9	C	3	NEW BOLTS ARE NOT PAINTED
4	L	3.9	C	4	RF(5)
5	L	3.8	H	5	SKIN SUPPORT CHANNEL IS CUT
6	L	3.5	L	6	RUST ON VERTICAL
7	L	3.5	D	7	RUST ON DIAGONAL
8	L	3.3	H	8	SKIN SUPPORT CHANNEL IS CUT
9	L	3.1	C	9	RF(9)
10	L	3.1	C	10	RF(3)
11	U	3.1	C	11	RF(4)
12	U	3.1	H	12	MINOR RUST ON BEAM
13	U	3.1	O	13	RUSTED CLIPS ON SAFETY CABLE
<i>Sutro Tower</i>				Signature: _____	Page: <u> 1 </u> of <u> 1 </u>
<i>San Francisco, CA</i>				File: _____	Date: 1-11-17

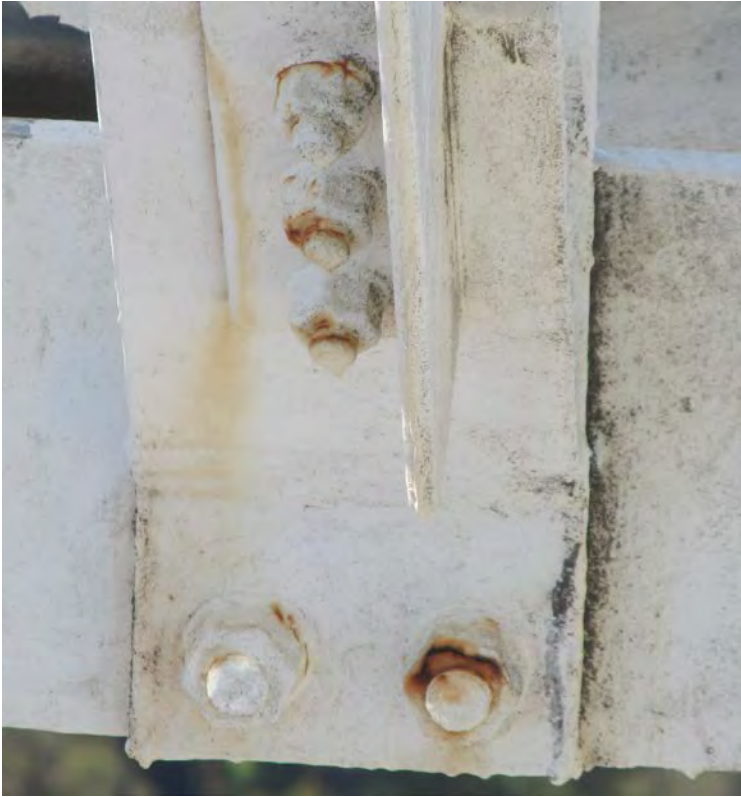
Photo 1.JPG
8/10/2016

Observ. No.	Location/Identification			Photo No.	Observation Comments
	Chord ¹	Horiz. Location	Item ²		
31	U	5.6	O	31	AUXILIARY OMNI ANTENNA
32	L	5.5	C	32	RF(7)
33	U	5.5	C	33	RF(7)
34	L	5.5	O	34	3" LINE JACKET IS DAMAGED
35	L	5.5	C	35	RF(5)
36	L	5.5	H	36	RUST ON BEAM
37	L	5.1	C	37	RF(10)
38	U	5.1	C	38	RF(7)
39	L	5.4	C	39	RF(4)
40	U	5.4	C	40	RF(14)
41	L	5.3	C	41	RF(4)
42	L	5.2	C	42	RF(3)
43	U	5.2	C	43	RF(8)
44	M	5.65	O	44	RUSTED CONDUIT
<i>Sutro Tower</i>				Signature: _____	Page: <u> 3 </u> of <u> 3 </u>
<i>San Francisco, CA</i>				File: _____	Date: 1-11-17

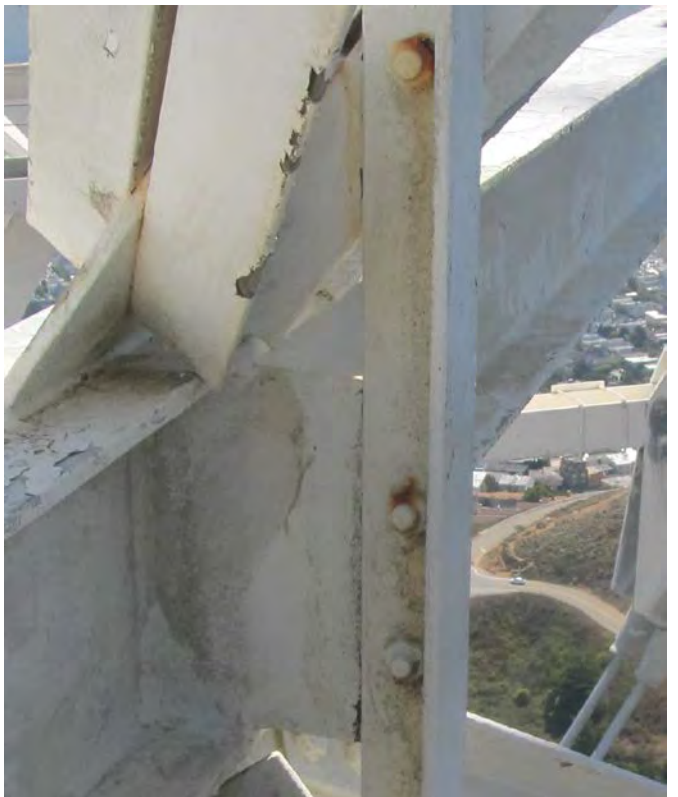
Photo 16.JPG
8/10/2016

Observ. No.	Location/Identification			Photo No.	Observation Comments
	Chord ¹	Horiz. Location	Item ²		
16	M	5.4	C	16	RF(2)
17	U	5.4	C	17	RF(1)
18	L	5.3	C	18	RF(2)
19	U	5.3	C	19	RF(4)
20	L	5.2	C	20	RF(4)
21	M	5.2	C	21	RF(1)
22	L	5.1	C	22	RF(1)
23	U	5.1	C	23	RF(2)
24	M	5.6	O	24	RUSTED HARDWARE FOR HANDRAIL CABLE
25	M	5.6	O	25	RUSTED HANDRAIL CABLES
26	M	5.8	O	26	HANDRAIL CABLE IS MISSING U-BOLT
27	L	5.7	C	27	RF(7)
28	U	5.7	C	28	RF(4)
29	L	5.6	C	29	RF(4)
30	U	5.6	C	30	RF(7)
