Project 067199.11 – Condition Assessment of Sutro Tower, 2018 Inspections
2017 Maintenance and Inspection Program

FIELD INSPECTION REPORT

WEST LEG A & NORTH TRUSS LEVEL 2-5

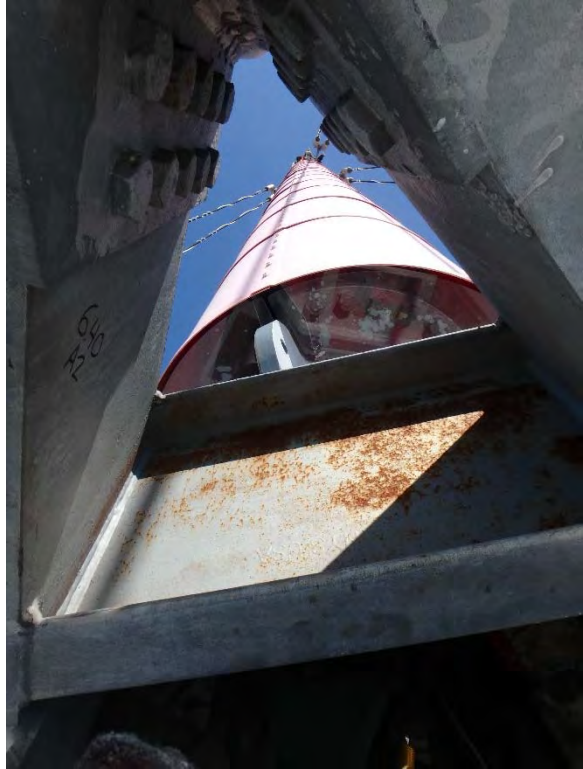
Picture 2: OBSERVATION 2

WEST STACK 'A' LATTICE MAST						
OBSERV. NO.	Location/Identification			Photo No.	OBSERVATION COMMENTS	RECOMMENDED CORRECTIVE ACTION (CA)
	Column	Elevation	Item			
1	A11	6.40	C	1	Minor Rust On Bolts, MRB (X6), Antenna Bolts	Surface prepare and treat
2	A2	6.40	H	2	Minor Rust On Inner Channel	Surface prepare and treat
3	A3	6.36	C	3	Short Bolt, SB (X1), ANCO Pin Not Fully Engaged, Leg Bolt	Replace with longer bolts, or remove flat washer to allow full engagement of ANCO locking pin
4	A2	6.36	C	4	SB (X2), ANCO Pin Not Fully Engaged, Leg Bolt	Replace with longer bolts, or remove flat washer to allow full engagement of ANCO locking pin
5	Z-FACE	6.36	C	5	Small Gouge In Gusset Plate (X1)	Lightly grind surface smooth and treat
6	(Inside)	6.34	O	6	J-Box Missing Plugs (X2)	Install missing plugs to keep weather-tight
7	Z-FACE	6.34	C	7	Hot Dip Galv, HDG, Coating Damaged (X2), Gusset Plate	Surface prepare and treat

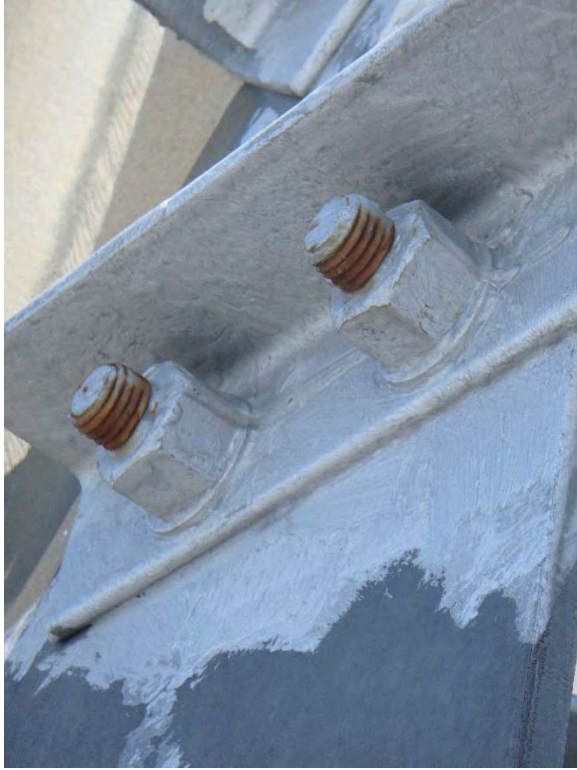
Picture 9: OBSERVATION 9

8	A3	6.32	C	8	SB (X1), ANCO Pin Not Fully Engaged, Leg Bolt	Replace with longer bolts, or remove flat washer to allow full engagement of ANCO locking pin
9	X-FACE	6.30	C	9	MRB (X2), Horiz Bolts	Surface prepare and treat
10	Y-FACE	6.30	C	10	MRB (X1), Diag Bolt	Surface prepare and treat
11	A1	6.24	C	11	SB (X2), ANCO Pin Not Fully Engaged, Leg Bolt	Replace with longer bolts, or remove flat washer to allow full engagement of ANCO locking pin
12	Y-FACE	6.22	C	12	MRB (X1), Diag Bolt	Surface prepare and treat
13	Y-FACE	6.20	C	13	MRB (X1), Diag Bolt	Surface prepare and treat
14	(Inside)	6.20	O	14	Minor Rust On J-Box Plugs (X2)	Replace plugs in near future
15	X-FACE	6.20	C	15-16	HDG Coating Damaged (X2), Gusset Plate	Surface prepare and treat
16	A2	6.16	C	17	SB (X2), ANCO Pin Not Fully Engaged, Leg Bolt	Replace with longer bolts, or remove flat washer to allow full engagement of ANCO locking pin
17	Y-FACE	6.16	O	18	Missing Rigid Line Spring Hanger (X1)	Corrected By Sutro Staff ~ Hanger installed 8/22/17

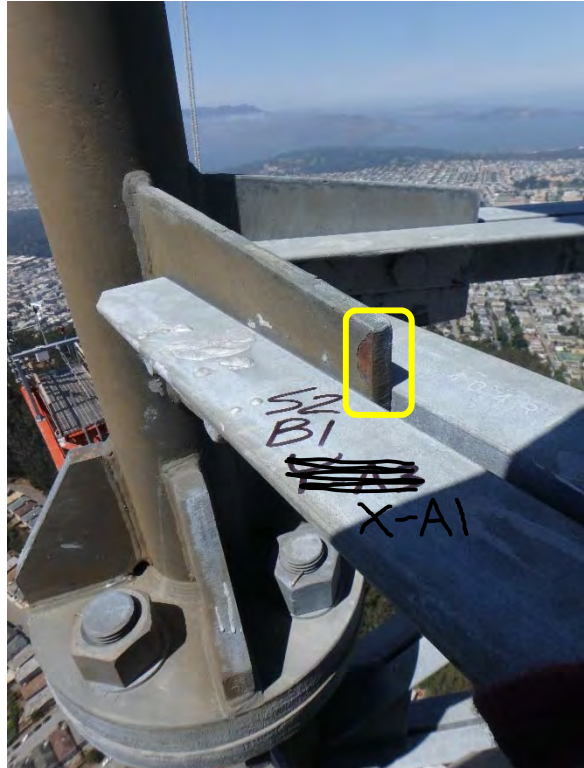
Picture 20: OBSERVATION 19

18	Z-FACE	6.14	C	19	HDG Coating Damaged (X2), Gusset Plate	Surface prepare and treat
19	X-FACE	6.6	C	20	HDG Coating Damaged (X1), Gusset Plate	Surface prepare and treat
20	Y-FACE	6.6	O	21-22	Rigid Line Spring Hanger Setting Off (X1)	Adjust hanger setting (34-3/8" at 40-80deg F)
21	(Inside)	6.2	O	23	SO J-Box Connector Broken (X1)	Replace connector
22	(Inside)	6	O	24	Minor Rust On 90° J-Box Connector	Replace connector in near future
23	Y-FACE	6	O	25	Standing Water In Gusseted Rigging Weldment	Drill drainage holes

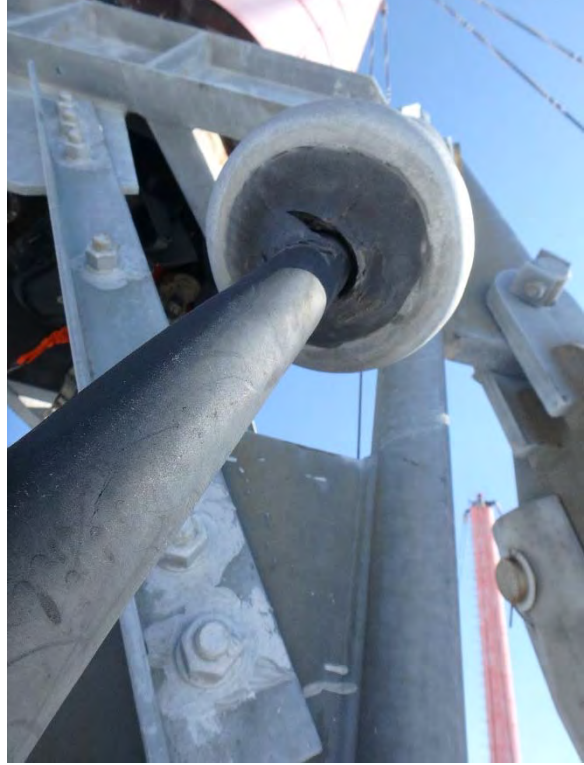
Picture 27: OBSERVATION 24 (TYP. TOWER END)

WEST STACK 'A' GUYING SYSTEM						
OBSERV. NO.	Location/Identification			Photo No.	OBSERVATION COMMENTS	RECOMMENDED CORRECTIVE ACTION (CA)
	Chord	Horiz. Location	Item			
24	Guying	All	O	26-27	Silicone Sealant At Socketed Corona Ends Has Split And Separated From The Cable And Socket At Most Locations Both At The Mast And Anchor Attachment Locations ~ No Damage Noted To Polyurethane Jackets Or Poured Resin	Remove loose silicone and debris and inject fresh pure black silicone ~ High quality pure black silicone from a local paint distributor may be used
25	Guying	All	O	-	Mild High Frequency Aeolian Vibration Noted On Multiple Cables During Inspection	Consider installing additional PLP spiral vibration dampers (SVD) to mitigate vibration ~ Recommend trial installation on single cable to compare with adjacent cable(s) prior to placing large order for SVD's to ensure adequate mitigation ~ Note, per discussion with Phillystran, high frequency aeolian vibration is not a structural concern for the Phillystran guying systems, but rather a general concern primarily for supported structures utilizing incandescent lighting where operational issues may arise from premature wear on filaments and electrical contact points imposed by the induced vibrations

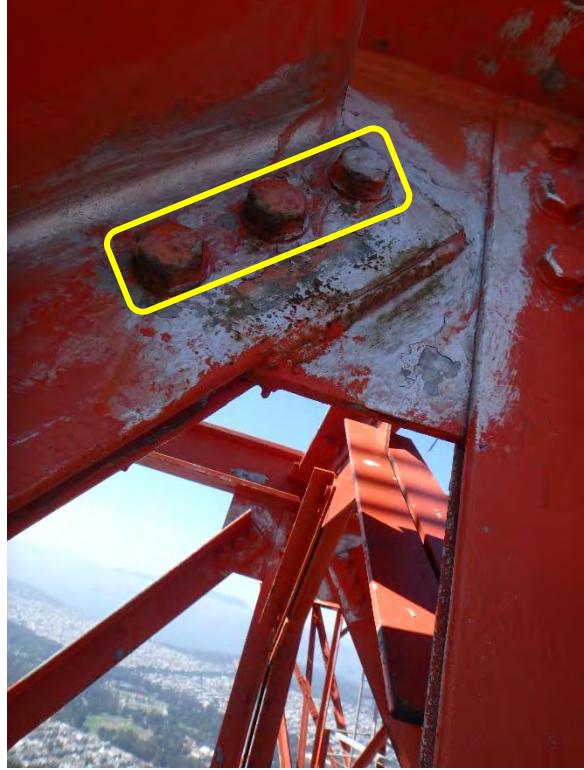
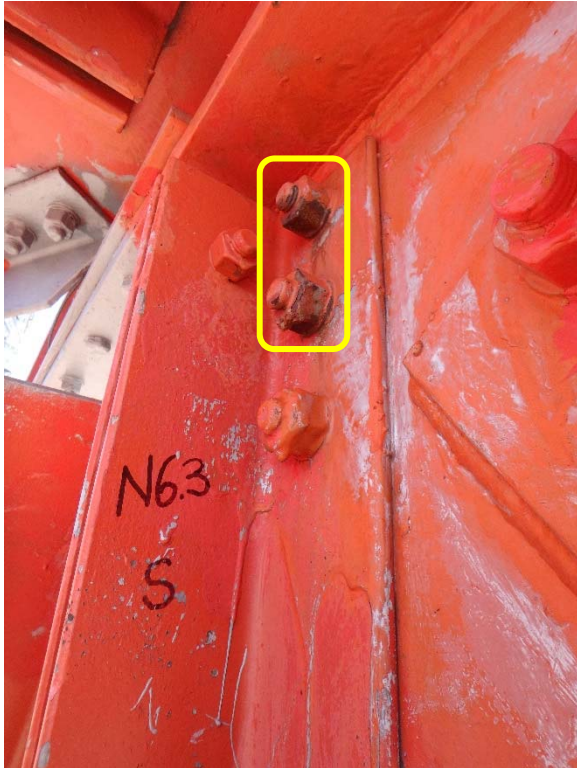
Picture 34: OBSERVATION 37

NORTH TRUSS (LEVEL 6)						
OBSERV. NO.	Location/Identification			Photo No.	OBSERVATION COMMENTS	RECOMMENDED CORRECTIVE ACTION (CA)
	Chord	Horiz. Location	Item			
36	IU	NW Outrigger	O	32-33	Damaged Cable, Apparrent Bird Damage	Consider running cable in flexible conduit to protect ~ Replace cable as needed
37	IU	6.3	C	34-35	MRB (X5), Leg & Diag Bolts	Surface prepare and treat
38	OU	6.3	C	36	MRB (X1), Leg Bolt	Surface prepare and treat
39	OL	6.10	C	37-38	MRB (X1), Leg Bolt	Surface prepare and treat
40	O	6.12	C	39-40	Loose Stitch Bolt Near Midspan, Leg	Properly drive stitch bolt and tighten
41	IU	6.12-6.13	D	41	Damaged Angle Reinforced Using Bolt-On Brace, Wind Brace	Issue previously assessed by EOR and deemed acceptable
42	IL	6.13	C	42-43	Loose Stitch Bolt Near Outer Leg, Wind Brace	Properly drive stitch bolt and tighten
43	IL	6.18-6.21	C	44-45	MRB (X4), Diag Bolts	Surface prepare and treat
44	IL	6.19	V/H	46-47	Minor Rust At Leg To Wind Brace Horiz Joint	Surface prepare and treat

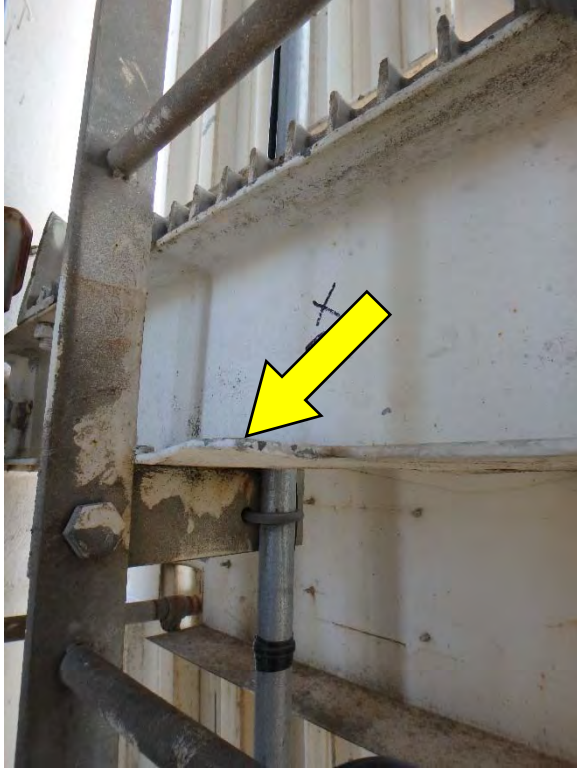
Picture 17: OBSERVATION 14

- **ON 14:** Damaged/bent flange on I-beam horizontal at elevation 5.10 on the X-Face inside the West Leg "A" (photo no. 17)
- **ON 47:** Damaged/bent angle leg on diagonal between elevations 1.29 and 1.31 on the Z-Face inside the West Leg "A" (photo no. 54-55)

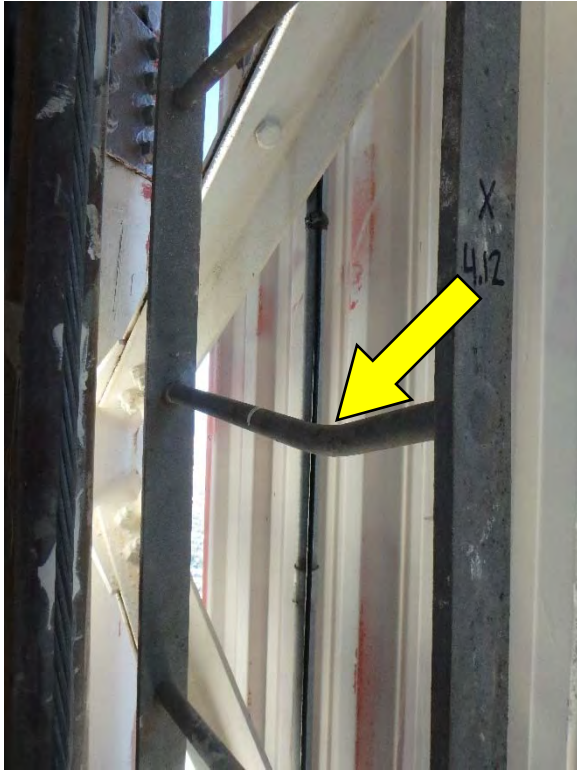
Picture 19: OBSERVATION 16

- **Observation Number (ON) 16:** Bent climbing ladder rung between elevations 4.11 and 4.13 on the X-face inside the West Leg “A” (photo no. 19)
- **ON 37:** Safety cable keeper gate broken between elevations 2.27 and 2.29 on the X-face inside the West Leg “A” (photo no. 41)
- **ON 78:** The magnetic safety gate does not properly latch closed in Truss Level 3 at Northeast Leg “C” (photo no. 92-93)
- **ON 105:** The magnetic safety gate does not properly latch closed in Truss Level 2 at Northeast Leg “C” (photo no. 124)
- **ON 140:** The existing staircase leading to the Leg A base access is not properly supported, and one of the supporting posts is not adequately anchored to the ground (photo no. 167-168)

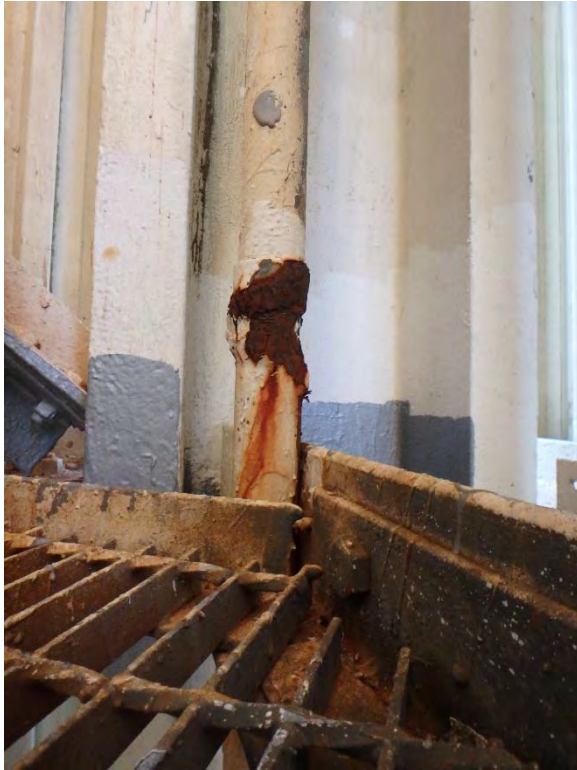
Picture 63: OBSERVATION 54

46	Z-Face	2.0-1	C	53	Missing stitch bolt; Diagonal	Install new Ø3/4"x2-1/2" HDG A325 bolt with ANCO lock nut
47	Z-Face	1.29-31	D	54-55	Damaged/bent angle leg on diagonal	Field-straighten, or contact EOR to determine if any CA is warranted
48	X-Face	1.27-29	O	56	Severe rust on Ø1.9" conduit	Replace conduit
49	Z-Face	1.27	O	57	Lighting fixture junction box cover is severely corroded/disconnected and moderate rust present on conduit	Replace junction box cover, and surface prepare and treat conduit, or replace
50	OB Level	1.27-29	O	58	Moderate rust on red light conduit feed	Surface prepare and treat
51	X-Face	1.19-21	O	59-60	Rusted plugs on junction box (x4)	Replace junction box plugs
52	Z-Face	1.19-21	O	61	Severe rust on Ø2.375" conduit	Replace conduit
53	Z-Face	1.17	O	62	Severe rust on Ø2.375" conduit	Replace conduit
54	Y-Face	1.15	O	63	Severe rust on Ø1.9" conduit	Replace conduit
55	Y-Face	1.13	O	64	Severe rust on Ø1.9" conduit	Replace conduit

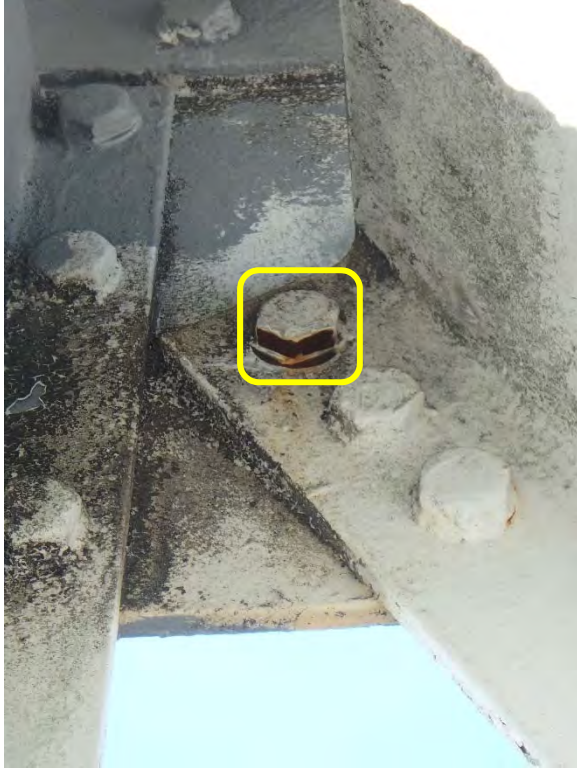
Picture 73: OBSERVATION 62

NORTH TRUSS (LEVEL 5)						
OBSERV. NO.	Location/Identification			Photo No.	OBSERVATION COMMENTS	RECOMMENDED CORRECTIVE ACTION (CA)
	Chord	Horiz. Location	Item			
62	U	5.4-5	C	73	MRB (x1); Diag bolt	Surface prepare and treat
63	U	5.4	C	74	MRB (x1); Vertical bolt	Surface prepare and treat
64	L	5.1	C	75	MRB (x2); Leg bolts	Surface prepare and treat
65	U	5.4-5	C	76	Loose/unseated stitch bolt; Diag	Drive bolt to properly seat and tighten, or replace if "shanked out"
66	U	Antenna Mount	C	77	MRB (x1); Mount u-bolt	Surface prepare and treat, or replace
67	L	5.90	C	78	MRB (x7); Leg bolts	Surface prepare and treat

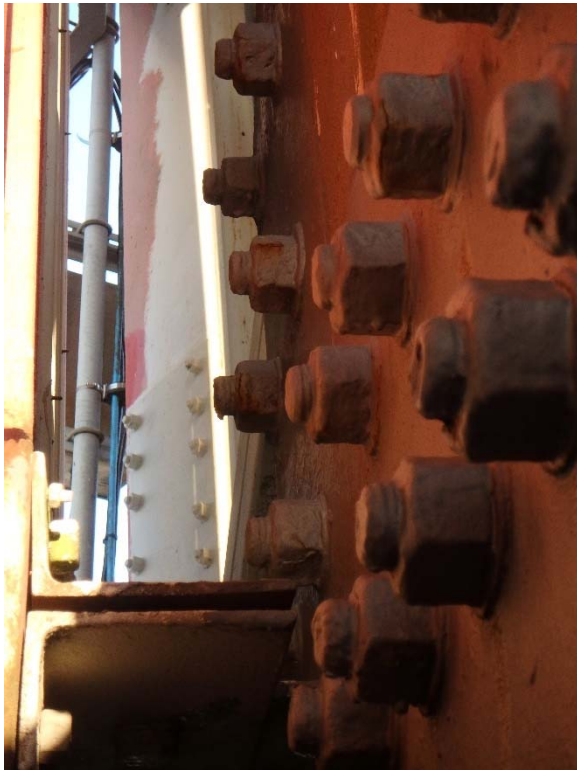
Picture 79: OBSERVATION 68

NORTH TRUSS (LEVEL 4)						
OBSERV. NO.	Location/Identification			Photo No.	OBSERVATION COMMENTS	RECOMMENDED CORRECTIVE ACTION (CA)
	Chord	Horiz. Location	Item			
68	U	4.7	C	79	MRB (x3); Leg bolts	Surface prepare and treat
69	U	4.3	V	80	Minor rust on vertical	Surface prepare and treat
70	U	4.6-7	D	81-82	Damaged/bent angle leg on diagonal	Field-straighten, or contact EOR to determine if any CA is warranted
71	L	4.7	C	83	MRB (x2); Leg bolts	Surface prepare and treat
72	U	HOIST	O	84	Minor rust on anti-two block fixture, counterweight, and counterweight cable/end terminations	Surface prepare and treat fixture and counterweight, or replace; and replace cable and end terminations to counterweight
73	U	---	O	85	Disconnected equipment atop Truss level	(For reference purposes only)
74	L	4.6	C	86-87	MRB (x7); Vertical bolts; and minor rust on Horiz & Diag	Surface prepare and treat
75	L	DISH	O	88-89	Butterfly hanger disconnected on EW line feeding dish, and apparent bird damage at old kit	Install new EW line hanger(s) to properly support and prevent ongoing wear and tear, and repair ground kit

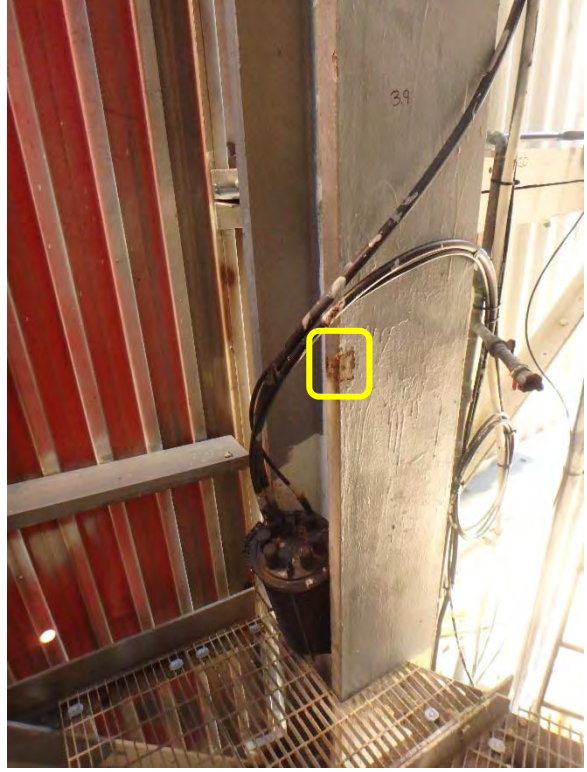
Picture 90: OBSERVATION 76

NORTH TRUSS (LEVEL 3)						
OBSERV. NO.	Location/Identification			Photo No.	OBSERVATION COMMENTS	RECOMMENDED CORRECTIVE ACTION (CA)
	Chord	Horiz. Location	Item			
76	M	3.9	L	90	Minor rust on Leg	Surface prepare and treat
77	U	3.9	C	91	MRB (x1); Leg bolt	Surface prepare and treat
78	M	Leg C	O	92-93	Safety gate does not properly latch closed	Reverse gate stop attached to ladder rail to ensure proper closure
79	M	3.3	V	94-95	Damaged/bent flange on I-beam vertical	Field-straighten, or contact EOR to determine if any CA is warranted
80	U	3.3	C	96	MRB (x1); Vertical bolt	Surface prepare and treat
81	U	3.2	C	97	MRB (x1); Vertical bolt	Surface prepare and treat
82	U	3.2	C	98	MRB (x2); Vertical bolt	Surface prepare and treat
83	U	3.6-7	C	99	Minor rust on stitch bolt spacer plate; Diag	Surface prepare and treat
84	L	3.4-5	C	100	Missing stitch bolt; Diagonal	Install new $\varnothing 3/4$ "x2-3/4" HDG A325 bolt with ANCO lock nut

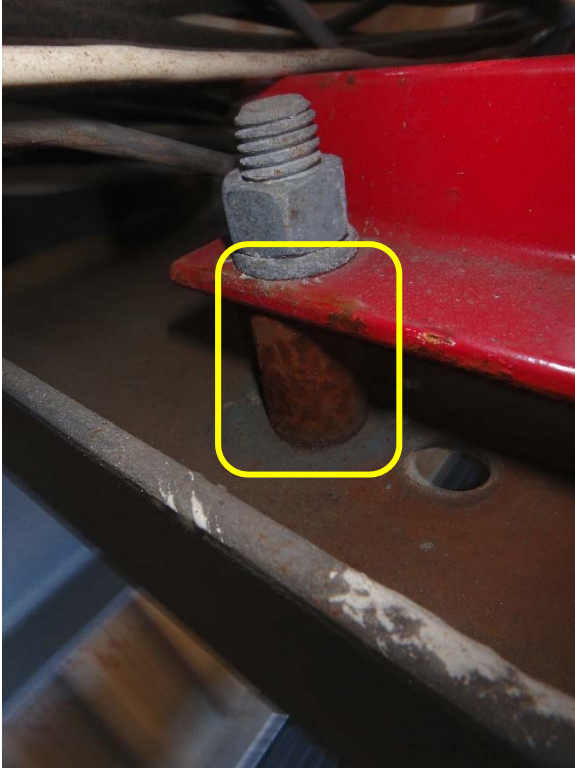
Picture 101: OBSERVATION 85

85	M	HOIST	O	101-102	Minor rust on hoist mount spacers	Surface prepare and treat, or replace
86	U	3.9	O	103	Rusted cotter on safety line turnbuckle pin	Replace cotter pin
87	U	Antenna Mount	C	104	MRB (x2); Mount v-bolts	Surface prepare and treat, or replace
88	U	Antenna Mount	C	105	MRB (x4); Mount all-thread	Surface prepare and treat, or replace
89	L	3.9	C	106	MRB (x10); Leg bolts	Surface prepare and treat
90	L	3.8	C	107	Minor rust on Vertical gusset	Surface prepare and treat
91	L	3.1-2	C	108	MRB (x3); Diag bolts	Surface prepare and treat
92	L	3.1	C	109	MRB (x3); Leg bolts	Surface prepare and treat
93	L	3.1	C	110-111	MRB (x1); Leg bolt	Surface prepare and treat

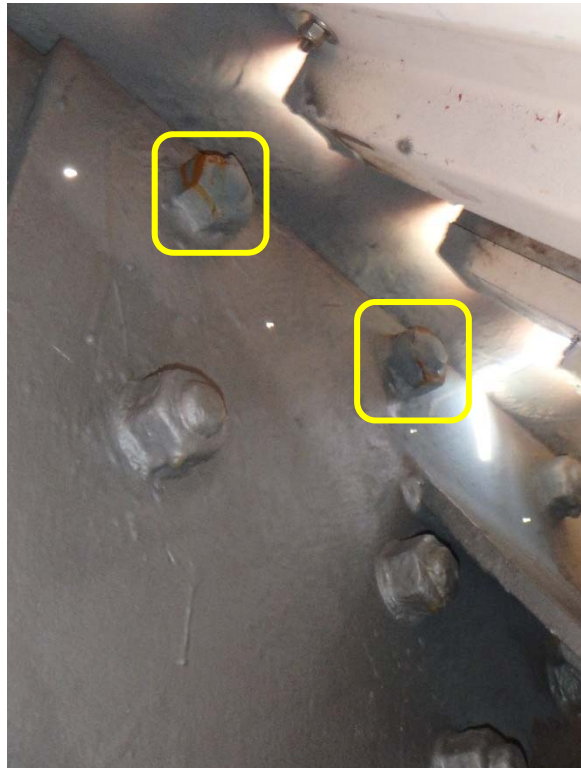
Picture 112: OBSERVATION 94

NORTH TRUSS (LEVEL 2) - 1 OF 2						
OBSERV. NO.	Location/Identification			Photo No.	OBSERVATION COMMENTS	RECOMMENDED CORRECTIVE ACTION (CA)
	Chord	Horiz. Location	Item			
94	U	2.10	C	112	MRB (x2); Vertical bolts	Surface prepare and treat
95	U	2.9	C	113-114	MRB (x2); Vertical bolts	Surface prepare and treat
96	U	2.8	C	115	MRB (x1); Vertical bolt	Surface prepare and treat
97	U	2.7	C	116	MRB (x2); Vertical bolts	Surface prepare and treat
98	M	2.8-9	C	117	Missing stitch bolt; Diagonal	Install new Ø3/4"x2-3/4" HDG A325 bolt with ANCO lock nut
99	U	2.9	C	118	Missing stitch bolt; Vertical	Install new Ø3/4"x3" HDG A325 bolt with ANCO lock nut
100	M	2.10-11	C	119	MRB (x1); Diag bolt	Surface prepare and treat
101	M	2.11	C	120	MRB (x1); Vertical bolt	Surface prepare and treat
102	M	2.12	C	121	MRB (x3); Vertical bolts	Surface prepare and treat
103	M	2.12-13	C	122	MRB (x2); Diag bolts	Surface prepare and treat
104	M	2.12	C	123	MRB (x1); Vertical bolt	Surface prepare and treat

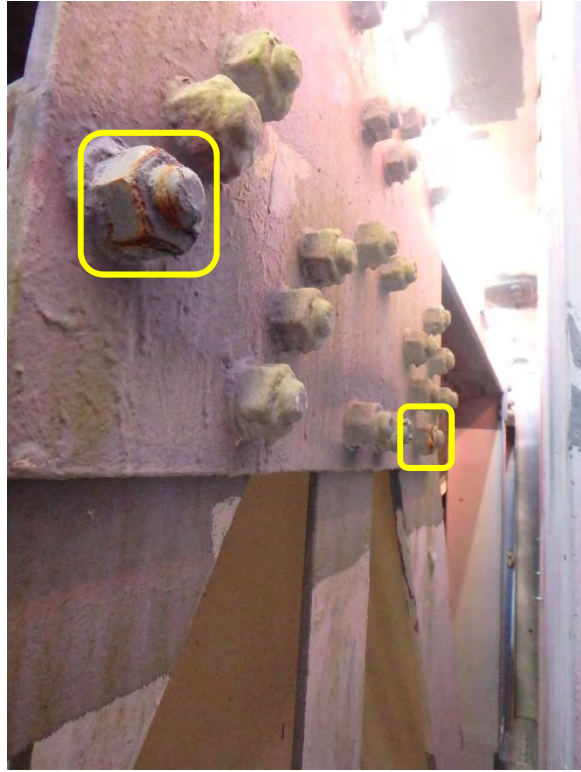
Picture 138: OBSERVATION 117

117	U	2.4	C	138	MRB (x2); Vertical bolts	Surface prepare and treat
118	U	2.3	C	139	MRB (x1); Vertical bolt	Surface prepare and treat
119	M	2.2-3	C	140	Conduit horiz run missing u-bolt at post	Install missing u-bolt
120	M	2.4-5	C	141	Conduit horiz run missing u-bolt at post	Install missing u-bolt
121	M	2.6-7	C	142	Conduit horiz run missing u-bolt at post	Install missing u-bolt
122	M	2.12-13	O	143	Conduit junction cover missing screw	Install missing screw
123	L	2.13	C	144	MRB (x1); Diag bolt	Surface prepare and treat
124	M	2.12	C	145	MRB (x1); Walkway support angle bolt	Surface prepare and treat
125	L	2.11	C	146	MRB (x1); Vertical bolt	Surface prepare and treat
126	M	2.10	C	147	MRB (x1); Walkway support angle bolt	Surface prepare and treat
127	L	2.7	C	148	MRB (x1); Vertical bolt	Surface prepare and treat
128	L	2.7	C	149	MRB (x2); Vertical bolts	Surface prepare and treat
129	M	2.6	C	150	MRB (x1); Walkway support angle bolt	Surface prepare and treat

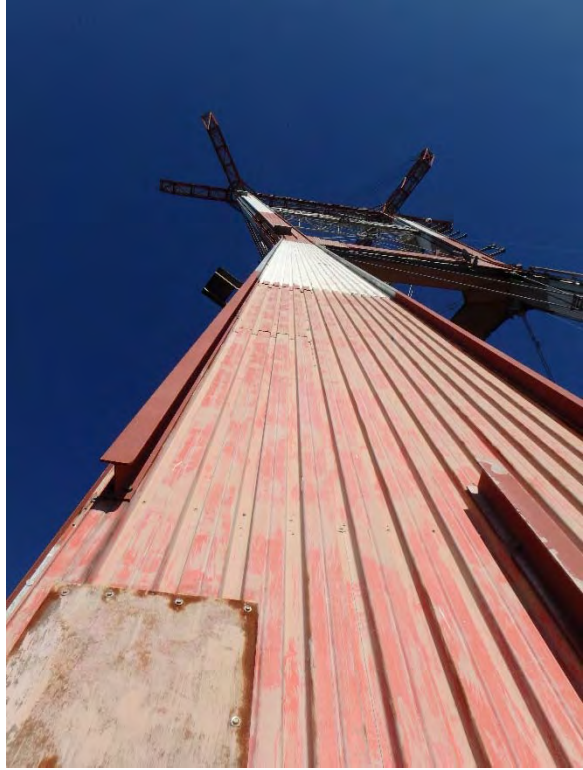
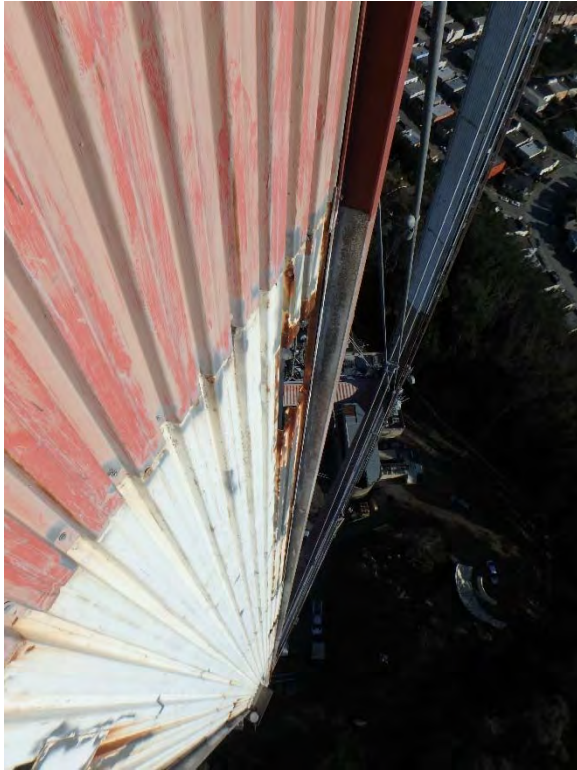
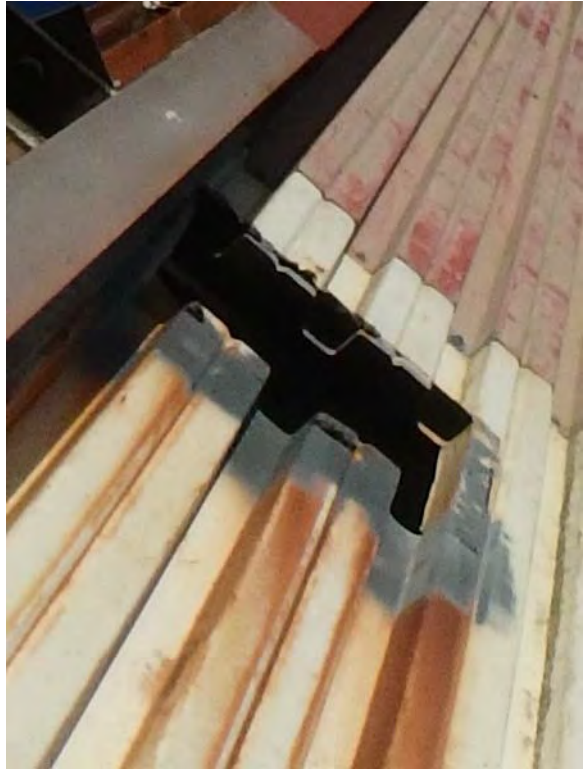
Picture 162: OBSERVATION 138

MISCELLANEOUS				
OBSERV. NO.	Location/Identification	Photo No.	OBSERVATION COMMENTS	RECOMMENDED CORRECTIVE ACTION (CA)
138	CLADDING	161-164	The existing cladding is considered in fair condition due to numerous cut-outs, minor surface rust, and inconsistent attachment means	Contact EOR to determine appropriate long-term repairs required for cladding including support framing and attachments
139	X-FACE (INSIDE LEG A)	165-166	Rope used for additional cladding support is degraded and should not be used for stabilizing cladding for long-term conditions	Structural supports should be used along with permanent attachments/fasteners for properly securing the cladding
140	LEG A BASE STAIRCASE	167-168	The existing staircase leading to the Leg A base access is not properly supported, and one of the supporting posts is not adequately anchored to the ground	Contact EOR to determine appropriate repairs to staircase; at minimum, one additional post should be installed and the existing post anchors should be repaired

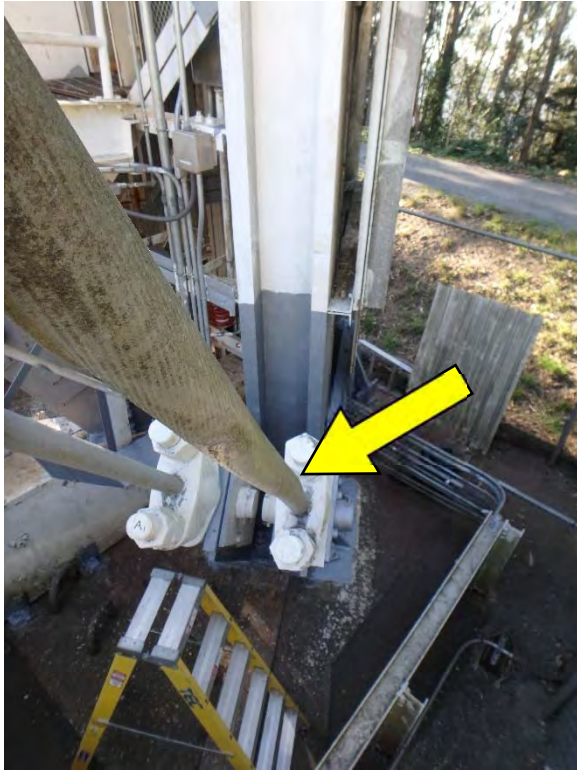
Picture 169: OBSERVATION 141

Note "Kink"

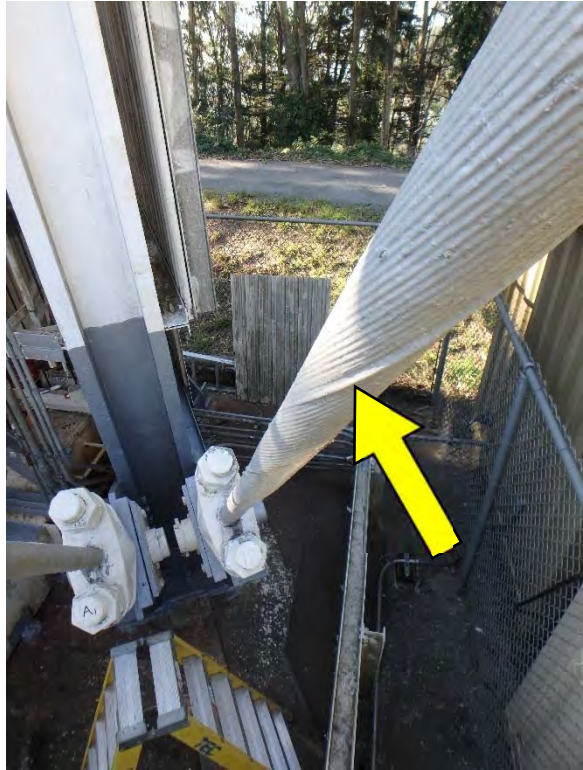
Picture 170: OBSERVATION 141

Note Unraveled Strands

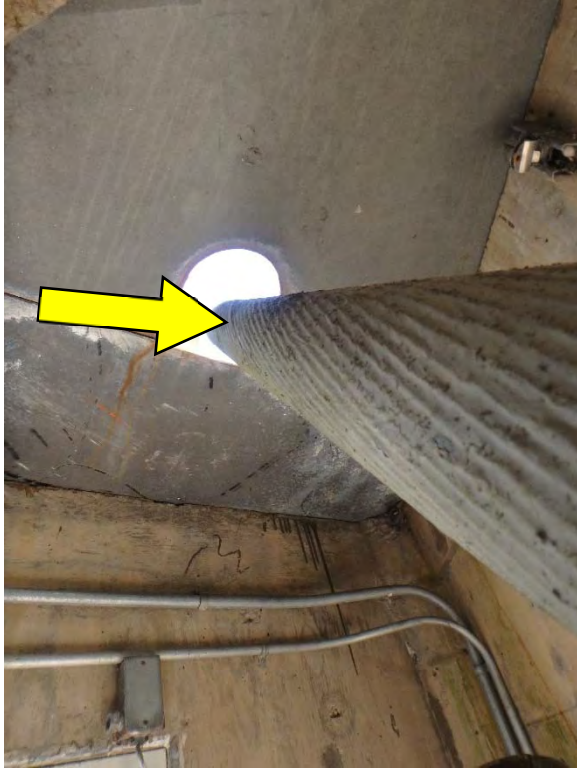
Picture 173: OBSERVATION 144

- **ON 144:** The outer North face strands between Levels 1 & 2 near the Leg C anchor attachment are slightly unraveled (photo no. 173)

Note Unraveled Strands

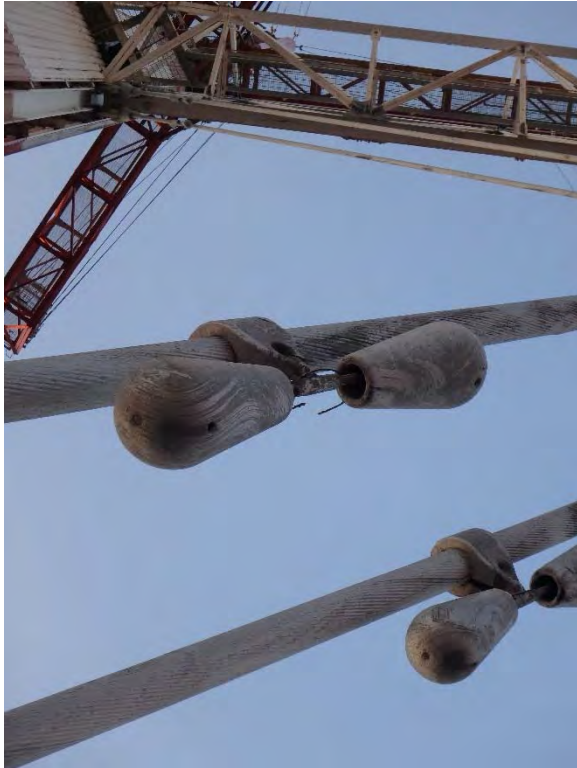
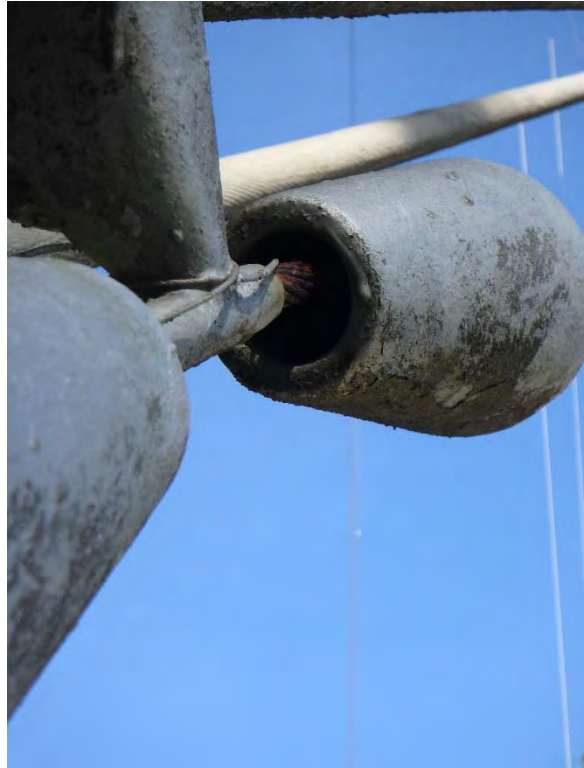
Picture 175: OBSERVATION 146

145	STRANDS	174	The end termination hairpin assembly for the outer North face strands between Levels 1 & 2 near the Leg C anchor attachment is out of square by roughly 3/8"	Adjust hairpin assembly to balance load
146	STRANDS	175-176	Strand high frequency dampers should be replaced throughout structure (numerous broken/degraded safeties, stiff/corroded damper cables, missing dampers, etc.)	Replace high frequency strand dampers
