# FIELD INSPECTION REPORT

## SE STACK B, SE LEG B & EAST TRUSS LEVELS 2-6

### MARCH 8, 2019

ERI PROJECT 36434/A  
977 FT SELF-SUPPORT TOWER  
SAN FRANCISCO, CA  
ASRN 1001289

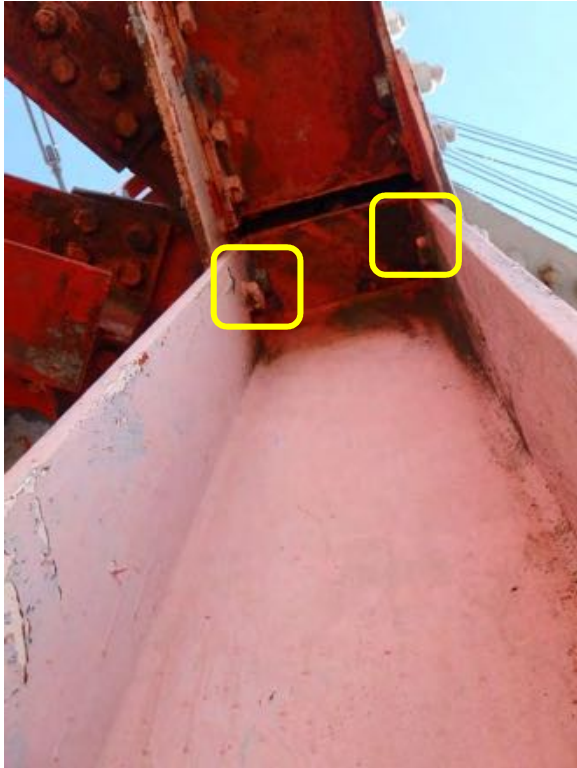
Picture 3: OBSERVATION 3

SOUTHEAST LEG 'B'						
OBSERV. NO.	Location/Identification			Photo No.	<sup>2</sup> OBSERVATION COMMENTS	RECOMMENDED CORRECTIVE ACTION (CA)
	Column	Elevation	<sup>1</sup> Item			
3	Ba	6.3	C	3	MRB (x6); Column bolts	Surface prepare and treat, or replace
4	Bc	6.3	C	4	MRB (x1); Column bolts	Surface prepare and treat, or replace
5	Bb	6.1	C	5	MRB (x3); Column bolts	Surface prepare and treat, or replace
6	N/A	6.0-6.1	O	6	MRB (x5); Top safety climb attachment hardware	Surface prepare and treat, or replace
7	Bb	6.0	C	7	MRB (x2); Horiz bolts	Surface prepare and treat, or replace
8	Ba	6.0	C	8	MRB (x3); Horiz bolts	Surface prepare and treat, or replace
9	Z-Face	6.0-6.1	C	9	MRB (x3); Diag bolts	Surface prepare and treat, or replace
10	Bb	6.0	C	10	Minor Rust; Gusset plates	Surface prepare and treat
11	Bb	5.20-6.0	C	11	MRB (x15); Rein plate bolts	Surface prepare and treat, or replace
12	Z-Face	5.17	C	12	MRB (x2); Horiz bolts	Surface prepare and treat, or replace

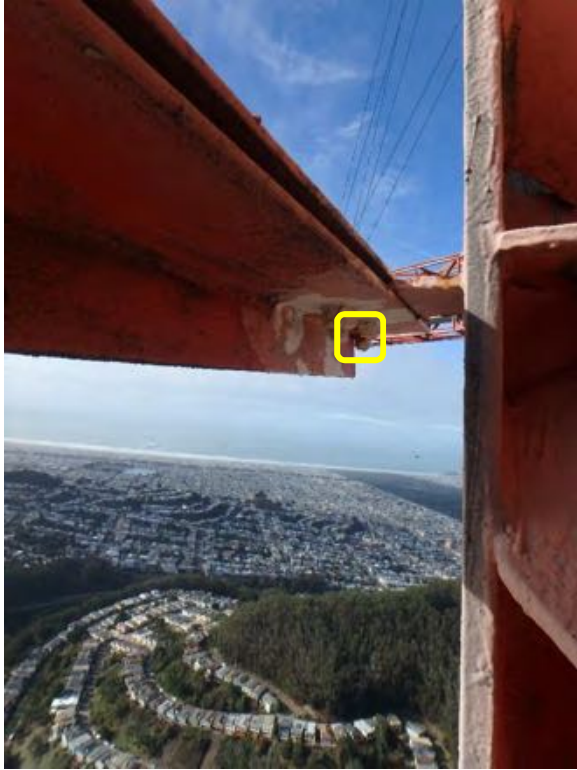
Picture 13: OBSERVATION 13

13	Z-Face	5.17	C	13	MRB (x1); Cladding support bolts	Surface prepare and treat, or replace
14	X-Face	5.13	C	14	MRB (x1); Cladding support bolts	Surface prepare and treat, or replace
15	Bb	5.10	C	15	MRB (x4); Column bolts	Surface prepare and treat, or replace
16	Bb	5.8	D	16	Minor Rust	Surface prepare and treat
17	Bb	5.7	C	17	MRB (x9); Rein plate bolts	Surface prepare and treat, or replace
18	Bc	5.7	C	18	Minor Rust; Gusset plates	Surface prepare and treat
19	Bb	5.6	C	19	MRB (x13); Rein plate bolts	Surface prepare and treat, or replace
20	Bb	5.5	C	20	MRB (x6); Rein plate bolts	Surface prepare and treat, or replace
21	Bb	5.4-5.5	C	21	MRB (x11); Column splice bolts	Surface prepare and treat, or replace
22	Ba	5.4-5.5	C	22	MRB (x4); Column splice bolts	Surface prepare and treat, or replace
23	Ba	5.3-5.4	C	23	Loose bolt in column	Tighten or replace bolt
24	Ba	5.3	C	24	MRB (x6); Column bolts	Surface prepare and treat, or replace

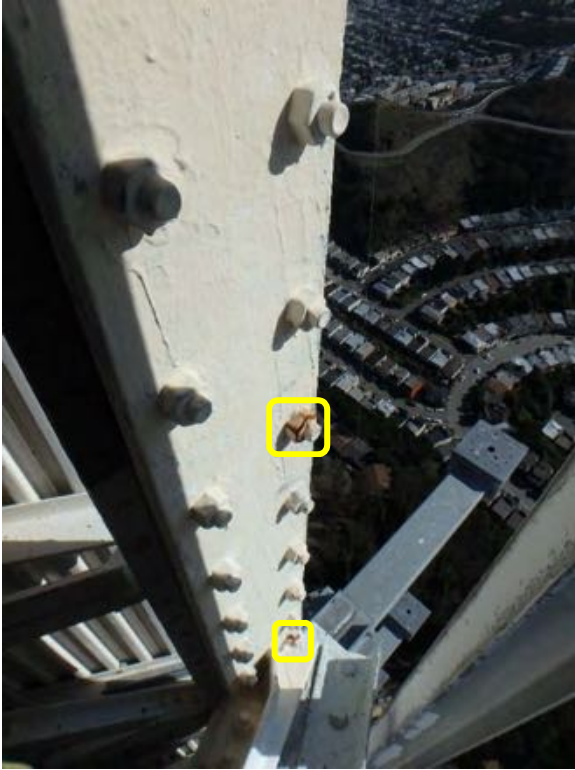
Picture 25: OBSERVATION 25

25	Ba	5.3	C	25	MRB (x2); Column bolts	Surface prepare and treat, or replace
26	Ba	5.2	C	26	MRB (x8); Rein plate bolts	Surface prepare and treat, or replace
27	X-Face	5.1	C	27	MRB (x1); Horiz bolts	Surface prepare and treat, or replace
28	Bc	5.1	C	28	Minor Rust; Gusset plates	Surface prepare and treat
29	Ba	5.1	C	29	MRB (x9); Rein plate bolts	Surface prepare and treat, or replace
30	Y-Face	5.0	C	30	MRB (x2); Cladding support bolts	Surface prepare and treat, or replace
31	Bc	5.0	C	31	MRB (x2); Column bolts	Surface prepare and treat, or replace
32	Y-Face	5.0	C	32	MRB (x1); Horiz bolts & Minor Rust; Gusset plates (Bc)	Surface prepare and treat, or replace
33	Ba	5.0	C	33	MRB (x5); Column bolts	Surface prepare and treat, or replace
34	Bb	5.0	C	34	MRB (x1) & Loose bolt; Column bolts	Surface prepare, treat, and tighten; or replace bolt
35	Bb	4.19	C	35	MRB (x6); Rein plate bolts	Surface prepare and treat, or replace

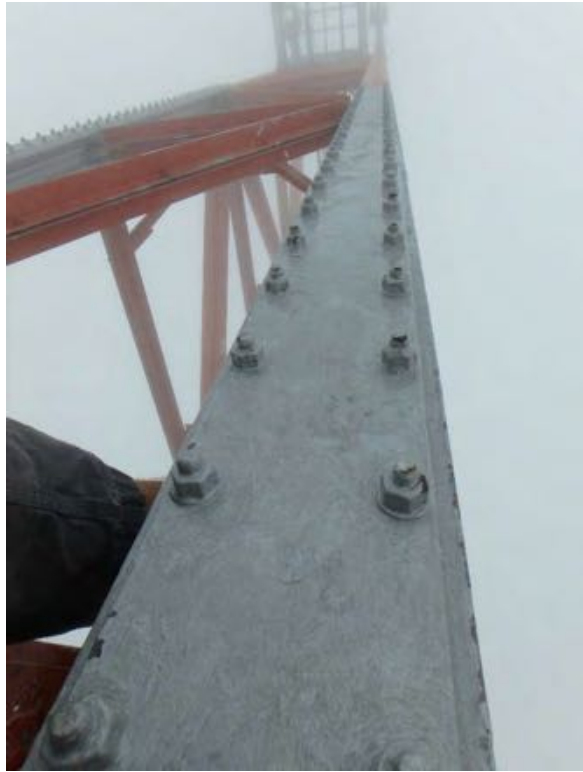
Picture 351: OBSERVATION 351

351	OU	6.4	C	351	Missing Bolt; Chord flange rein plate	Install missing bolt; If interference prevents installation, contact EOR
352	L	6.4	C	352	MRB (x1); Horiz wind brace bolts	Surface prepare and treat, or replace
353	O	6.5-6.6	C	353	Diag stitch bolt spacer plate too thin	Replace with 1/2" spacer plate
354	OU	6.2-6.3	C	354	MRB (x2); Diag bolts	Surface prepare and treat, or replace
355	OL	6.5	C	355	MRB (x1); Vertical bolts	Surface prepare and treat, or replace
356	---	6.2	O	356	Moderate Rust; Top rail	Surface prepare and treat, or replace
357	I	6.10	C	357	MRB (x1); Vertical bolts	Surface prepare and treat, or replace
358	IL	6.14-6.15	C	358	MRB (x1); Chord splice plate bolts	Surface prepare and treat, or replace
359	IL	6.17-6.18	Chord	359	Minor Yielding; Chord web ~ Web out 1/2" over 18" span	Contact EOR to determine if any CA is warranted
360	'C' LEG	'C' LEG	O	360	Safety gate does not properly latch closed	Adjust gate to ensure proper closure

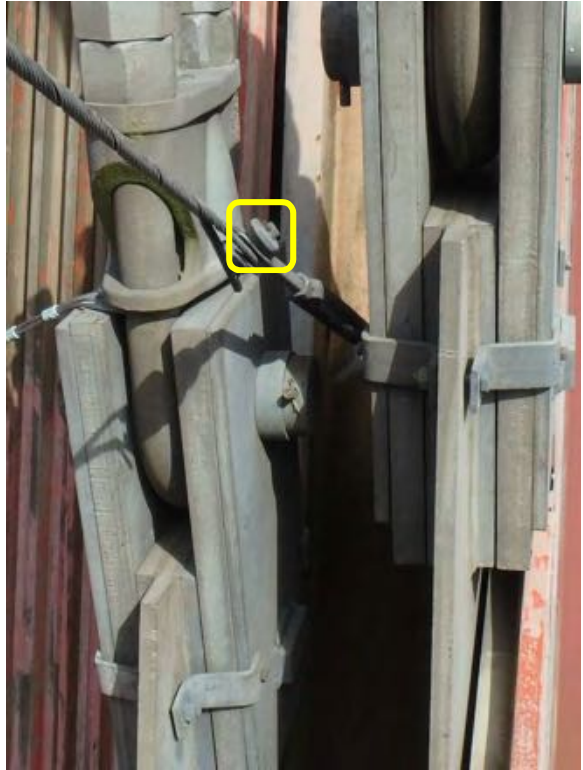
Picture 464: OBSERVATION 464

EAST TRUSS (LEVEL 2)						
OBSERV. NO.	Location/Identification			Photo No.	OBSERVATION COMMENTS	RECOMMENDED CORRECTIVE ACTION (CA)
	<sup>1</sup> Chord	Horiz. Location	<sup>2</sup> Item			
464	U	2.1	O	464	Minor Rust; HLL turnbuckle cotter pins	Surface prepare and treat, or replace
465	U	2.13	C	465	Minor Rust; HLL turnbuckle cotter pins	Surface prepare and treat, or replace
466	U	2.13	C	466	MRB (x3); Chord splice plate bolts	Surface prepare and treat, or replace
467	U	2.13	C	467	MRB (x6); Chord splice plate bolts	Surface prepare and treat, or replace
468	U	2.12	C	468	MRB (x4); Chord splice plate bolts	Surface prepare and treat, or replace
469	U	2.11	C	469	MRB (x1); Chord splice plate bolts	Surface prepare and treat, or replace
470	U	2.11	C	470	MRB (x1); Chord splice plate bolts	Surface prepare and treat, or replace
471	U	2.10-2.11	C	471	MRB (x4); Cladding support bolts	Surface prepare and treat, or replace

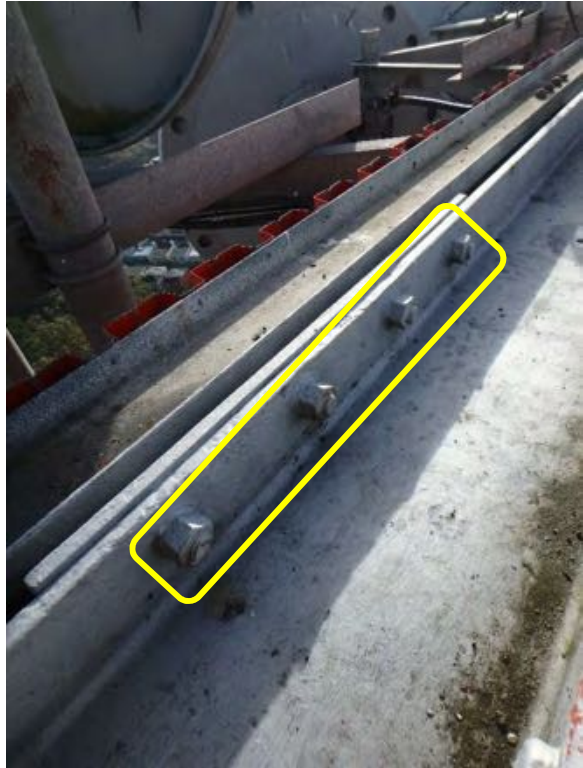
Picture 472: OBSERVATION 472

472	U	2.10	C	472	MRB (x4); Chord splice plate bolts	Surface prepare and treat, or replace
473	U	2.10	C	473	Minor Rust; Antenna mount hardware	Surface prepare and treat, or replace
474	U	2.9-2.10	C	474	MRB (x4); Cladding support bolts	Surface prepare and treat, or replace
475	U	2.9	C	475	Minor/Moderate Rust; Antenna support pole	Surface prepare and treat, or replace
476	U	2.9	C	476	Moderate/Severe Rust; Antenna pole base flange bolts	Replace all base flange bolts
477	U	2.9	O	477	Moderate/Severe Rust; Support pole step bolts	Replace steps bolts, or eliminate to prevent usage
478	U	2.9	C	478	MRB (x3); Chord splice plate bolts	Surface prepare and treat, or replace
479	U	2.8	C	479	Minor Rust; Antenna mount hardware	Surface prepare and treat, or replace
480	U	2.7	C	480	Minor Rust; Antenna mount hardware	Surface prepare and treat, or replace
481	U	2.7	C	481	Minor Rust; Antenna mount	Surface prepare and treat, or replace

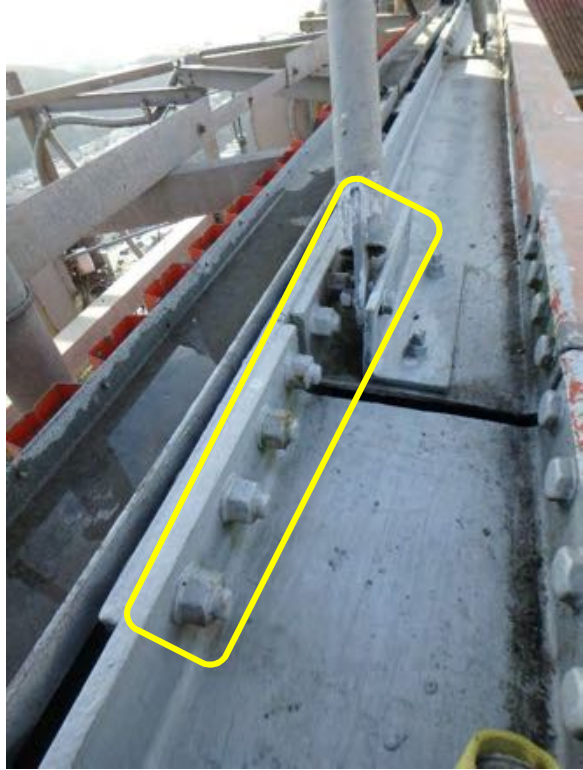
Picture 482: OBSERVATION 482

482	U	2.7	C	482	MRB (x7); Chord splice plate bolts	Surface prepare and treat, or replace
483	U	2.6-2.7	C	483	MRB (x1); Cladding support bolts	Surface prepare and treat, or replace
484	U	2.6	C	484	MRB (x3); Chord splice plate bolts	Surface prepare and treat, or replace
485	U	2.5-2.6	C	485	Minor Rust; Chord member	Surface prepare and treat
486	U	2.5	C	486	MRB (x1); Chord splice plate bolts	Surface prepare and treat, or replace
487	U	2.4	C	487	MRB (x4); Chord splice plate bolts	Surface prepare and treat, or replace
488	U	2.3-2.4	C	488	MRB (x2); Cladding support bolts	Surface prepare and treat, or replace
489	U	2.2-2.4	C	489	Minor Rust; Antenna mounts & hardware	Surface prepare and treat, or replace
490	U	2.2	C	490	MRB (x3); Chord splice plate bolts	Surface prepare and treat, or replace
491	U	2.2	C	491	MRB (x3); Chord splice plate bolts	Surface prepare and treat, or replace
492	U	2.1	C	492	MRB (x2); Chord splice plate bolts	Surface prepare and treat, or replace

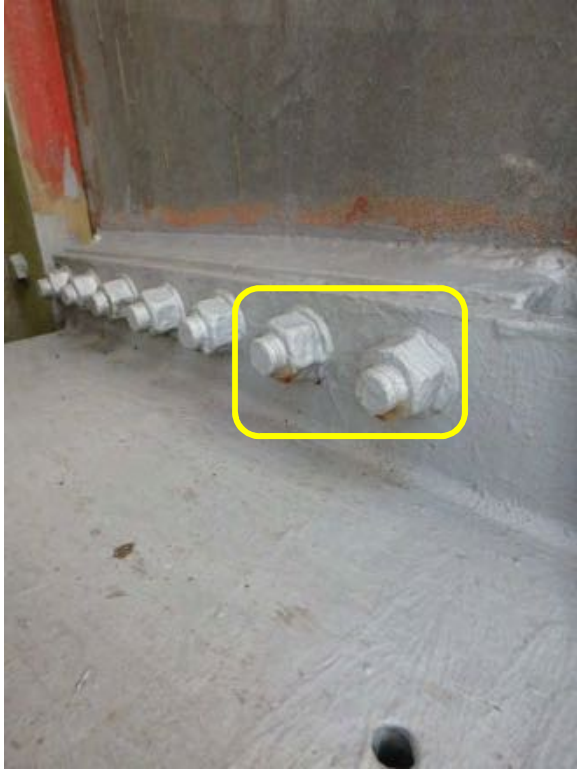
Picture 493: OBSERVATION 493

493	U	2.1	C	493	MRB (x2); Chord splice plate bolts	Surface prepare and treat, or replace
494	L	2.4	C	494	MRB (x8); Antenna support pole bolts	Surface prepare and treat, or replace
495	L	2.4	C	495	MRB (x1); External platform framing bolts	Surface prepare and treat, or replace
496	M	2.4	C	496	Minor Rust; Line elbow support chain and turnbuckle	Surface prepare and treat, or replace
497	---	2.13	Bc Column	497	Minor Rust; Column flange	Surface prepare and treat
498	L	2.13	C	498	MRB (x2); Chord splice plate bolts	Surface prepare and treat, or replace
499	U	2.12	C	499	MRB (x2); Chord splice plate bolts	Surface prepare and treat, or replace
500	U	2.8	C	500	MRB (x1); Chord splice plate bolts	Surface prepare and treat, or replace
501	---	2.7	C	501	Minor Rust; Vertical flange	Surface prepare and treat
502	U	2.7	C	502	MRB (x5); Chord splice plate bolts	Surface prepare and treat, or replace
503	U	2.5	C	503	MRB (x4); Chord splice plate bolts	Surface prepare and treat, or replace

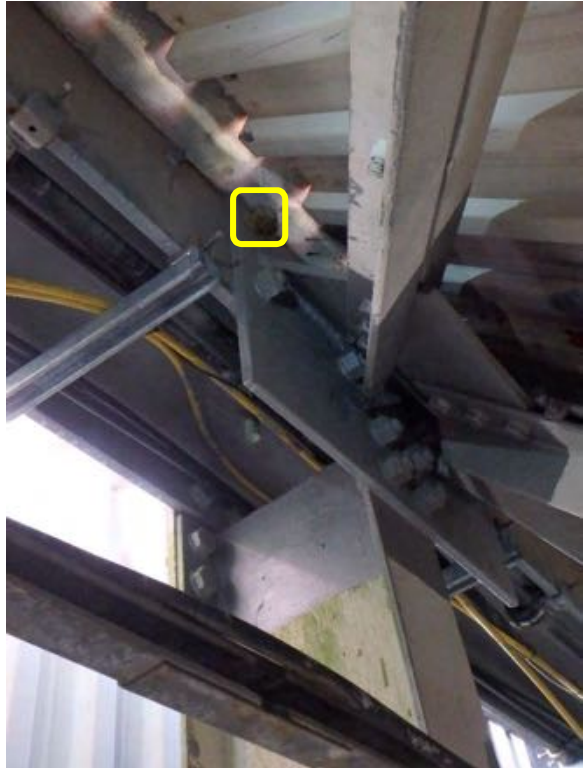
Picture 504: OBSERVATION 504

504	U	2.3	C	504	MRB (x1); Chord splice plate bolts	Surface prepare and treat, or replace

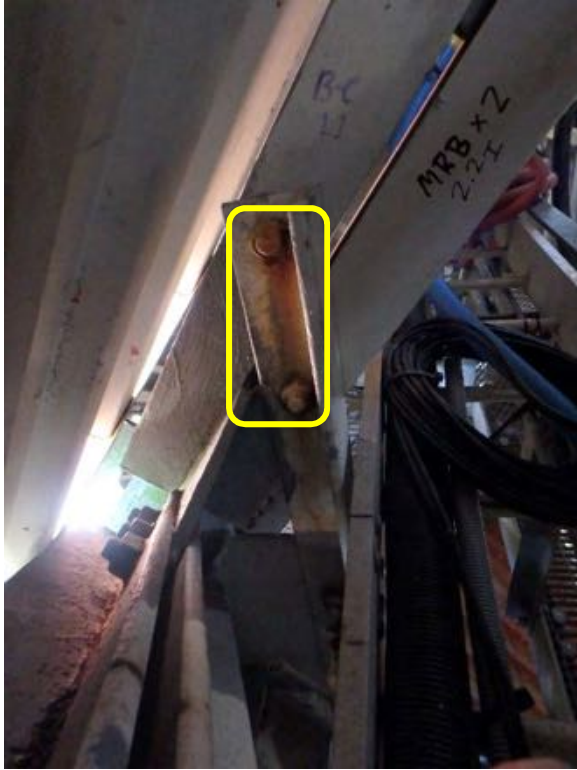
Picture 505: OBSERVATION 505

EAST TRUSS (LEVEL 2)						
505	M	2.2	C	505	MRB (x2); Inner brace bolts	Surface prepare and treat, or replace
506	L	2.2	C	506	MRB (x3); Inner brace bolts	Surface prepare and treat, or replace
507	L	2.2	C	507	MRB (x3); Inner brace bolts	Surface prepare and treat, or replace
508	L	2.3	C	508	MRB (x5); Chord splice plate bolts	Surface prepare and treat, or replace
509	L	2.3	C	509	Minor/Moderate Rust; Vertical web	Surface prepare and treat
510	L	2.5	C	510	MRB (x1); Chord splice plate bolts	Surface prepare and treat, or replace
511	L	2.6	C	511	MRB (x2); Chord splice plate bolts	Surface prepare and treat, or replace
512	L	2.7	C	512	MRB (x4); Chord splice plate bolts	Surface prepare and treat, or replace
513	L	2.9	C	513	MRB (x4); Chord splice plate bolts	Surface prepare and treat, or replace
514	L	2.9	C	514	Minor Rust; Vertical flange	Surface prepare and treat
515	L	2.9	C	515	Minor Rust; Chord flange	Surface prepare and treat

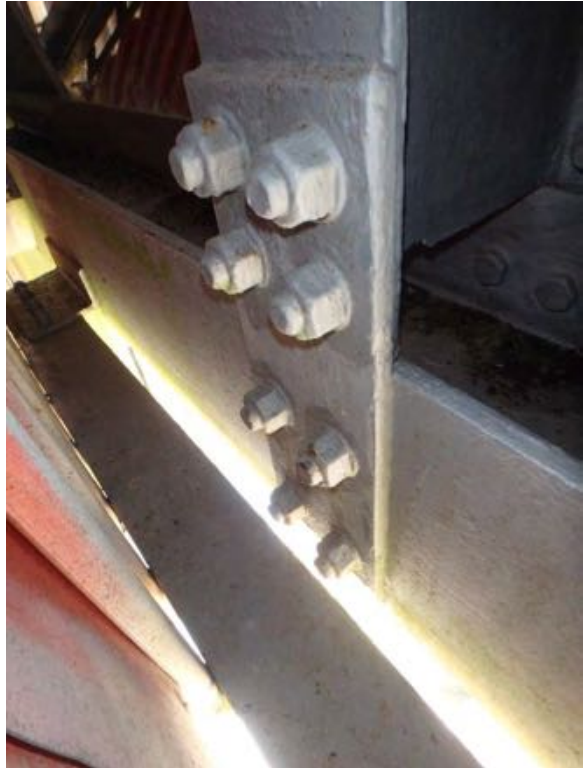
Picture 516: OBSERVATION 516

516	L	2.12	C	516	MRB (x3); Chord splice plate bolts	Surface prepare and treat, or replace
517	L	2.13	C	517	MRB (x3); Chord splice plate bolts	Surface prepare and treat, or replace

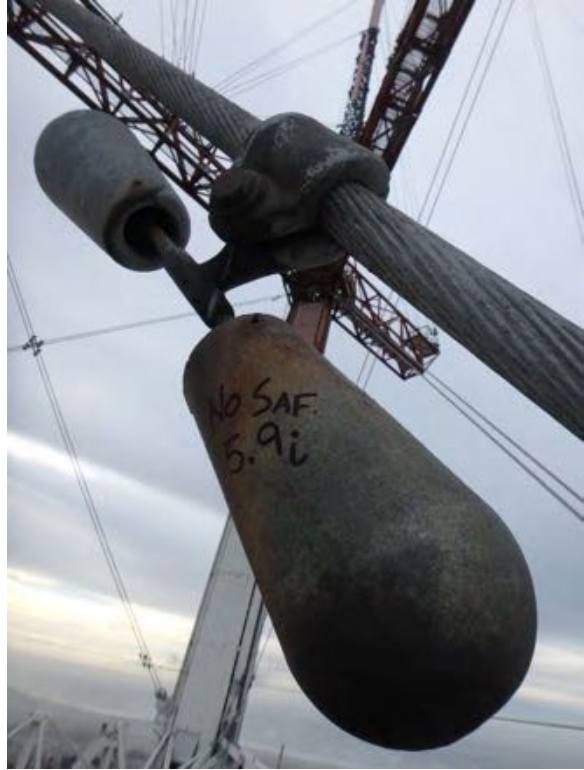
Picture 518: OBSERVATION 518

MISCELLANEOUS				
OBSERV. NO.	Location/Identification	Photo No.	<sup>2</sup> OBSERVATION COMMENTS	RECOMMENDED CORRECTIVE ACTION (CA)
518	STRANDS	518	Strand high frequency dampers are in poor condition throughout structure (numerous broken/degraded safeties, stiff/corroded damper cables, missing dampers, etc.)	Replace high frequency strand dampers
519	Z-Face (Inside 'B' Leg)	519	Minor Rust; Spring hangers on (3) 6-1/8" lines (typ.)	Treat or replace springs if lines are to remain
