FIELD INSPECTION REPORT

WEST STACK A & NORTH TRUSS (LEVEL 6)

APRIL 13, 2018

ERI PROJECT 35473, ADDENDUM 1
977 FT SELF-SUPPORT TOWER
SAN FRANCISCO, CA
ASRN 1001289

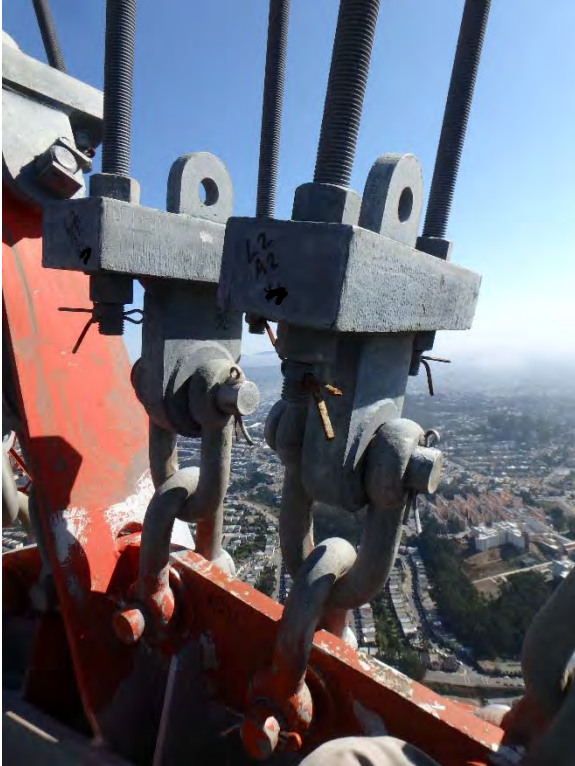
Picture 28: OBSERVATION 26

26	Guying	L1-L3, A2, YL & YR	O	28-29	Minor Rust On All-Thread Cotter Pins (x12)	Replace cotter pins in near future
27	Guying	L3, A1, X	O	30	Top Lock Nuts Not Tightened Down	Run down and tighten top lock nuts
28	Guying	L3, A2, YL	O	31	All-Thread Out By ~1/2"	Adjust all-thread to balance load
29	Guying	L3, A2, YR	O	31	All-Thread Out By ~1/4"	Adjust all-thread to balance load
30	Guying	L2, A3, YR	O	31	All-Thread Out By ~1/4"	Adjust all-thread to balance load
31	Guying	L1, A2, X	O	31	All-Thread Out By ~1/4"	Adjust all-thread to balance load
32	Guying	L2, A2, X	O	31	All-Thread Out By ~1/2"	Adjust all-thread to balance load
33	Guying	L3, A2, X	O	31	All-Thread Out By ~1/4"	Adjust all-thread to balance load
34	Guying	L3, A3, Z	O	31	All-Thread Out By ~1/2"	Adjust all-thread to balance load
35	Guying	L3, A1, Z	O	31	All-Thread Out By ~1/4"	Adjust all-thread to balance load
