Re: **Field Evaluation of Existing  
977-Foot Self-Support Tower  
San Francisco, California  
TCI Project Number 15.082.001**

## Inspection Data Sheet: Leg B (Level 1 to Level 2)

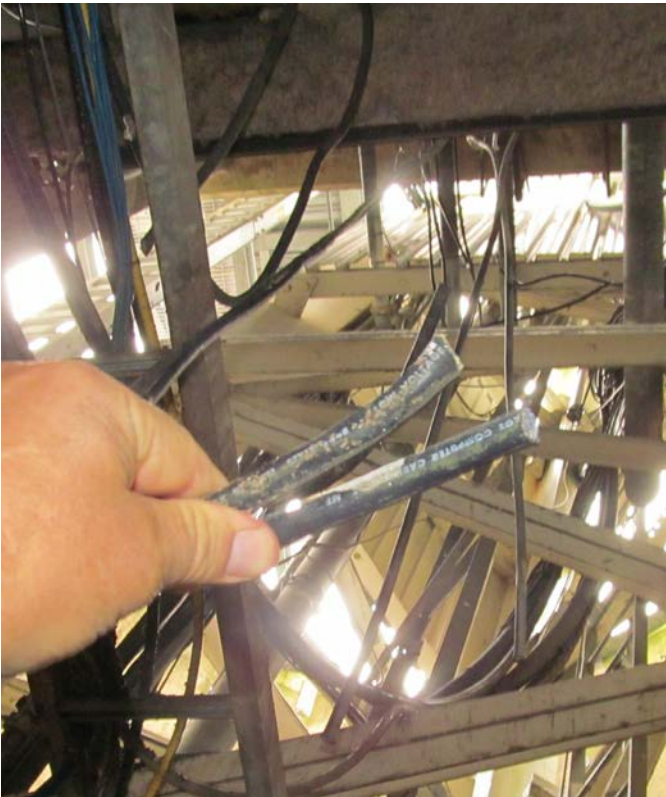
Photo 01.JPG  
7/10/2015

Observ. No.	Location / Identification			Photo No.	Observation Comments
	Column	Elevation	Item <sup>1</sup>		
1	CENTER	1	O	1	SOME COAX CABLES ARE CUT AND ABANDONED AT THE BASE
2	X-FACE	1	O	2	1-1/16" O.D. CONDUIT IS ABANDONED
3	B3	1.1	L	3	RUST ON LEG
4	Y-FACE	1.2	C	4	RUST ON GUSSET
5	Z-FACE	1.1	C	5	RF(1), DIAGONAL BOLT
6	Y-FACE	1.2	C	6	RF(2), DIAGONAL BOLTS
7	B1	1.3	L	7	RUST ON LEG
8	B1	1.3	C	8	RUST ON GUSSETS
9	Z-FACE	1.3	C	9	RF(2), BOLTS FOR SKIN FRAME
10	CENTER	1.7	O	10	(2) 6" RIGID LINES ARE ABANDONED
11	Y-FACE	1.4	C	11	RUSTED GUSSETS
12	Y-FACE	1.4	C	12	RF(3), DIAGONAL BOLTS
13	B2	1.4	L	13	RUST ON LEG
14	CENTER	1.5	O	14	LIGHT FIXTURE HAS MINOR RUST
15	Z-FACE	1.4	C	15	RF(1), DIAGONAL BOLT
16	Z-FACE	1.5	C	16	RF(1), DIAGONAL BOLT
17	Z-FACE	1.4	C	17	RF(2), FOR SKIN FRAME
<b>Sutro Tower</b>				Signature: _____	Page: <u>1</u> of <u>5</u>
<b>San Francisco, CA</b>				File: _____	Date: <u>2-9-16</u>

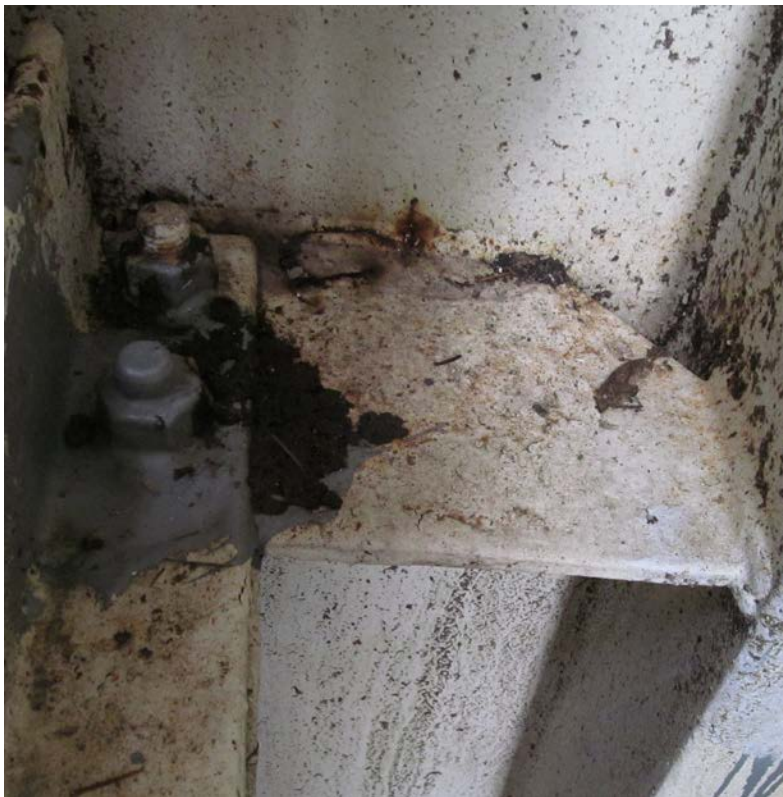
Photo 18.JPG  
7/10/2015

Observ. No.	Location / Identification			Photo No.	Observation Comments
	Column	Elevation	Item <sup>1</sup>		
18	Y-FACE	1.5	C	18	RUST ON GUSSET
19	Z-FACE	1.5	C	19	RUST ON GUSSET
20	ALL FACES	1 - 2	O	20	RUST ON SKIN AT VARIOUS LEVELS
21	Y-FACE	1.5	O	21	SPRING FOR 3" RIGID LINE IS RUSTED
22	X-FACE	1.6	D	22	BENT DIAGONAL MEMBER
23	Z-FACE	1.6	C	23	RF(4), DIAGONAL BOLTS AND RUST ON GUSSET
24	ALL LEGS	1.6	C	24	MINOR RUST ON LEG SPLICE BOLTS AND LEG
25	Y-FACE	1.6	C	25	RUST ON GUSSET AND LEG
26	Z-FACE	1.7	C	26	RUST ON GUSSET AND LEG
27	Z-FACE	1.7	C	27	RF(2), HORIZONTAL BOLTS AND RUST ON GUSSET
28	Y-FACE	1.8	C	28	RF(1), DIAGONAL BOLT AND RUST ON GUSSET
29	Y-FACE	1.9	C	29	RF(1), DIAGONAL BOLT
30	Y-FACE	1.9	C	30	RF(1), HORIZONTAL BOLT
31	Z-FACE	1.10	C	31	RF(1), DIAGONAL BOLT
32	Z-FACE	1.11	C	32	(1) MISSING 3/4" BOLT ON SKIN FRAME
33	Z-FACE	1.11	C	33	RF(1), DIAGONAL BOLT
34	Z-FACE	1.11	C	34	RF(2), HORIZONTAL BOLTS AND RUST ON GUSSET

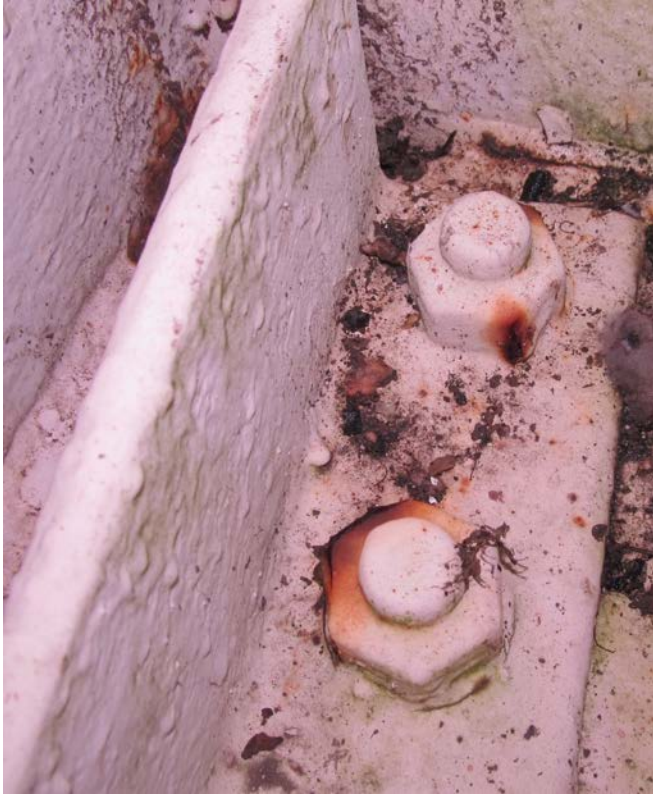
Photo 35.JPG  
7/10/2015

Observ. No.	Location / Identification			Photo No.	Observation Comments
	Column	Elevation	Item <sup>1</sup>		
35	Y-FACE	1.11	C	35	RF(2), HORIZONTAL BOLTS
36	Y-FACE	1.11	C	36	RUSTED GUSSET
37	Z-FACE	1.12	C	37	RF(3), DIAGONAL BOLTS
38	B1	1.13	C	38	RF(15), LEG BOLTS AND RUST ON LEG
39	B2	1.13	C	39	RF(2), LEG BOLTS
40	CENTER	1.13	O	40	1/2" COAX IS LOOSE
41	Z-FACE	1.13	O	41	(1) 1-5/8" AND (2) 1/4" FEED LINES ARE LOOSE
42	X-FACE	1.13	C	42	RF(2), DIAGONAL BOLTS
43	X-FACE	1.14	C	43	RF(1), DIAGONAL BOLT
44	Y-FACE	1.14	C	44	RUSTED GUSSET
45	Z-FACE	1.15	C	45	SEVERELY RUSTED GUSSET
46	Z-FACE	1.15	C	46	RF(1), HORIZONTAL BOLT
47	Z-FACE	1.17	C	47	SEVERELY RUSTED GUSSET
48	Z-FACE	1.19	C	48	(2) RUSTED GUSSETS
49	Z-FACE	1.20	C	49	(1) RUSTED GUSSET
50	B3	1.19	L	50	RUST ON LEG
51	ALL LEGS	1.19	C	51	MINOR RUST ON LEG BOLTS
<b>Sutro Tower</b>				Signature: _____	Page: <u>3</u> of <u>5</u>
<b>San Francisco, CA</b>				File: _____	Date: <u>2-9-16</u>

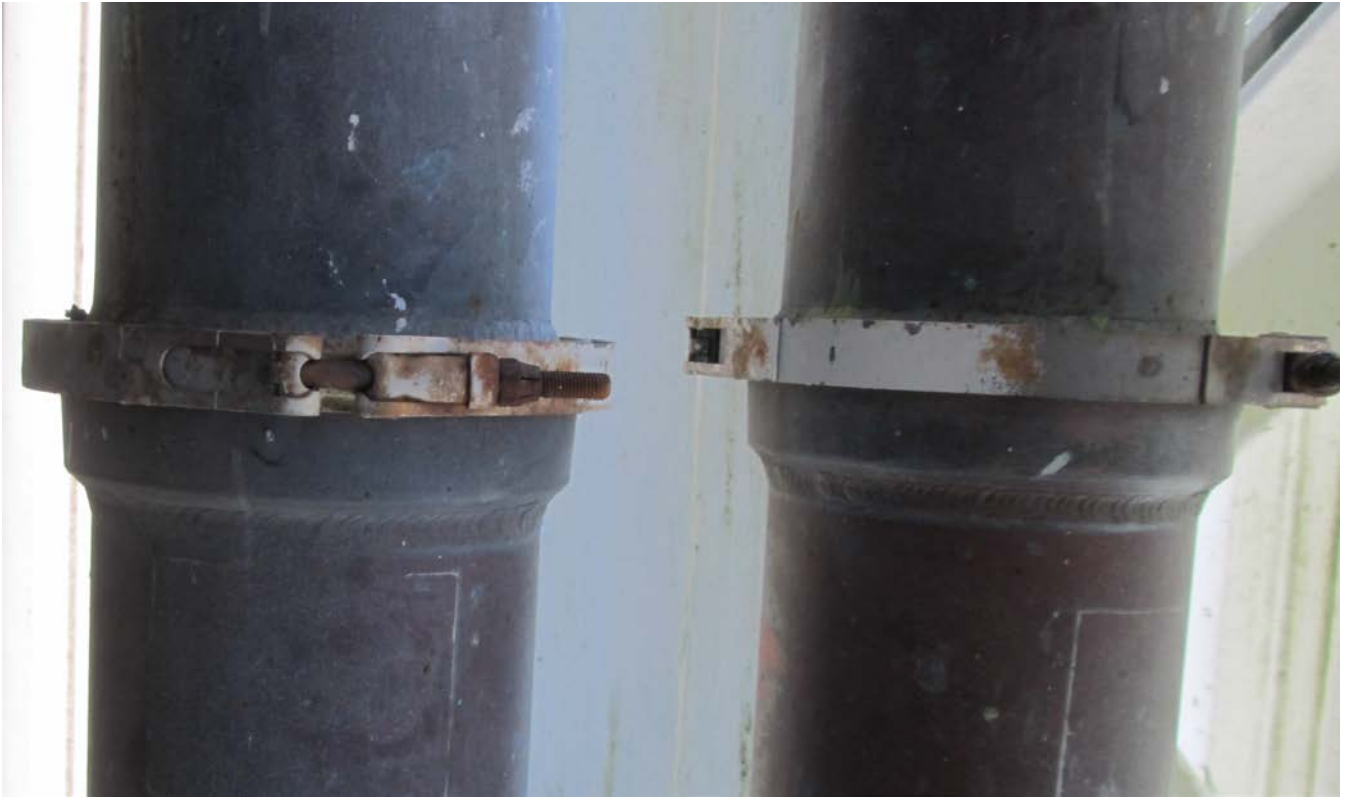
Photo 16.JPG  
8/26/2015

Leg B (Level 2 to Level 3)

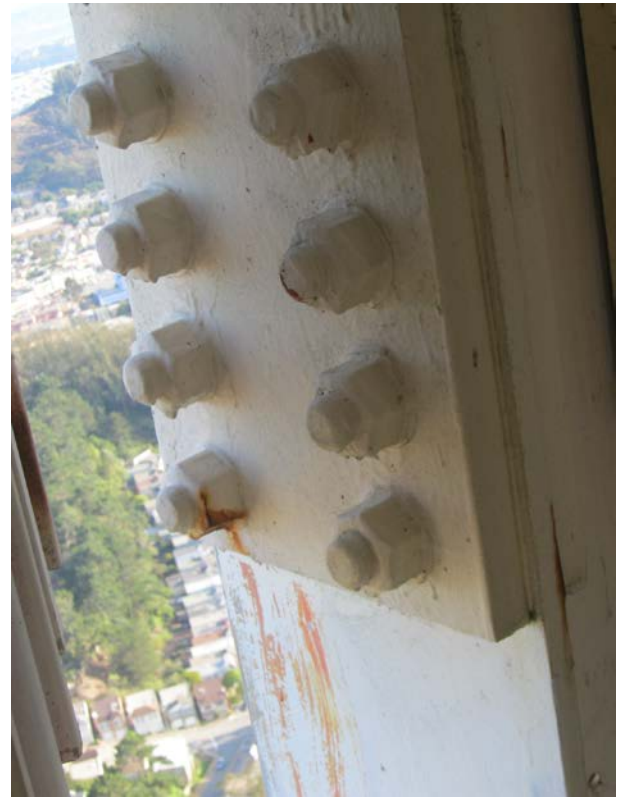
Photo 24.JPG  
8/27/2015

Leg B (Level 3 to Level 4)

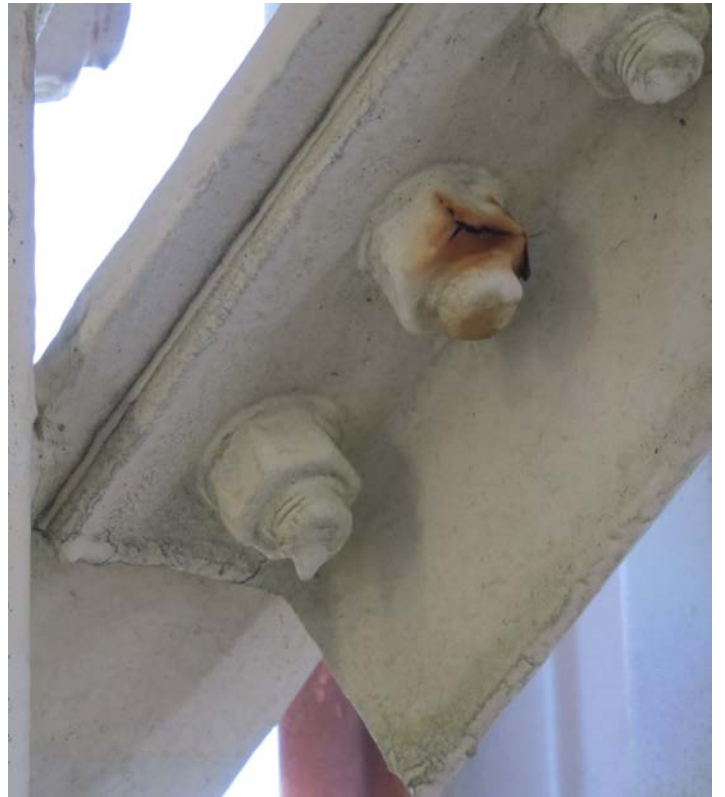
Photo 28.JPG  
8/27/2015

Leg B (Level 3 to Level 4)
