Re: **Field Evaluation of Existing
977-Foot Self-Support Tower
San Francisco, California
TCI Project Number 16.082.001**

Tower Consultants Incorporated was retained by Sutro Tower Inc. to conduct a field observation of the 977-foot self-support tower. The inspection work has been performed in accordance with the requirements of the ANSI/TIA-222-G standard.

The purpose of the field observation was to visually evaluate the condition and structural integrity of the tower. A routine inspection was performed of leg C, the south face trusses and strands, the bases and stack C above the 6th level.

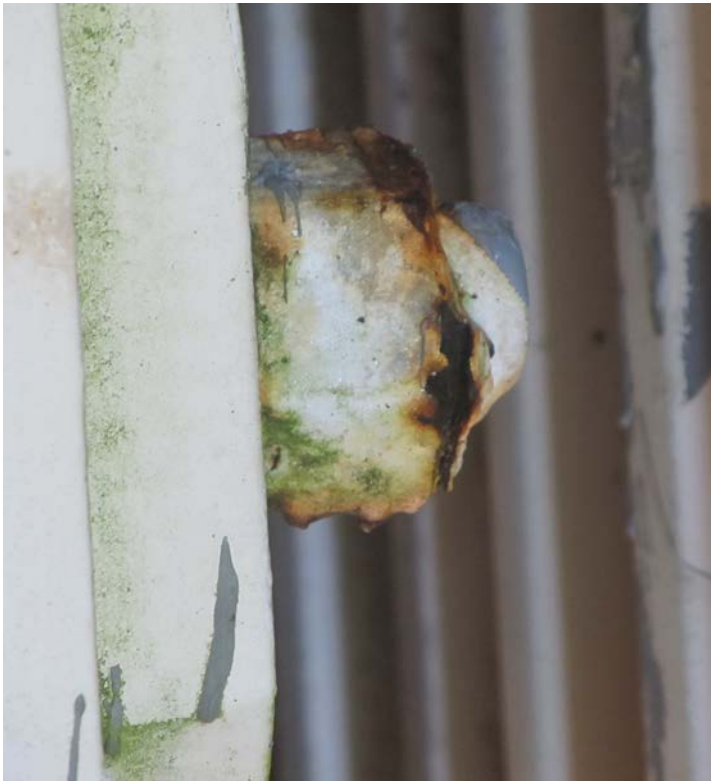
Photo 1.JPG
8/9/2016

Observ. No.	Location/Identification			Photo No.	Observation Comments
	Column	Elevation	Item ¹		
1	Y-FACE	2	C	1	RF(4)
2	Y-FACE	1.33	C	2	RF(1), SKIN SUPPORT ANGLE BOLT
3	Z-FACE	1.33	C	3	RF(2), SKIN SUPPORT BOLTS AND ONE BOLT IS MISSING
4	Z-FACE	1.33	C	4	RF(1), HORIZONTAL BOLT
5	Y-FACE	1.33	C	5	RUSTED DIAGONAL GUSSET
6	X-FACE	1.33	C	6	RF(1), DIAGONAL BOLT
7	Z-FACE	1.33	C	7	RUST ON TWO GUSSETS
8	X-FACE	1.33	C	8	RUST ON LEG AND GUSSET
9	X-FACE	1.31	L	9	RUST ON LEG
10	Z-FACE	1.31	C	10	ONE LOOSE BEAM CONNECTION BOLT
11	Z-FACE	1.31	C	11	RF(1), DIAGONAL BOLT AND RUST ON GUSSET
12	C2	1.31	C	12	RF(3), LEG BOLTS
13	Y-FACE	1.31	L	13	RUST ON LEG
14	C1	1.31	C	14	RF(4), LEG BOLTS
15	C3	1.31	C	15	RF(3), LEG BOLTS
16	Z-FACE	1.29	C	16	TWO BEAM CONNECTION BOLTS ARE LOOSE
17	Y-FACE	1.29	C	17	RF(1), SKIN SUPPORT ANGLE
Sutro Tower				Signature:	Page: <u> 1 </u> of <u> 8 </u>
San Francisco, CA				File:	Date: 1-11-17

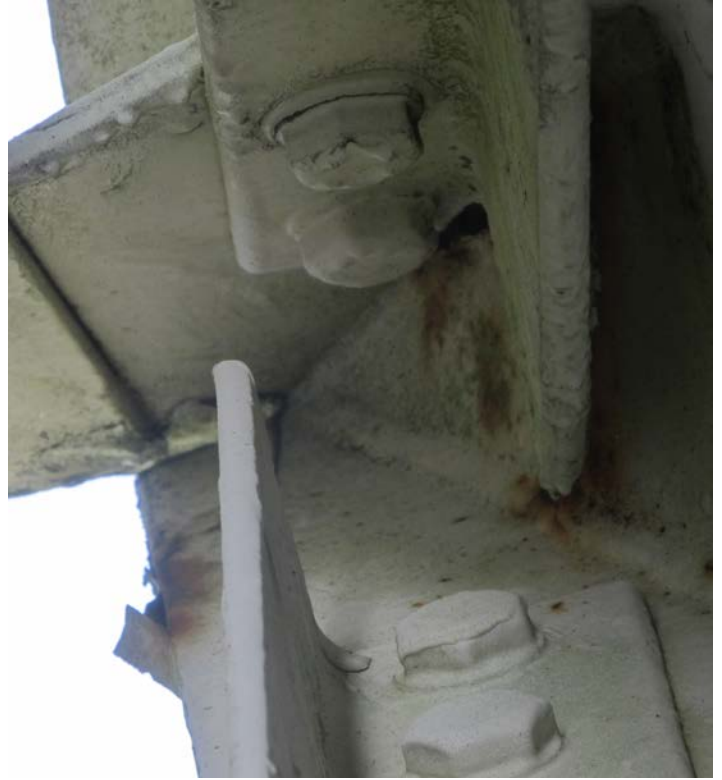
Photo 18.JPG
8/9/2016

Observ. No.	Location/Identification			Photo No.	Observation Comments
	Column	Elevation	Item ¹		
18	Y-FACE	1.29	C	18	RUST ON GUSSET
19	C2	1.28	L	19	RUST ON LEG
20	Z-FACE	1.27	O	20	CONDUIT HAS RUSTED HARDWARE AND JUNCTION BOX HAS BROKEN CONNECTORS
21	Z-FACE	1.27	C	21	RF(1), HORIZONTAL BOLT
22	Y-FACE	1.27	C	22	RF(1), DIAGONAL BOLT
23	Y-FACE	1.27	C	23	RF(2), SKIN SUPPORT ANGLE BOLT
24	Y-FACE	1.28	C	24	RUST ON DIAGONAL GUSSET
25	X-FACE	1.28	C	25	RUST ON DIAGONAL GUSSET
26	X-FACE	1.27	O	26	TWO SCREWS ARE MISSING FOR JUNCTION BOX CONDUIT
27	X-FACE	1.27	C	27	RF(1), DIAGONAL BOLT
28	Z-FACE	1.26	C	28	RUST ON DIAGONAL GUSSET
29	Y-FACE	1.25	C	29	RF(2), SKIN SUPPORT ANGLE BOLTS
30	C2	1.25	C	30	RF(5), LEG BOLTS
31	Y-FACE	1.24	C	31	RF(1), DIAGONAL BOLT AND RUST ON GUSSET
32	C1	1.25	C	32	RF(5), LEG BOLTS
33	Y-FACE	1.25	C	33	RF(2), SKIN SUPPORT BOLTS AND BOLT IS LOOSE
34	Y-FACE	1.23	C	34	RF(1), DIAGONAL BOLT & RF(1), SKIN SUPPORT ANGLE BOLT

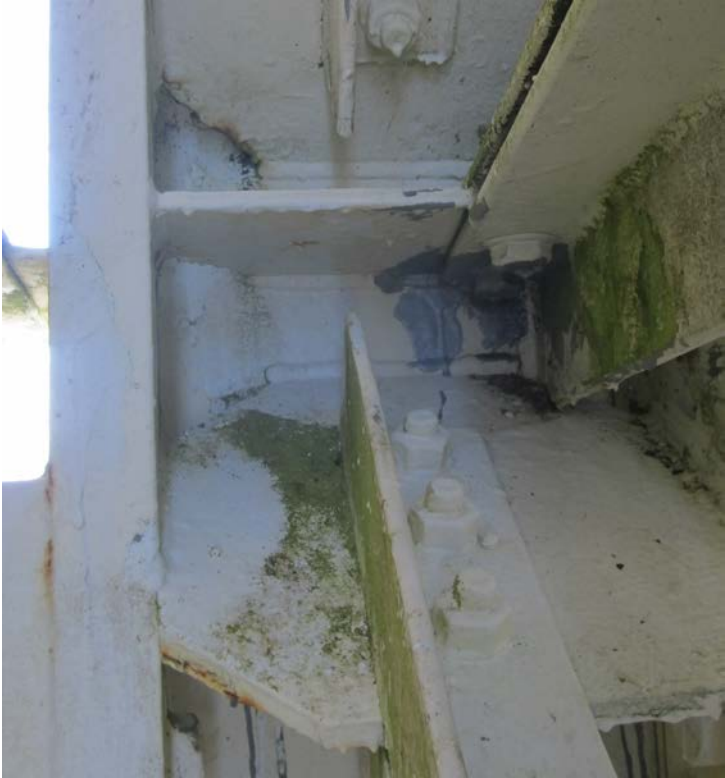
Photo 56.JPG
8/9/2016

Leg C (Level 2 to Level 3)

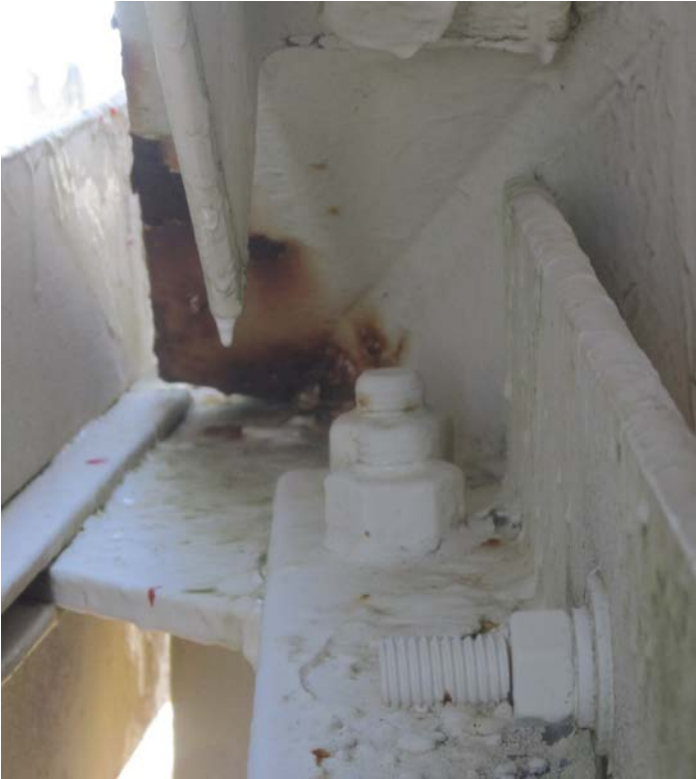
Photo 68.JPG
8/9/2016

Leg C (Level 2 to Level 3)

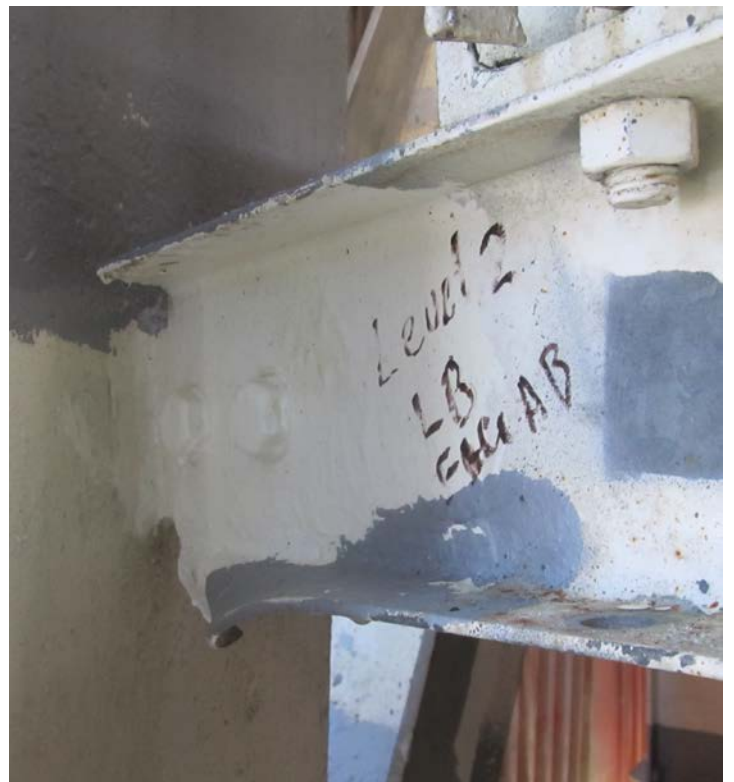
Photo 104.JPG
8/9/2016

Leg C (Level 2 to Level 3)

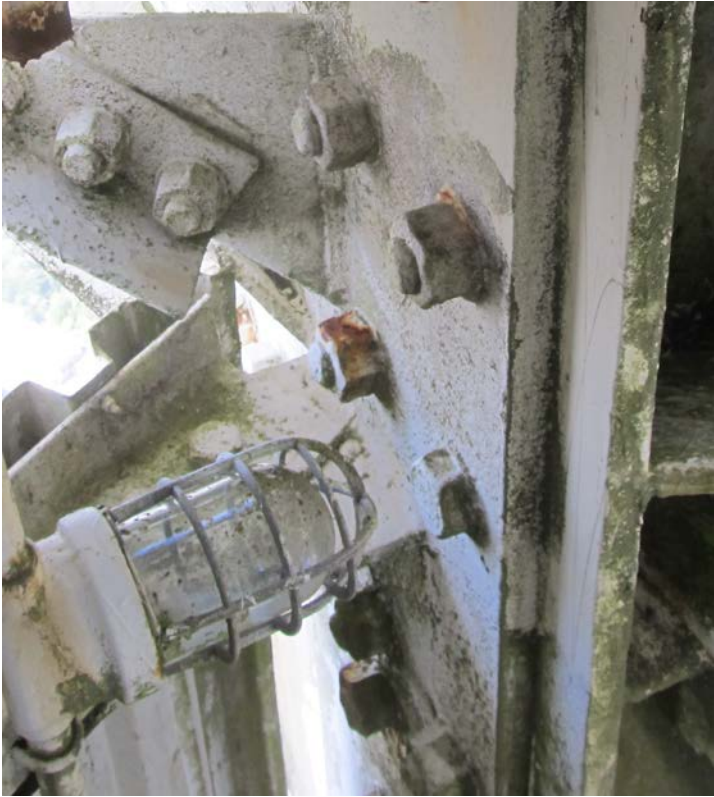
Photo 1.JPG
8/10/2016

Observ. No.	Location/Identification			Photo No.	Observation Comments
	Column	Elevation	Item ¹		
1	C2	5	C	1	RF(12), LEG BOLTS
2	C3	5	C	2	RF(3), LEG BOLTS
3	C1	5	C	3	RF(7), LEG REINFORCEMENT BOLTS AND RUST ON PLATE
4	Y-FACE	4.19	C	4	RF(1), AND RUST ON GUSSET
5	X-FACE	4.19	H	5	BENT HORIZONTAL
6	Y-FACE	4.18	C	6	RF(1), DIAGONAL BOLT
7	C3	4.18	C	7	RF(8), LEG REINFORCING BOLTS
8	Y-FACE	4.16	C	8	RF(5), LEG REINFORCING BOLTS
9	Y-FACE	4.13	C	9	MINOR RUST ON HORIZONTAL GUSSET
10	X-FACE	4.15	C	10	RF(2), HORIZONTAL BOLTS
11	Y-FACE	4.15	C	11	MINOR RUST ON HORIZONTAL GUSSET
12	C1	4.11	L	12	RUST ON LEG
13	C2	4.13	C	13	RF(7), LEG BOLTS
14	C3	4.13	C	14	RF(5), LEG BOLTS
15	Y-FACE	4.7	L	15	RUST ON LEG
16	Y-FACE	4.7	C	16	RF(1), DIAGONAL BOLT
17	C2	4.7	C	17	RF(6), LEG BOLTS
Sutro Tower				Signature: _____	Page: <u> 1 </u> of <u> 2 </u>
San Francisco, CA				File: _____	Date: 1-11-17

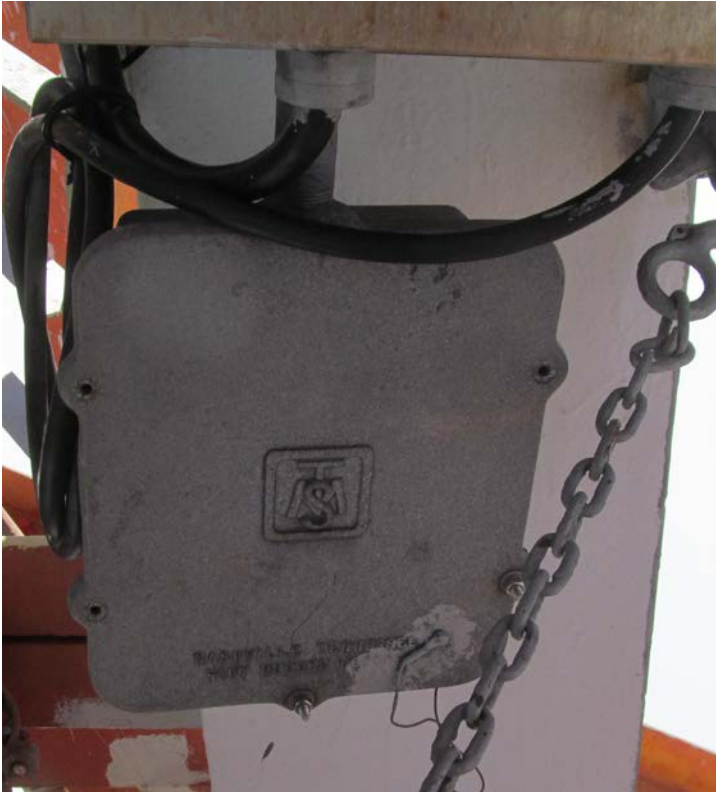
Photo 1.JPG
7/11/2016

Observ. No.	Location/Identification			Photo No.	Observation Comments
	Column	Elevation	Item ¹		
1	Z-FACE	6.2	O	1	JUNCTION BOX IS MISSING SCREWS
2	Y-FACE	6.3	O	2	LOOSE JUMPER CABLE
3	C3	6.3	L	3	RUST ON LEG
4	Z-FACE	6	O	4	ONE AUXILIARY CONDUIT
5	Z-FACE	6.2	O	5	BROKEN LIGHT
6	CENTER	6.3	O	6	RUSTED HARDWARE FOR SAFETY CABLE RAIL
7	C2	6	C	7	RF(2), HORIZONTAL BOLTS
8	C3	6	C	8	RF(6), LEG REINFORCEMENT BOLTS
9	X-FACE	6.1	C	9	RF(1), HORIZONTAL BOLT
10	C1	6.1	C	10	GUSSET SHOWS MINOR RUST
11	Y-FACE	6.05	O	11	ELECT. COND. JUNCTION BOX COVER IS RUSTED
12	C3	6	C	12	RF(3), HORIZONTAL BOLTS
13	C1	6	C	13	RF(1) AND ONE BOLT IS SHORT
14	X-FACE	6	C	14	COTTER PIN IS RUSTED ON RIGGING FAN PLATE
15	Y-FACE	6	C	15	RF(2), HORIZONTAL BOLTS & RF(1) DIAGONAL BOLT
16	Y-FACE	6	C	16	RF(1), DIAGONAL BOLT AND GUSSET IS RUSTED
17	Z-FACE	5.195	C	17	RUST ON TWO DIAGONAL GUSSETS
Sutro Tower				Signature: _____	Page: <u> 1 </u> of <u> 4 </u>
San Francisco, CA				File: _____	Date: 1-11-17

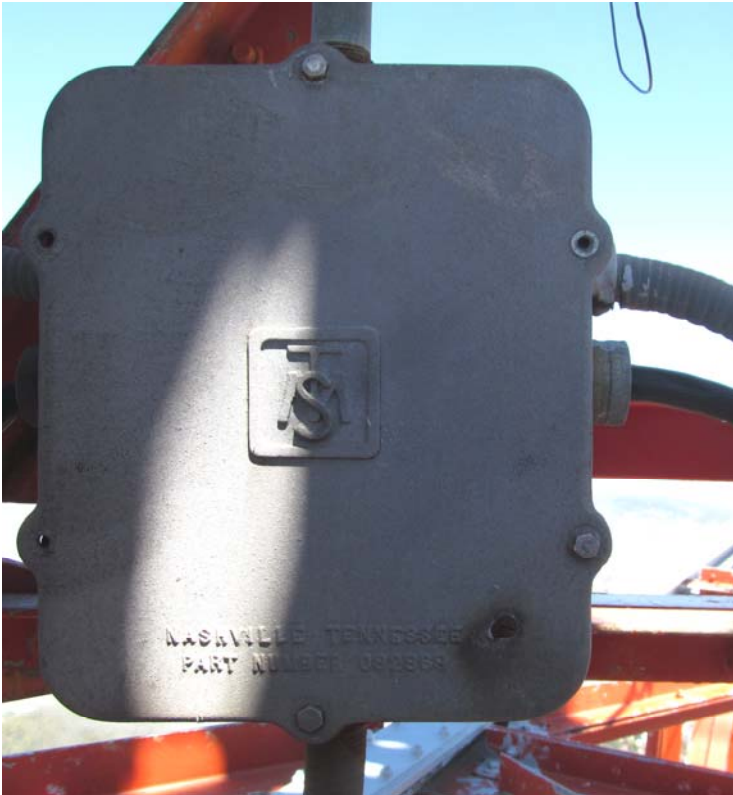
Photo 01.JPG
7/12/2016

Observ. No.	Location/Identification			Photo No.	Observation Comments
	Column	Elevation	Item ¹		
1	Y-FACE	6	O	1	JUNCTION BOX IS MISSING SCREWS
2	Y-FACE	6	O	2	DAMAGED JACKET FOR FLEX LINE
3	Z-FACE	6	O	3	LOOSE FEED LINE
<i>Sutro Tower</i>				Signature: _____	Page: <u> 1 </u> of <u> 1 </u>
<i>San Francisco, CA</i>				File: _____	Date: 1-11-17

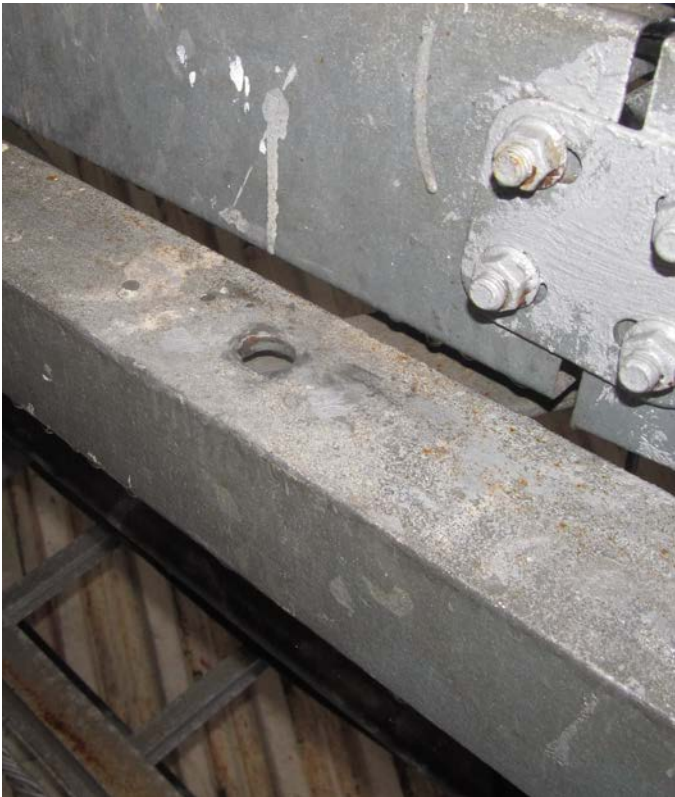
Photo 01.JPG
8/11/2016

Observ. No.	Location/Identification			Photo No.	Observation Comments
	Chord ¹	Horiz. Location	Item ²		
1	M	3.1	O	1	CATWALK HANDRAIL IS MISSING A BOLT
2	L	3.1	C	2	RF(1)
3	L	3.9	C	3	NEW BOLTS ARE NOT PAINTED
4	L	3.9	C	4	RF(5)
5	L	3.8	H	5	SKIN SUPPORT CHANNEL IS CUT
6	L	3.5	L	6	RUST ON VERTICAL
7	L	3.5	D	7	RUST ON DIAGONAL
8	L	3.3	H	8	SKIN SUPPORT CHANNEL IS CUT
9	L	3.1	C	9	RF(9)
10	L	3.1	C	10	RF(3)
11	U	3.1	C	11	RF(4)
12	U	3.1	H	12	MINOR RUST ON BEAM
13	U	3.1	O	13	RUSTED CLIPS ON SAFETY CABLE
<i>Sutro Tower</i>				Signature:	Page: <u> 1 </u> of <u> 1 </u>
<i>San Francisco, CA</i>				File:	Date: 1-11-17
